Source: Journal of Raptor Research, 51(3) : 293-304

## AVIAN ELECTROCUTIONS ON INCORRECTLY RETROFITTED POWER POLES

JAMES F. DWYER,<sup>1</sup> RICHARD E. HARNESS, AND DUNCAN ECCLESTON  
*EDM International Inc., Fort Collins, CO 80525 U.S.A.*

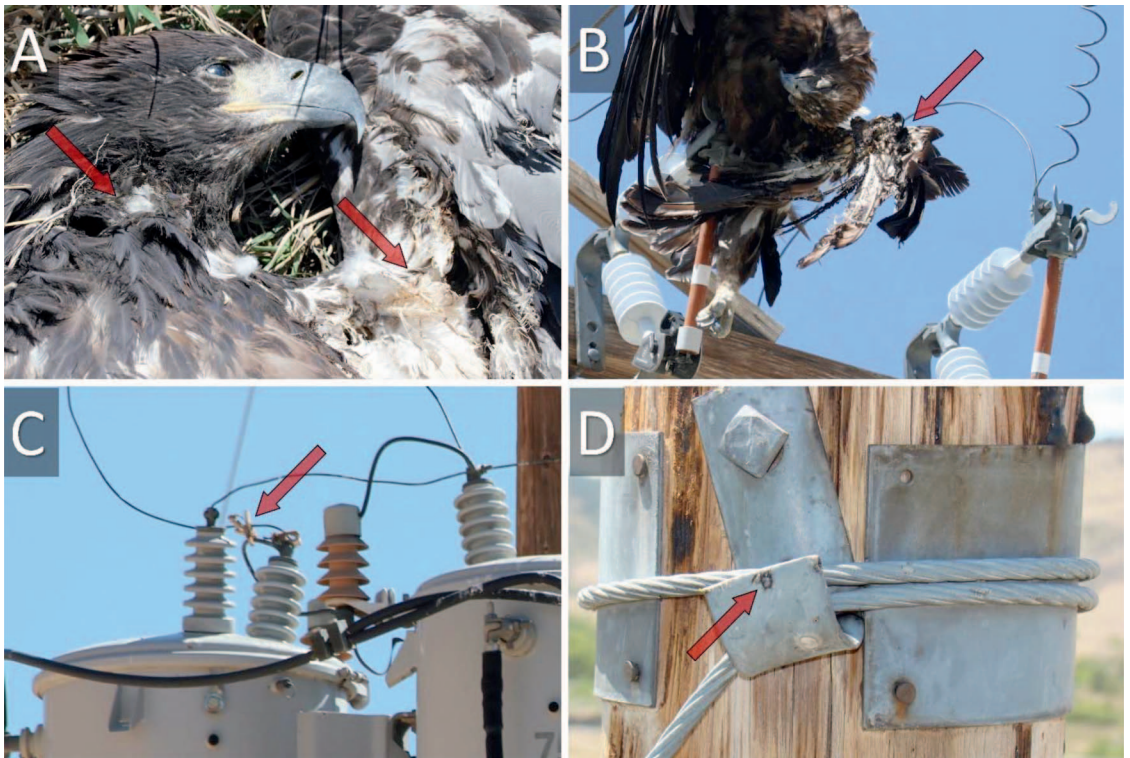
Figure 3. (A) Burns on the neck and axillary feathers of the carcass of an electrocuted Bald Eagle. (B) Burns on the left wing of the carcass of an electrocuted Golden Eagle suspended on energized equipment. (C) The feet of an unidentified electrocuted *Buteo* species grasping an energized jumper. (D) Arc mark on a grounded guy wire connection following the electrocution of a Bald Eagle.

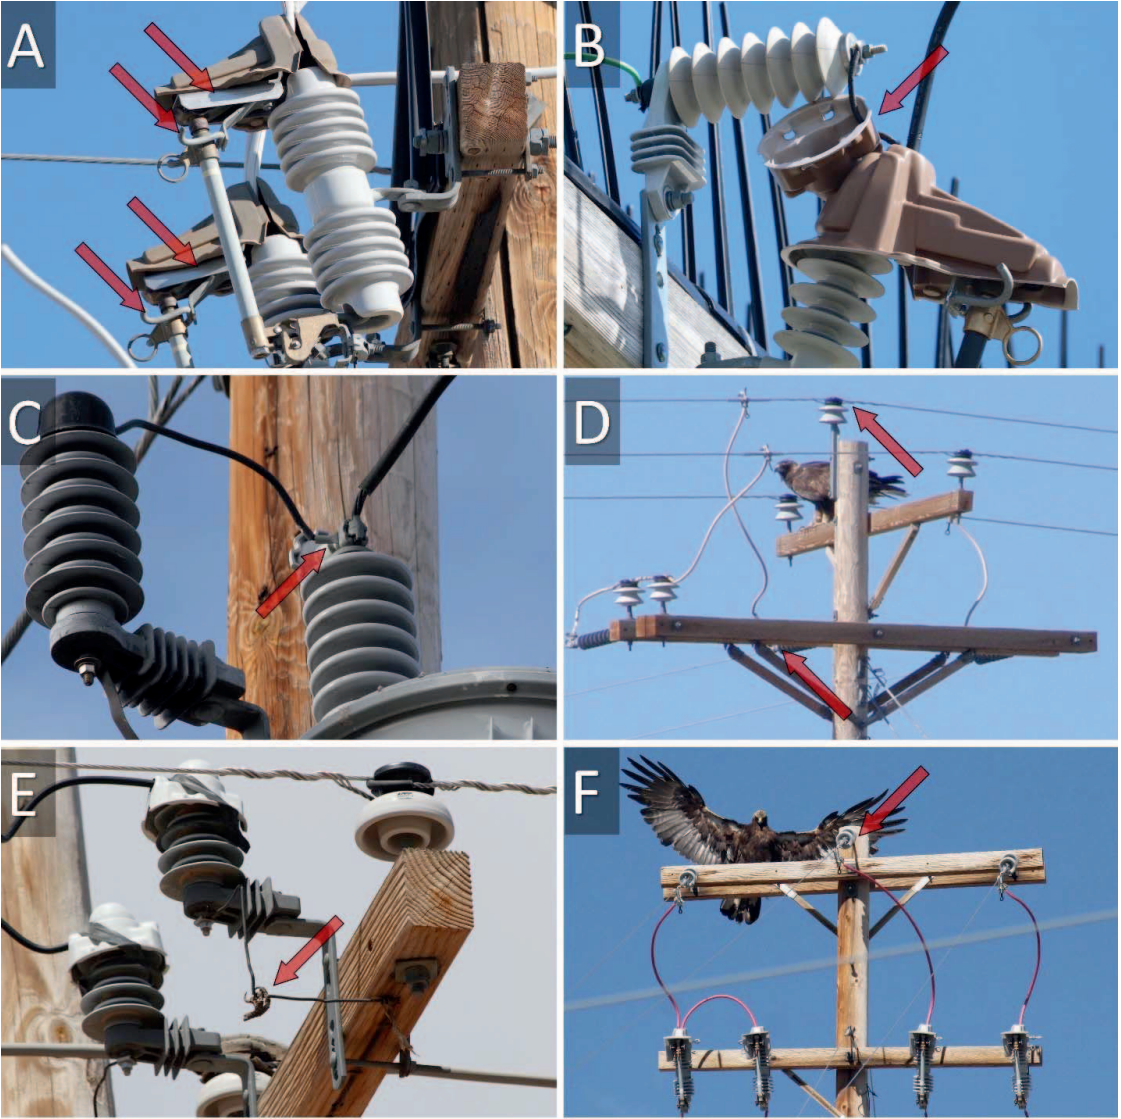
Mitigation plan errors were most frequent, followed by application errors, and product design errors. Components involved in electrocutions differed by error type (Table 3), but all resulted from inadequate insulation. Product design errors occurred when covers did not fully cover all energized parts of the tops of cutouts (Fig. 4A), and when covers fell off (Fig. 4B, C). Among mitigation plan errors, the most common errors were failures to specify covers for all energized equipment and all energized jumpers on poles. We identified omissions of one or more conductor covers and deadend covers (Fig. 4D, E, F), cutout covers and arrester covers (Fig. 5A), bushing covers (Fig. 5B), and jumper covers (Fig. 5C). Mitigation plan errors also occurred where vertical clearances were not adequately considered (Fig. 5D). Application errors consistently resulted from gaps in jumper coverage (Fig. 5E, F).

Figure 4. Arrows indicate retrofitting errors. (A) Product design error: covers installed on cutouts but energized tops remain exposed. (B) Product design error: arrester cap dislodged and locking horns exposed. (C) Product design error: arrester and jumpers covered, but bushing cover dislodged. (D) Mitigation plan error: jumpers covered, but conductor cover (upper arrow) and deadend cover (lower arrow) absent. (E) Mitigation plan error: the foot of a Chihuahuan Raven on an arrester ground resulting from routing the uninsulated ground wire below the exposed primary conductor. (F) Mitigation plan error: all energized equipment covered, except deadend cover absent.
