Source: Journal of Raptor Research, 51(3) : 293-304

AVIAN ELECTROCUTIONS ON INCORRECTLY RETROFITTED POWER POLES

JAMES F. DWYER,¹ RICHARD E. HARNESS, AND DUNCAN ECCLESTON
EDM International Inc., Fort Collins, CO 80525 U.S.A.

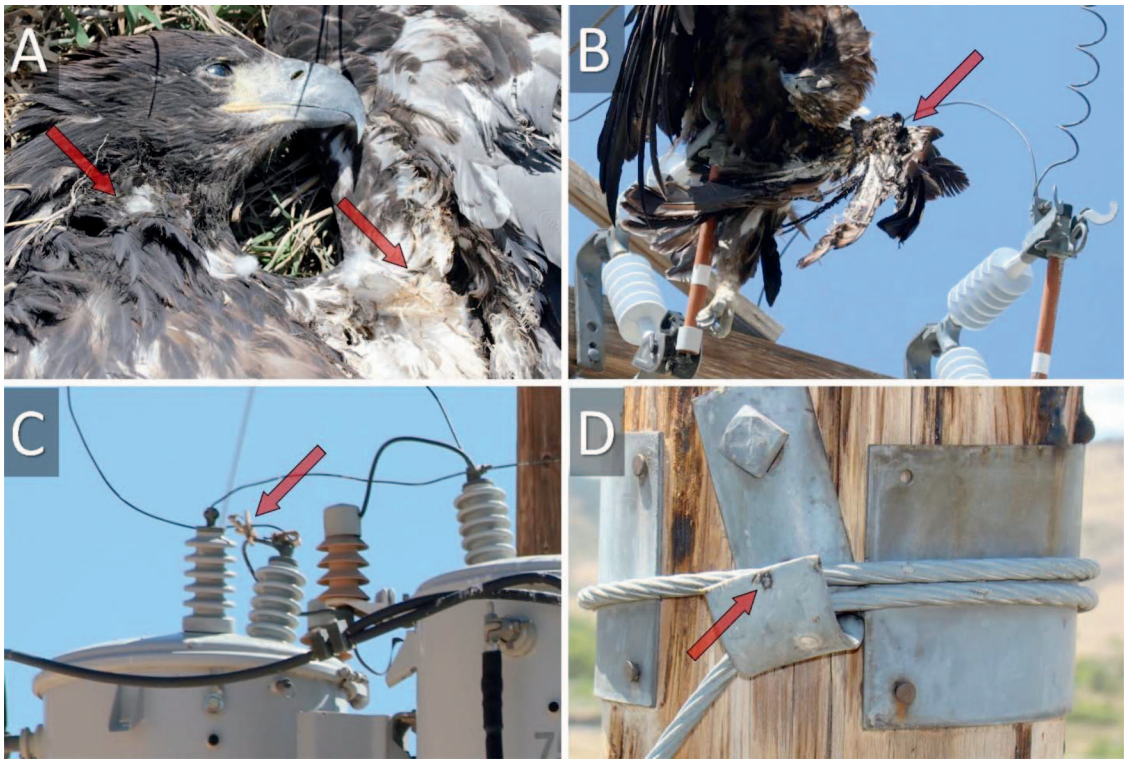
Figure 3. (A) Burns on the neck and axillary feathers of the carcass of an electrocuted Bald Eagle. (B) Burns on the left wing of the carcass of an electrocuted Golden Eagle suspended on energized equipment. (C) The feet of an unidentified electrocuted *Buteo* species grasping an energized jumper. (D) Arc mark on a grounded guy wire connection following the electrocution of a Bald Eagle.
