Source: Journal of Raptor Research, 51(3) : 293-304

AVIAN ELECTROCUTIONS ON INCORRECTLY RETROFITTED POWER POLES

JAMES F. DWYER,¹ RICHARD E. HARNESS, AND DUNCAN ECCLESTON
EDM International Inc., Fort Collins, CO 80525 U.S.A.

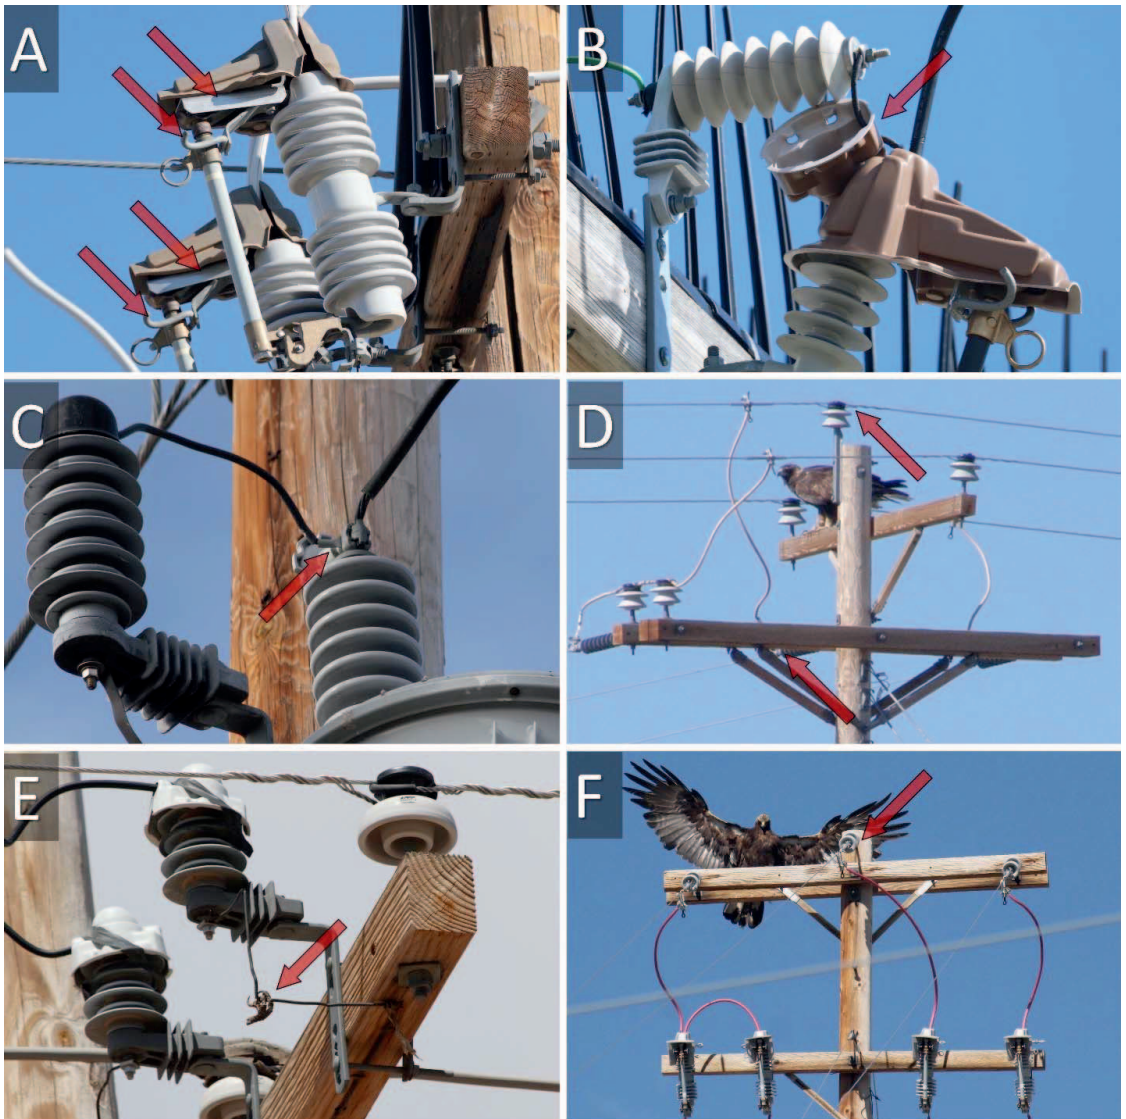
Components involved in electrocutions differed by error type (Table 3), but all resulted from inadequate insulation. Product design errors occurred when covers did not fully cover all energized parts of the tops of cutouts (Fig. 4A), and when covers fell off (Fig. 4B, C). Among mitigation plan errors, the most common errors were failures to specify covers for all

energized equipment and all energized jumpers on poles. We identified omissions of one or more conductor covers and deadend covers (Fig. 4D, E, F), cutout covers and arrester covers (Fig. 5A), bushing covers (Fig. 5B), and jumper covers (Fig. 5C). Mitigation plan errors also occurred where vertical clearances were not adequately considered (Fig. 5D). Application errors consistently resulted from gaps in jumper coverage (Fig. 5E, F).

Figure 4. Arrows indicate retrofitting errors. (A) Product design error: covers installed on cutouts but energized tops remain exposed. (B) Product design error: arrester cap dislodged and locking horns exposed. (C) Product design error: arrester and jumpers covered, but bushing cover dislodged. (D) Mitigation plan error: jumpers covered, but conductor cover (upper arrow) and deadend cover (lower arrow) absent. (E) Mitigation plan error: the foot of a Chihuahuan Raven on an arrester ground resulting from routing the uninsulated ground wire below the exposed primary conductor. (F) Mitigation plan error: all energized equipment covered, except deadend cover absent.

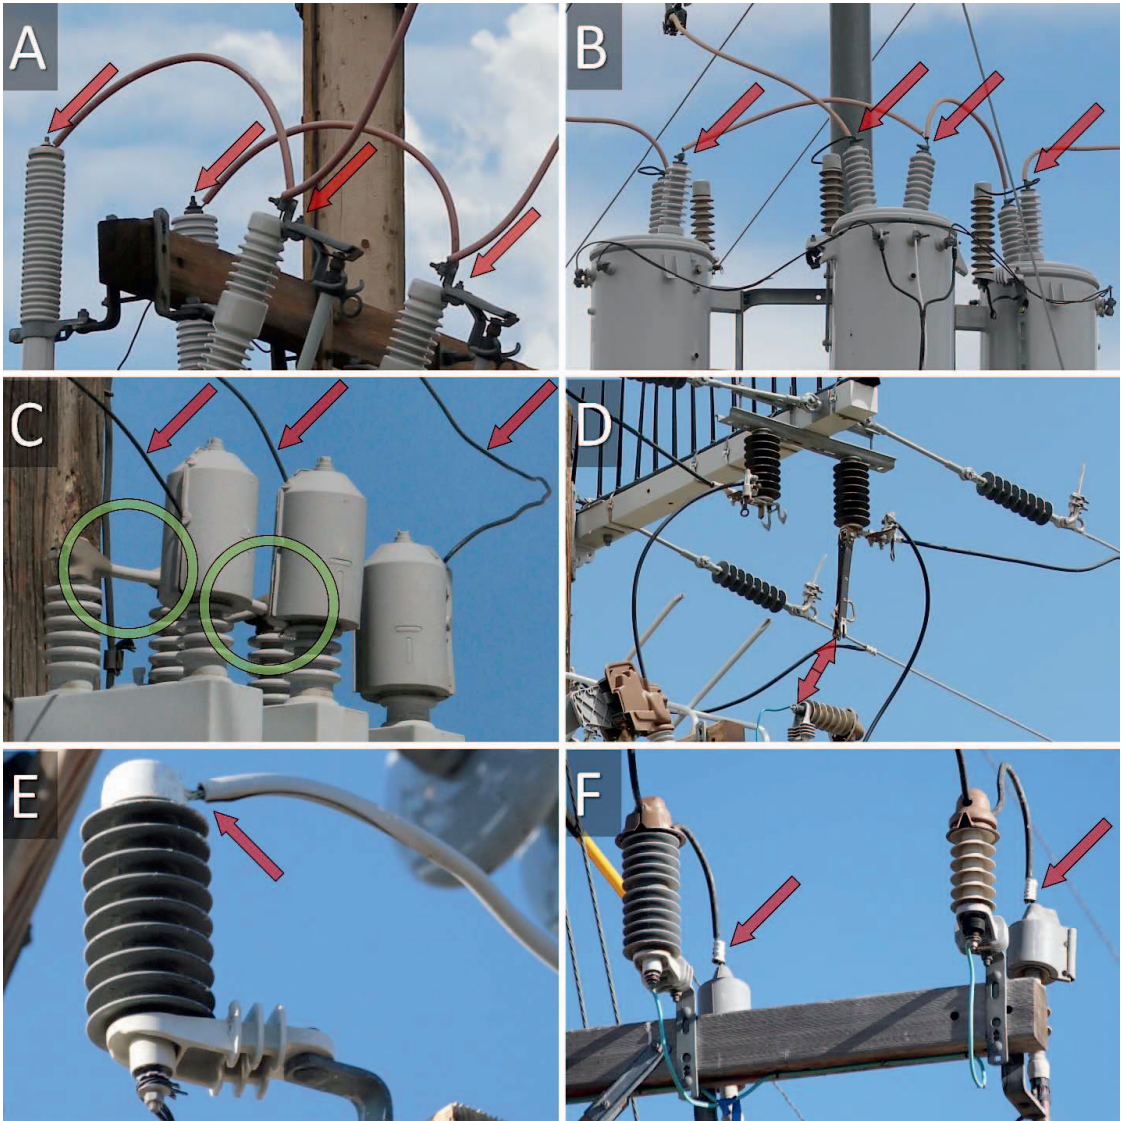
Figure 5. Arrows indicate retrofitting errors. (A) Mitigation plan error: jumpers covered, but arrester covers (left arrows) and cutout covers (right arrows) absent. (B) Mitigation plan error: jumpers and arresters covered, but bushing covers not installed. (C) Mitigation plan error: bushings and jumpers between bushings (circles) covered, but jumpers exposed above (arrows). (D) Mitigation plan error: insufficient clearance between open switch above and grounded arrester connection below. Redirection materials on the upper crossarm may also push birds into perching near energized components on the lower crossarm. (E) Application error: jumper and arrester covered, but a gap in jumper coverage exists between retrofitting products. (F) Application error: all equipment covered, but gaps in coverage where jumpers connect.

Application errors were the second-most common error type ($n = 13$ poles, 5 Golden Eagles). Application errors were unexpected given that personnel installing retrofitting products are well-trained to be aware of potential points of electrical contact for their own safety. Correcting application errors may be a simple matter of conveying more clearly to installation crews that they must completely cover all energized components of equipment identified for insulation. For example, when jumpers are insulated, the insulation should be inserted inside insulating covers on equipment (Fig. 6E). Regular training regarding application materials, techniques, and errors observed would help in this regard.

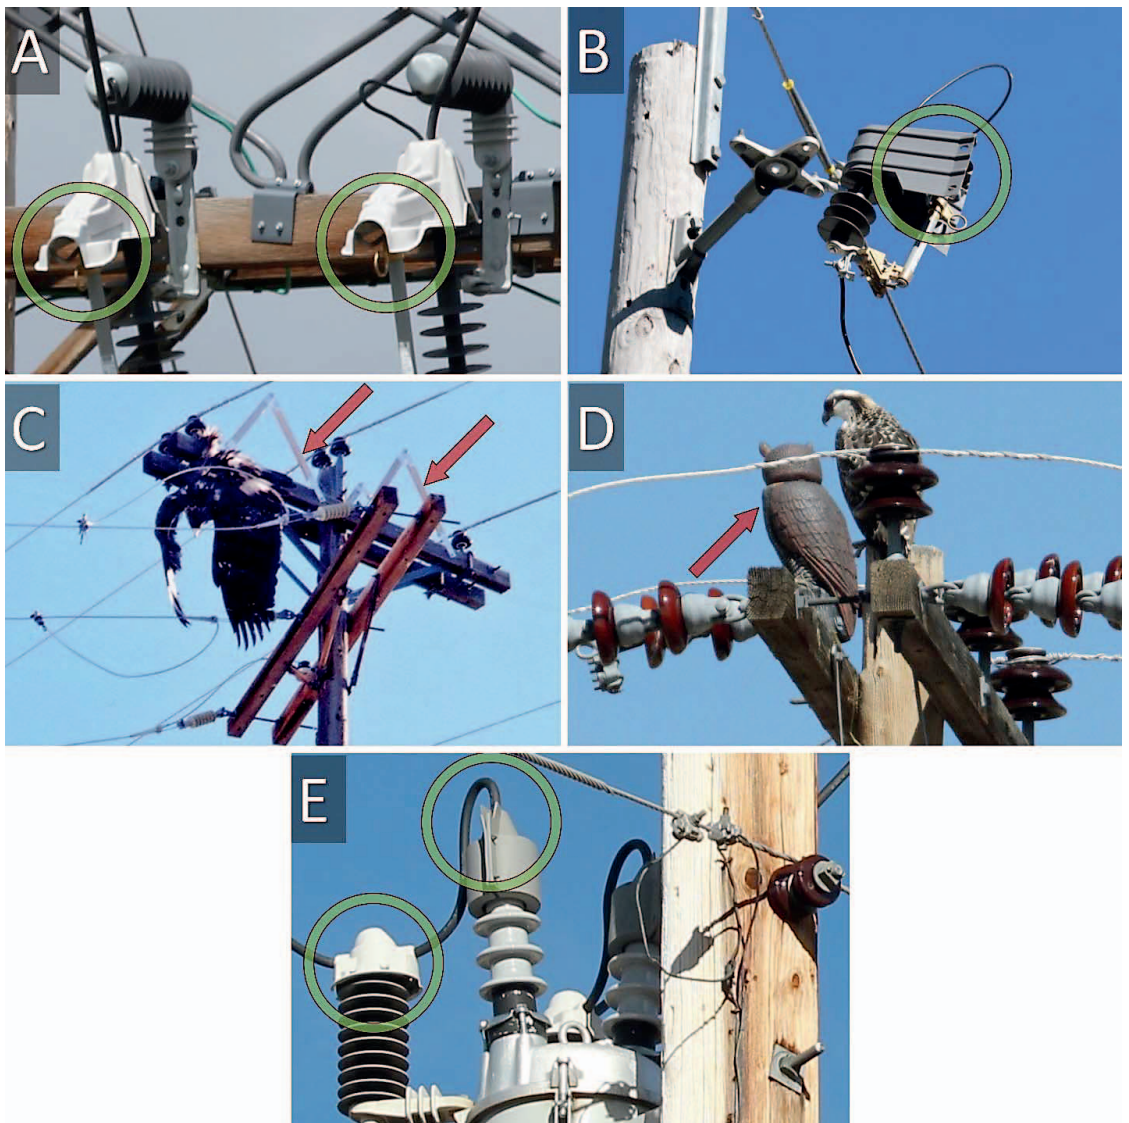
Figure 6. Arrows indicate retrofitting errors. Circles indicate correct retrofitting. (A) Cutout covers fully covering all energized parts on the upper portion of cutouts minimize avian electrocution risk. (B) Cutout cover fully covering all energized parts on the upper portion of cutouts minimize avian electrocution risk. (C) Golden Eagle electrocuted on a pole fitted with early model perch discouragers, ineffective in redirecting perching. (D) An Osprey perched next to a plastic owl, ineffective in redirecting perching. (E) Jumper insulation inserted inside insulating covers on arresters and bushings to minimize electrocution risk.

cutout covers that did not cover the entire tops of cutouts have resulted in the development of covers that include greater coverage (Fig. 6A, B). Because many manufacturers state a willingness to work with utilities to refine or develop retrofitting products

critical link in reducing electrocutions, as demonstrated by shifting retrofitting strategies from largely redirection-based mitigation (Fig. 6C, D) to largely insulation-based products. This change occurred specifically because perch discouragers were not meeting retrofitting objectives on some configura-
