Ecosystem Services of Riparian Restoration: A Review of Rock Detention Structures in the Madrean Archipelago Ecoregion

Laura M Norman

US Geological Survey, Western Geographic Science Center, Tucson, USA.

Air, Soil and Water Research
Volume 13: 1–13
© The Author(s) 2020
Article reuse guidelines:
sagepub.com/journals-permissions
DOI: 10.1177/1178622120946337

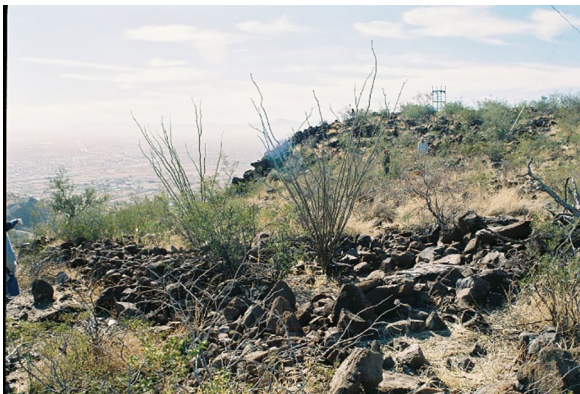
Figure 2. A massive ca. 2000-year-old Native American trinchera feature (built-up rock terrace) near the crown of Tumamoc Hill, Arizona.³⁷

BCE to CE 1450, are prehistoric terraces with rock retaining walls used for various functions including habitation, ceremonial purposes, defense refuges, and related to early forms of irrigating agriculture (Figures 1 and 2).^{31–36} Classification of *trincheras* for agricultural sites includes: (1) “terraces” (check dams) built as low walls across small stream channels to hold soil and cause flowing water to soak in rather than runoff, and (2) “linear borders” (riprap) built as alignments of stones along gentle slopes to reduce soil erosion, slow runoff, and increase infiltration for agricultural purposes.³⁶

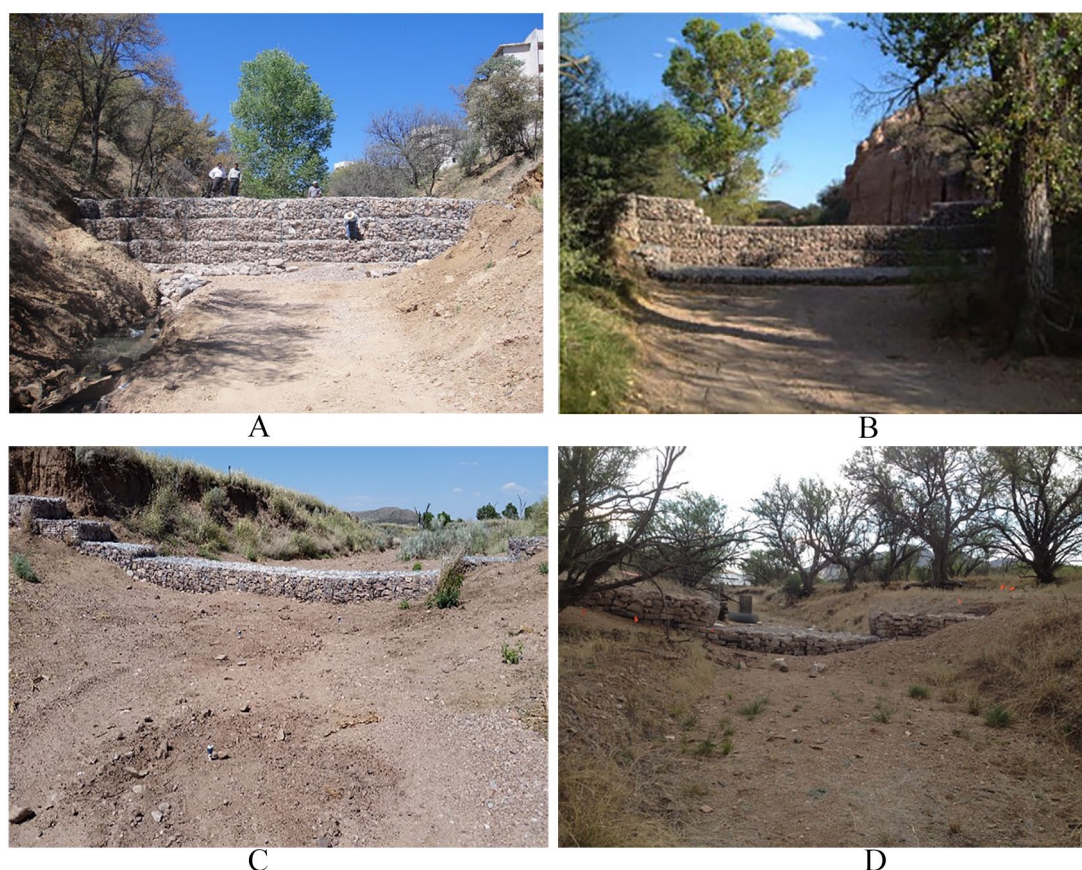
Figure 4. (A) Looking downstream at Cinco de Febrero, which experiences major flooding during monsoons, in Nogales, Sonora, Mexico (photo by Hans Huth [April 12, 2010]); (B) Gabion in Hay Hollow at Rancho San Bernardino, Sonora, Mexico (by Josiah Austin [October 27, 2001])⁶⁷; (C) Gabion in Vaughn Canyon on the Babacomari Ranch (by James Callegary June 19, 2015); and (D) Gabion installed at Bone Creek on the Deep Dirt Farm Institute (by Kate Tirion (2014). See Figure 3 for map locations.

implemented to predict the capacity of suggested gabions under various flood and urbanization scenarios (Figure 4(A)). The model predicted that some of the intended gabions would reduce peak flows in small rainfall events (ie, 10-year, 1-h storm event) but would have little impact for larger storm flows (ie, 100-year, 6-h storm event). Conversely, other gabions were predicted to have little impact from either small- or large-sized storms, depending on location, upstream contributing source area, soil, slope, and so on (Figure 6).⁶⁹ The potential for RDS to regulate flood events and help reduce hazards was documented, and structures were installed at recommended locations around Nogales, Sonora, Mexico. This work also demonstrated the additional potential for gabions to capture large amounts of sediment regardless of storm size and highlighted the need for regular maintenance therein.⁷⁰

and by the Cuenca los Ojos (CLO) Foundation over the course of 20+ years to restore surface water for native fishes (Figures 3 and 4(B)). *Cienegas*, or desert wetlands, are biodiverse yet sensitive habitats imperiled by demands for water and by changing climates.¹⁸ A remote-sensing analysis, coupled with field data, was conducted to document impacts of gabion installation over time. Using a vegetation index (ie, Normalized Difference Vegetation Index; NDVI), health and plant biomass were quantified to compare gabion and control sites over a 27-year period. Results portray live green vegetation present at most sites treated by gabion installation and at a few of the control sites, where no gabions exist (Figure 7). Field sites established within the study area between 2000 and 2012 corroborate findings of established biomass at gabions. This research documented the potential to restore riparian vegetation using gabions with the implication of increased water availability, and further suggested the potential to alleviate drought conditions in a desert *cienega*.⁶⁷

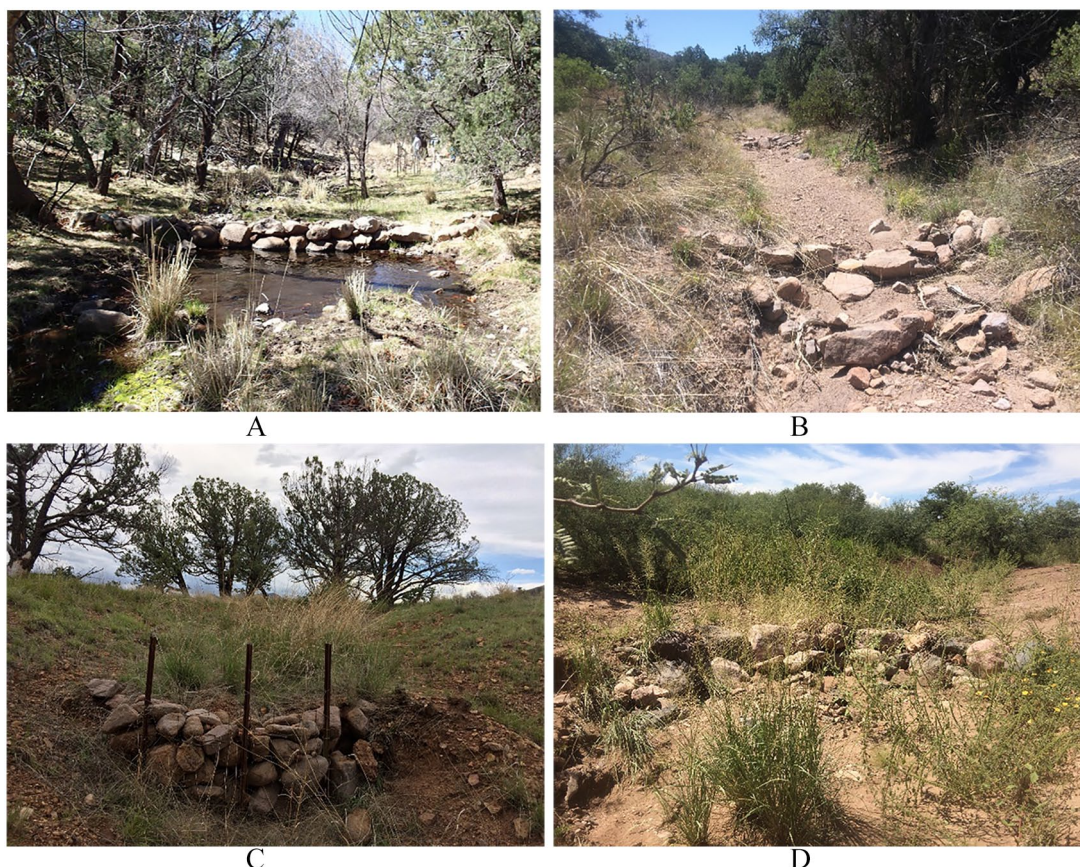
Figure 5. Photos of small structures at (A) Turkey Pen in the El Coronado Ranch, by Leila Gass, March 23, 2016)). (B) Bar Boot Allotment on the Douglas Ranger District, USFS; photo by Natalie R. Wilson, July 19, 2019)). (C) Tex Canyon on the Douglas Ranger District, USFS; photo by Natalie R. Wilson, July 14, 2015)). (D) Silver Creek on the Malpai Ranch, photo by Natalie R. Wilson (September 12, 2016). See Figure 3 for map locations.

small dams at the Bar Boot and Tex Canyon drainages (Figures 3, 5(B) and 5(C)).⁵³ In the Silver Creek drainage, the Bureau of Land Management contracted Stream Dynamics to install RDS in the Wildcat Draw tributary on the Malpai Ranch (Figures 3 and 5(D)). United States Geological Survey scientists partnered with these various practitioners and land managers to develop long- and short-term vegetation study plots to investigate vegetation changes over a 5-year period. Preliminary findings have indicated positive responses to RDS, with increases of perennial vegetation observed at most study sites.^{72,73}

course of 30 years (Figure 5(A)), while another had been left untreated (control). A paired-watershed approach was established to analyze the impacts of check dams on hydrologic function, given the adjacent location, similar land use, geology, vegetation, and precipitation. A new stream-gauging mechanism developed for remote areas, was modified and installed to measure discharge.^{74,75} The watershed treated with check dams had a reduced runoff response to precipitation, especially noticeable in peak flows compared with the untreated watershed. At the beginning of the season, the runoff response to precipitation in the treated watershed was negligible, but over the course of the summer “monsoon,” the response of the treated watershed increased to more than twice that of the untreated watershed, resulting in 28% more flow volume per area in the treated watershed compare to the untreated watershed (Figure 9). The cause for this delayed but increased response was hypothesized to be increased baseflow incurred from the RDS installed in arid and semiarid environments.⁷⁵ It was also noted that most of the check dams were still functional despite the age of construction.

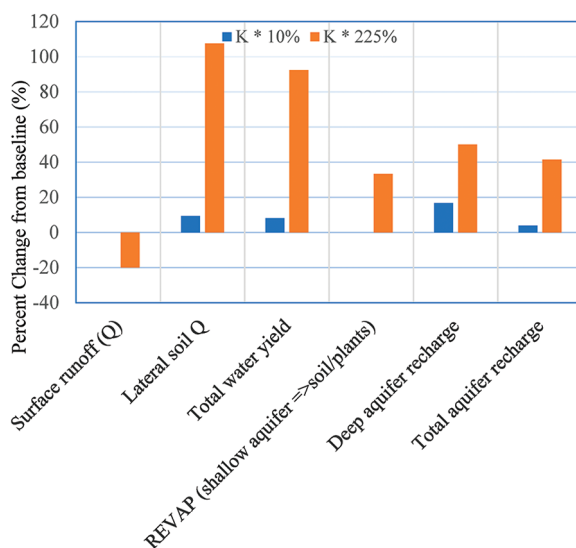
Figure 10. Chart portraying change predictions for the water budget in the future (2050) if gabions are installed throughout the watershed, where K = hydraulic conductivity.⁷⁶

At the Babocomari Ranch, in a tributary of the San Pedro River, southeastern Arizona (Figure 3), field experiments were coupled with surface and groundwater modeling to investigate using gabions to augment aquifer recharge (Figure 4(C)). Models were used to identify the best location to attempt recharge in an ephemeral channel, and field data were collected before and after gabions were installed by the BRN.⁷⁶ Downstream discharge measurements and a 3-dimensional computer model were used to calibrate a watershed model, simulate flow volumes, and extrapolate findings. In locations with gabions installed, average infiltration behind the gabions increased 10% compared to locations without gabions.⁷⁷ The average and high estimates of potential infiltration were used to alter hydraulic conductivity input to a watershed model to examine potential variations expected in the water budget, as a result of potential impacts from gabion installations (Figure 10).⁷⁶ Model results indicated a potential increase in lateral soil water incurred from gabion installation, as previously hypothesized at the El Coronado Ranch study.^{75,76}
