# Reducing Vehicle Collisions With the Central American Tapir in Central Belize District, Belize

Authors: Poot, Celso, and Clevenger, Anthony P.

Source: Tropical Conservation Science, 11(1)

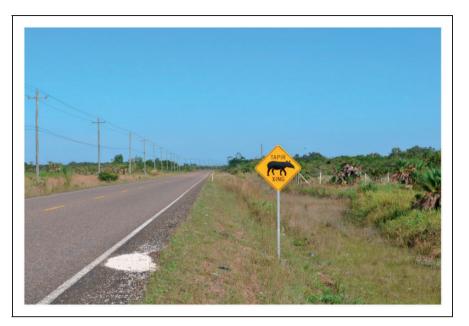
Figure 2. Two sets of reflective wildlife crossing signs were installed at two hot spots identified for tapir-vehicle collisions.
