Managing Debris Flow Risks

Source: Mountain Research and Development, 24(1) : 19-23

Security Measures for a Hazard-Prone Resort in Switzerland

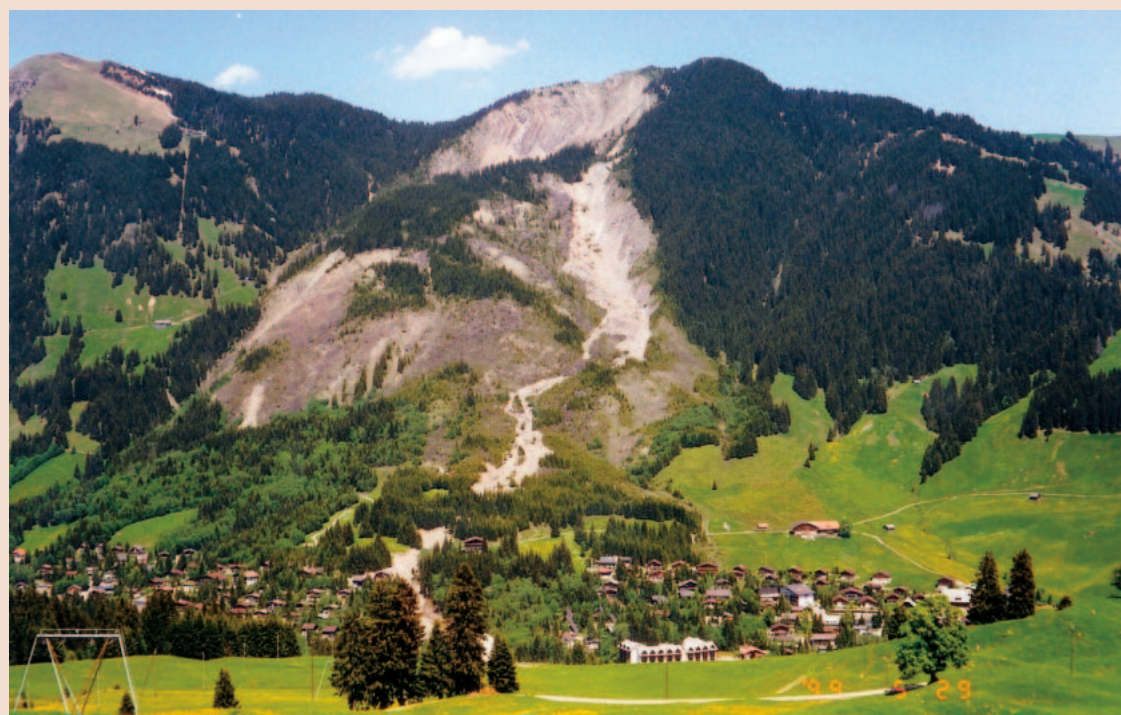
FIGURE 1 The tourist resort of Sörenberg, located in the Entlebuch Biosphere Reserve, Central Switzerland. The village is located at the foot of a deep-seated landslide complex. The bright surfaces mark the geomorphological zones active in 1999. (Photo by author)

Sörenberg is a typical small tourist resort located on the periphery of the Swiss Alps in Central Switzerland (Figure 1). The village has developed only during the last 40 years; prior to that, it was known as a spa. Today, about 800 housing units—mainly secondary homes (chalets and tourist apartments)—are situated on old debris flow deposits. In addition, a number of sports and leisure facilities have been constructed in recent years. The slopes above the village belong to a large (15 million m³)

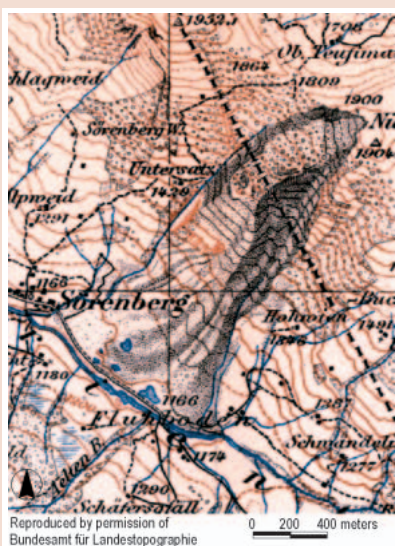
FIGURE 2 1918 topographic map, showing the open scars on either side of the mass and the typical accumulation features developed in 1910 and 1912. The few houses with the church (at the center of the village) are located in a safe place. (Map reproduced by permission of Bundesamt für Landestopographie, BA024084)

Analysis of past events makes an important contribution to the understanding of present and future hazards in a particular location. A number of historic documents such as maps (Figure 2), postcards or photographs, as well as a detailed description of the 1910 events by the famous geologist Albert Heim, provided the necessary information to reconstruct the sequence of landslide events in the 20th century. Between 1860 and 1910 the entire complex shifted downhill by more than 30 m in a large vertical movement. In 1910 another large vertical movement occurred, lasting several days and causing 2 major lateral collapses and massive debris flows of over 3 million m³. Throughout the rest of the 20th century development was irregular. Several lateral and frontal collapses occurred in 1912, 1922, and 1986, with 6 decades of geomorphic inactivity in between.

At the beginning of the 20th century the area now occupied by the village was used as grazing land. The map (Figure 2) indicates that the existing few houses in Sörenberg were arranged around the church in a safe place. Within the accumulation area of the 1910, 1912 and 1922 debris flows, only a very few isolated houses were destroyed.

Sörenberg's development into the tourist resort that it is today took place only over the past 30 to 40 years. The 1918 map (Figure 2) clearly shows that at that time only very few buildings were located in what was once a highly active accumulation area. Today this area is completely covered by houses (Figure 3). The long period of geomorphic inactivity following the events of 1922 was interpreted as a sign of future security. An analysis by experts in 1974 proved that there was no immediate threat, but did not altogether exclude the possibility of damaging events. An indication of the uncertainty of the situation was provided by displacement measurements begun in 1978. These clearly show that the whole mass is continuously moving about 3 to 10 cm per year. The speed of this movement increased dramatically in 1999 but has slowed down again since.

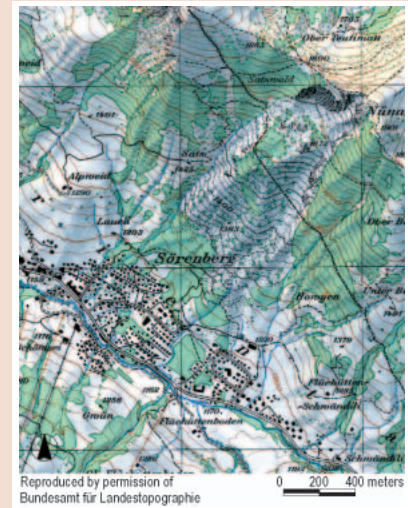
FIGURE 3 1993 topographic map, showing how the village has developed in the past 30 years in the area where debris flow formerly accumulated. (Map reproduced by permission of Bundesamt für Landestopographie, BA024084)

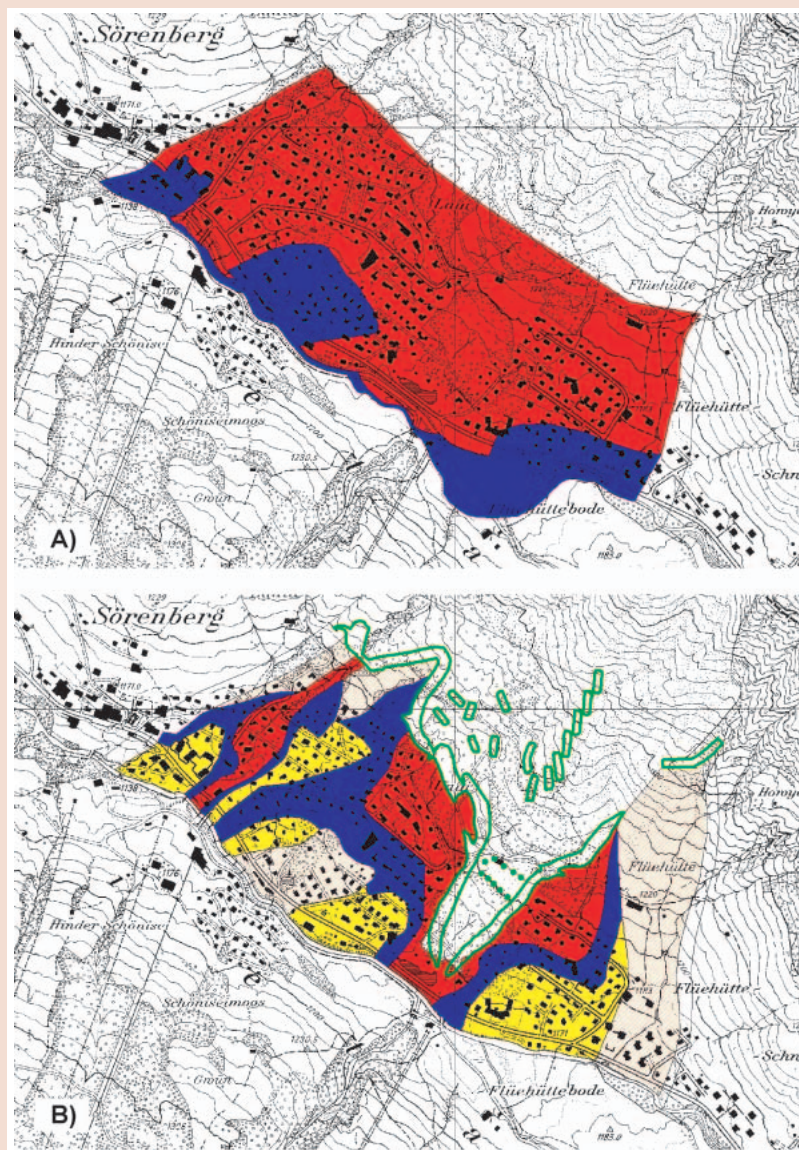
FIGURE 4, A AND B Hazard map for Sörenberg. Top (A) before, and bottom (B) after the implementation of the planned structural measures. Red: high degree of hazard; blue: moderate degree of hazard; yellow: low degree of hazard; yellow-white: hazards with a very low probability of occurrence; green: planned structural measures. (Maps reproduced by permission of swisstopo, BA035840)

Secondary processes caused by primary movement occur only after relatively long intervals. It can be concluded that Sörenberg remains at risk. The risk of further collapses and subsequent flows must be taken into account, even though conditions above the village are currently calm. However, it is assumed that large-scale events such as the ones in 1910 are no longer possible. These facts were considered in the hazard map that was prepared in 2001 (Figure 4A).

The first step towards definition of protective measures is a thorough investigation of all hazards and the creation of a hazard map. In Switzerland, such maps are based on definite probability and magnitude classes. Under present conditions, most of the village is within red and blue hazard zones (Figure 4A), ie those subject to a high or moderate risk, respectively. This constitutes a de facto ban on future economic development of the village: construction of new houses and major changes to existing houses are normally not permitted within the red zone. This, of course, was not acceptable to the municipal authorities. Solutions had to be found that would guarantee the safety of the population while at the same time allowing moderate development of the village.

- A set of regulations in the local land use plan and building code defines what is possible in red, blue and yellow zones. These regulations should curb further increase of vulnerability (see Table 1 and Figure 4B).
- In addition to village regulations, plans call for a complete ban on grazing throughout the landslide-prone area as well as an increase in forest cover.
- Municipal and cantonal authorities established a hazard map for the whole area in order to show whether adjacent areas are more suitable for village development. Unfortunately, there are only a few places that are appropriate as housing lots.

- People argued that the primary process should be stopped. Geophysical investigations showed, however, that control of the water table in this extremely fractured and fast-moving mass is hardly possible;
- A number of (reasonable) structural protection measures (Figure 4B, green markings) are planned to reduce the risks to a bearable level. But even with these protection measures, some parts of the village remain in the red danger zone. Owing to financial constraints, the state would like to minimize these measures. The local authorities, on the other hand, have an interest in reducing the red zone as much as possible. Costs of about CHF 14 million (US\$ 10 million) will be shared by the canton and the municipality, with heavy subsidies from the federal government. Home owners may also make contributions.
