## **Sand dune management problems and techniques, Spain.**

Authors: Gómez-Pina, Gregorio, Muñoz-Pérez, Juan J., Ramírez, Jose L., and Ley, Carlos

Source: Journal of Coastal Research, 36(sp1) : 325-332

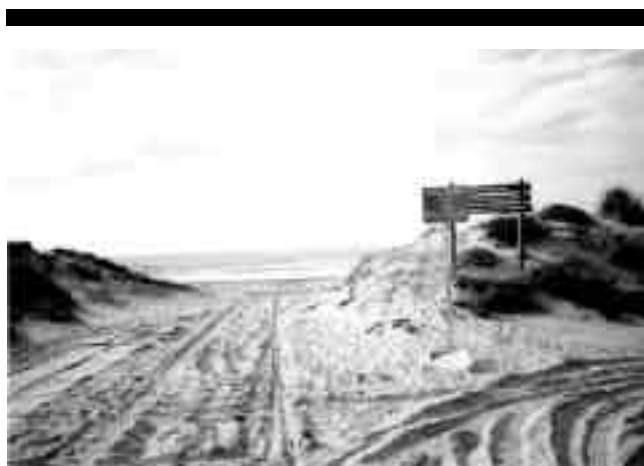
Figures from GÓMEZ-PINA(1999) are representative of dune degradation in La Bota beach (Huelva). Figure 1 shows a typical dune breach caused by off-road vehicles and human trampling. Figure 2 depicts the existing public road, crossing the foredunes longitudinally. The removal of this road is part of a very ambitious integrated dune management project being carried out by the National Spanish Coast Directorate, Ministry of Environment.

Figure 1. Typical dune breaching in La Bota (Huelva, Spain), Gómez-Pina 1997

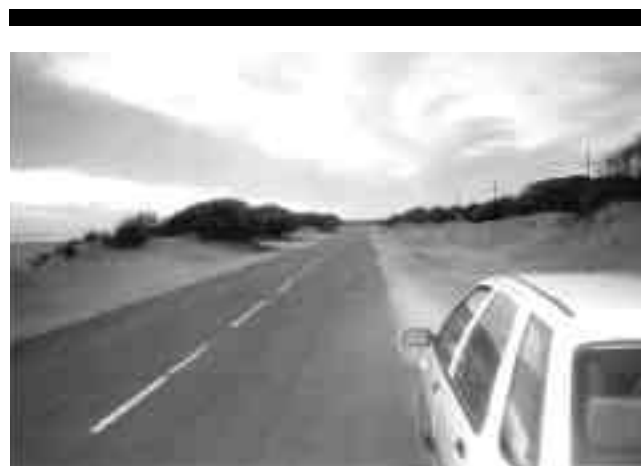
Figure 2. Existing road alongside La Bota beach (Huelva, Spain), Gómez-Pina 1997.

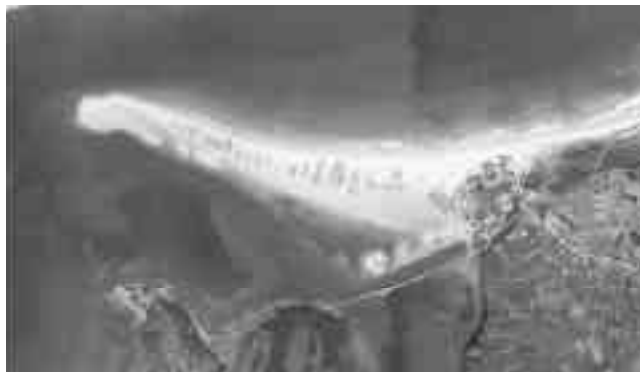
Figure 3. An aerial view of Somo spit (Cantabrian, Spain) before dune restoration.

Figures 3 and 4 show aerial views of Somo spit before and after dune restoration. In Figure 5 a detailed perspective of fencing and transplanted vegetation is displayed.

Since 1992 dune restoration works have been carried out in several phases consisting of the reinforcement of the deteriorated dune system by using willow sand trappers in conjunction with transplanted vegetation (*ammophila arenaria*) from the neighbouring dune plant nursery. Fencing was used in sensitive areas to reduce the effects of human trampling. Elevated dune walkovers for access to the beach were conveniently placed near parking areas, beachfront subdivisions and public facilities to avoid damage to the dunes from pedestrian traffic. Finally, information posters were placed in adequate locations to make beach visitors aware of the importance of the dunes and the restoration works in place.

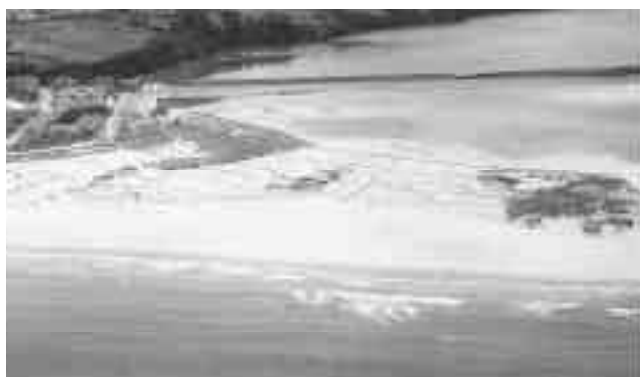
Figure 4. An aerial view of Somo spit (Cantabrian, Spain) after dune restoration.

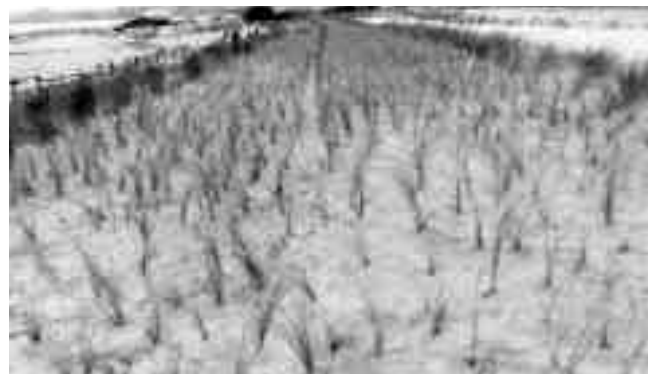
Figure 5. Fencing and transplanted vegetation in Somo spit (Cantabrian, Spain).

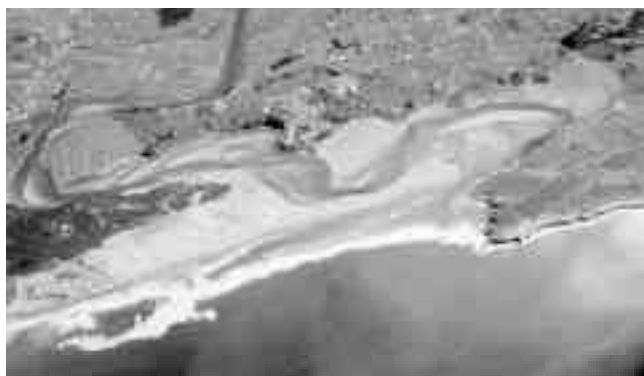
Figure 6. An aerial view of Liencres spit (Cantabrian, Spain) after breaching.

Figure 6 depicts an aerial view of Liencres spit after dune breaching. In Figure 7 sand accumulation caused by willow fences can be seen. Elevated dune walkovers and fencing are shown in Figure 8.

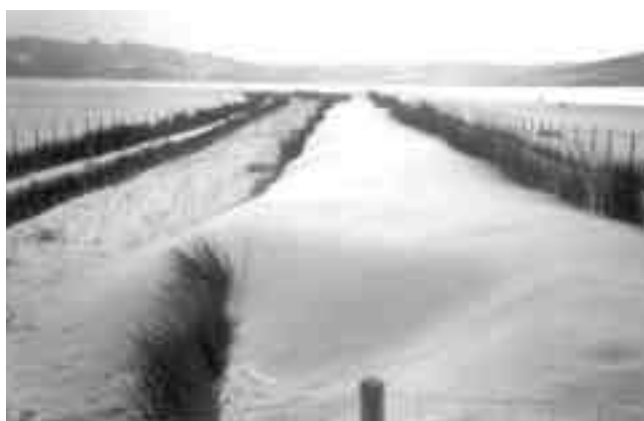
Figure 7. A detail of dune restoration in Liencres spit (Cantabrian, Spain)

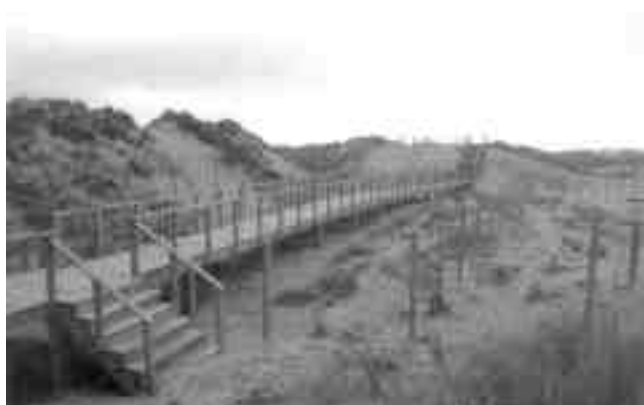
Figure 8. Dune walkover and fencing in Liencres spit (Cantabrian, Spain)

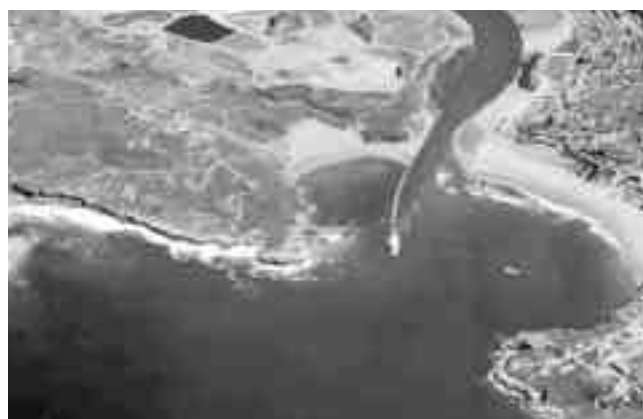
Figure 9 shows an aerial view of Cuchía beach and Suances estuary. A panoramic of Cuchía beach after rehabilitation is depicted in Figure 10.

Figure 9. An aerial view of Cuchía beach (Cantabrian, Spain)

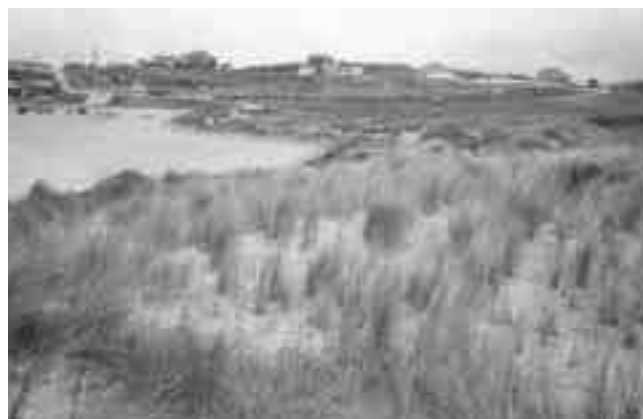
Figure 10. Cuchía beach (Cantabrian, Spain) after dune restoration

As a result of former sand mining, human trampling and disorderly garbage dumping in Cuchía beach, coppice mounds and foredunes lost all kind of dune vegetation presenting a very degrading state. After cleaning operations, foredunes were restored with adequate dredging from the neighbouring inner harbour in Suances estuary ("ría"). Finally, willow sand trappers together with transplanted vegetation were used to stabilise the foredune surface.

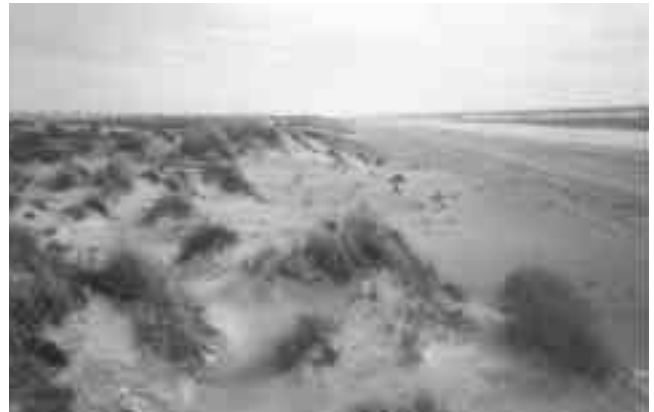
Figure 13. Dune blow-outs in Isla Cristina beach (Huelva, Spain)

Fig.13 shows typical dune blow-outs in Isla Cristina beach. Fig.14 depicts an illustrative grazing scene. Fig.15 shows dune fencing and revegetation.

The relatively high longitudinal net sediment transport along the Huelva coast (up to 400,000 m<sup>3</sup>/year eastward) together with littoral drift interruption by the harbour entrance jetties, decrease sediments by river discharge and urbanisation developed too close to the beach generally expose Huelva beaches and foredunes to high erosive rates. Isla Cristina beach is one of the representative Huelva tourist beaches showing beach and foredune erosion due to the conjunction of the aforementioned causes and in particular to the interruption of the littoral drift

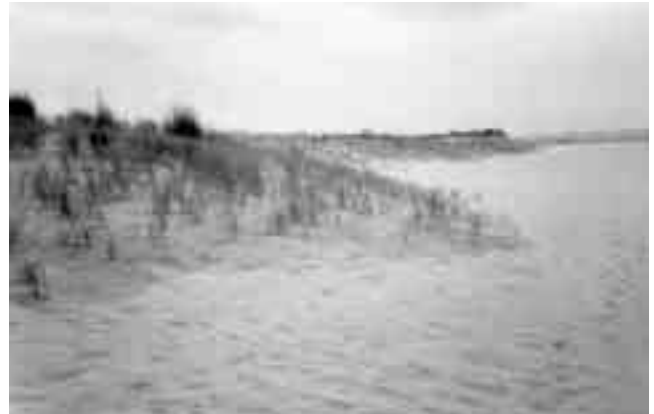
Figure 14. Grazing in Isla Cristina beach (Spain).

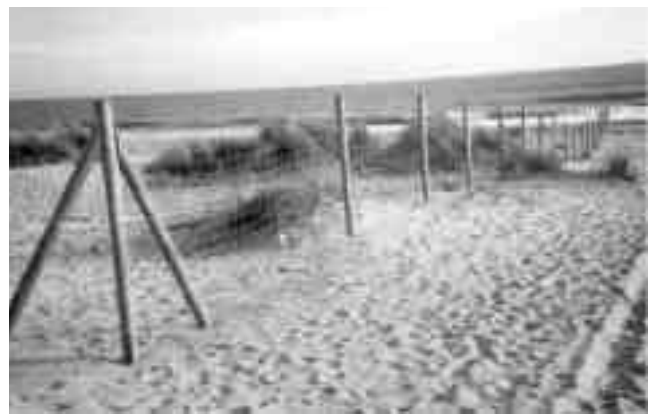
Figure 15. Dune fencing and revegetation in Isla Cristina beach (Huelva, Spain)

As a consequence of the high longitudinal littoral drift rates, it is precluded, in general, to use coastal structures to stabilize Huelva beaches. Only beach nourishment and /or dune restoration are the preferred methods to mitigate erosive coastal processes in Huelva beaches.

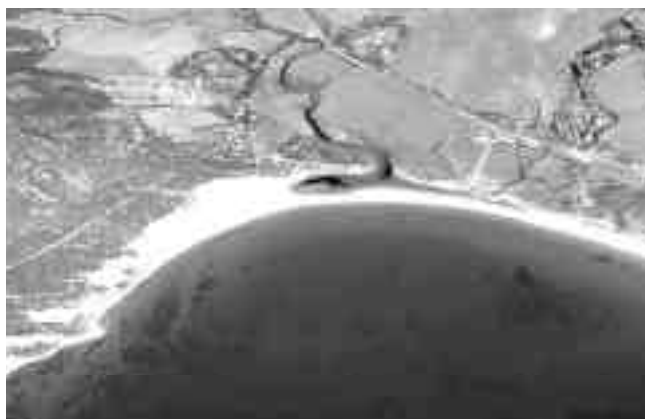
Figure 16. An aerial view of Valdevaqueros cove (Cádiz, Spain)

Figure 16 depicts an aerial view of Valdevaqueros cove. Figure 17 shows backdune restoration near the adjacent pine grove. Figure 18 shows foredune accretion after restoration.

The special characteristics of these mobile dunes together with their natural and scenic values confer to Valdevaqueros cove a great attraction. The frequent local Levante wind regimes give rise to high wind speeds of up to 100 km/hr. The high longitudinal aeolian transport is responsible for building up a huge dune at the northern beach side. Wind conditions and low rainfall, together with the direct burden caused by dune visitors, make it difficult to establish permanent vegetation on the dune. As a result the dune became unstable, showing a continuous massive movement towards an adjacent pine grove.

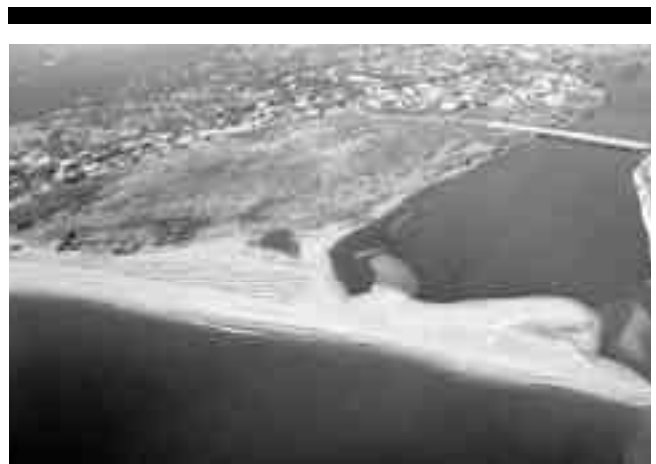
Guadalquítón beach (Fig. 19) is located in the Guadiaro river estuary on the Mediterranean sea, under the influence of the waters from the Gibraltar strait. Coastal dunes at the Mediterranean sea are, in general, less developed than Atlantic dunes due, among other factors, to the almost absence of tides in the Mediterranean sea. Extensive Mediterranean dune areas were totally altered and destroyed in the course of enormous tourist urbanisation projects during the 1960s-1970s (e.g. the beautiful barrier island of La Manga in Cartagena, GÓMEZ-PINA 1999). Furthermore, littoral drift interruption by harbour and marinas contributed to the acceleration of dune degradational processes. Although the case of Guadalquítón beach did not escape from this problem its conditions at the time of undertaking the restoration project were not as irreversible as in other Mediterranean beaches.

Figure 19. An aerial view of Guadalquítón estuary after restoration (Cádiz, Spain)

The dune restoration project was only a part of an integrated plan to improve coastal zone management aspects at the Guadiaro estuary, such as river flushing recovery, garbage cleaning, water quality improvement, wetland restoration, fencing of sensitive areas, public access improvement, sea bird observatories, beach nourishment and dune reinforcement. New sand trapping methods were experimented with as well as native transplanted vegetation under critical climatic conditions (yearly run-off is less than 250 mm)

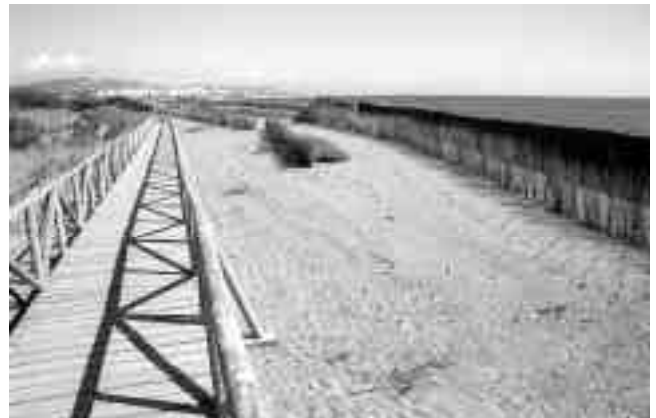
Figure 20. A detailed view of Guadalquítón dune restoration (Cádiz, Spain)
