## **Ecosystem Services of Riparian Restoration: A Review of Rock Detention Structures in the Madrean Archipelago Ecoregion**

Air, Soil and Water Research  
Volume 13: 1–13  
© The Author(s) 2020  
Article reuse guidelines:  
sagepub.com/journals-permissions  
DOI: 10.1177/1178622120946337

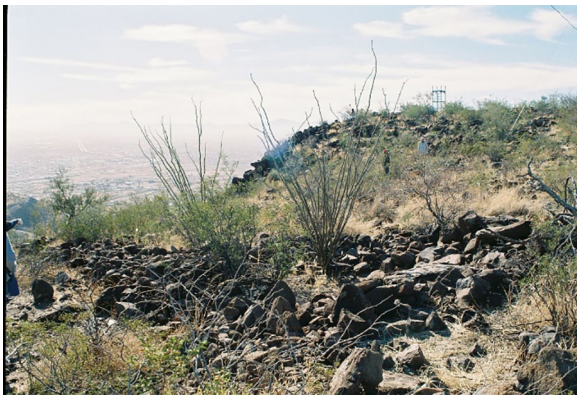
**Figure 2.** A massive ca. 2000-year-old Native American trinchera feature (built-up rock terrace) near the crown of Tumamoc Hill, Arizona.<sup>37</sup>

BCE to CE 1450, are prehistoric terraces with rock retaining walls used for various functions including habitation, ceremonial purposes, defense refuges, and related to early forms of irrigating agriculture (Figures 1 and 2).<sup>31–36</sup> Classification of *trincheras* for agricultural sites includes: (1) “terraces” (check dams) built as low walls across small stream channels to hold soil and cause flowing water to soak in rather than runoff, and (2) “linear borders” (riprap) built as alignments of stones along gentle slopes to reduce soil erosion, slow runoff, and increase infiltration for agricultural purposes.<sup>36</sup>

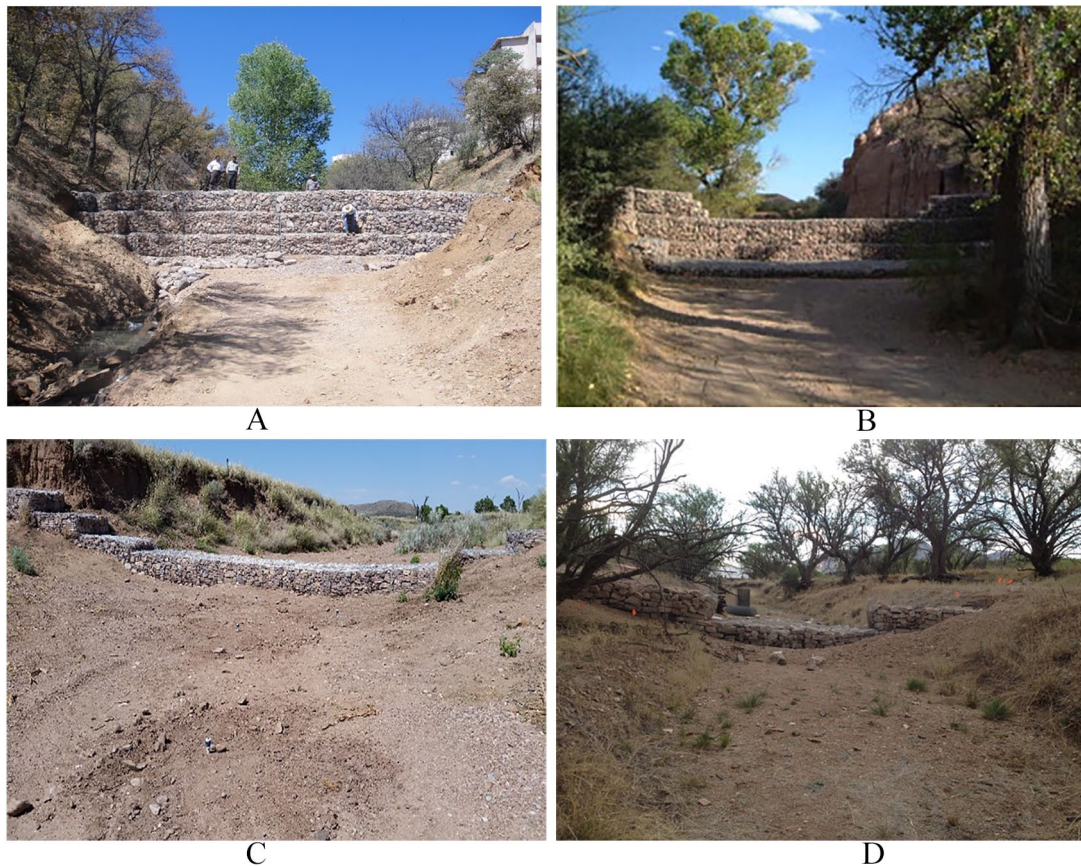
**Figure 4.** (A) Looking downstream at Cinco de Febrero, which experiences major flooding during monsoons, in Nogales, Sonora, Mexico (photo by Hans Huth [April 12, 2010]); (B) Gabion in Hay Hollow at Rancho San Bernardino, Sonora, Mexico (by Josiah Austin [October 27, 2001])<sup>67</sup>; (C) Gabion in Vaughn Canyon on the Babacomari Ranch (by James Callegary June 19, 2015); and (D) Gabion installed at Bone Creek on the Deep Dirt Farm Institute (by Kate Tirion (2014). See Figure 3 for map locations.

implemented to predict the capacity of suggested gabions under various flood and urbanization scenarios (Figure 4(A)). The model predicted that some of the intended gabions would reduce peak flows in small rainfall events (ie, 10-year, 1-h storm event) but would have little impact for larger storm flows (ie, 100-year, 6-h storm event). Conversely, other gabions were predicted to have little impact from either small- or large-sized storms, depending on location, upstream contributing source area, soil, slope, and so on (Figure 6).<sup>69</sup> The potential for RDS to regulate flood events and help reduce hazards was documented, and structures were installed at recommended locations around Nogales, Sonora, Mexico. This work also demonstrated the additional potential for gabions to capture large amounts of sediment regardless of storm size and highlighted the need for regular maintenance therein.<sup>70</sup>

and by the Cuenca los Ojos (CLO) Foundation over the course of 20+ years to restore surface water for native fishes (Figures 3 and 4(B)). *Cienegas*, or desert wetlands, are biodiverse yet sensitive habitats imperiled by demands for water and by changing climates.<sup>18</sup> A remote-sensing analysis, coupled with field data, was conducted to document impacts of gabion installation over time. Using a vegetation index (ie, Normalized Difference Vegetation Index; NDVI), health and plant biomass were quantified to compare gabion and control sites over a 27-year period. Results portray live green vegetation present at most sites treated by gabion installation and at a few of the control sites, where no gabions exist (Figure 7). Field sites established within the study area between 2000 and 2012 corroborate findings of established biomass at gabions. This research documented the potential to restore riparian vegetation using gabions with the implication of increased water availability, and further suggested the potential to alleviate drought conditions in a desert *cienega*.<sup>67</sup>

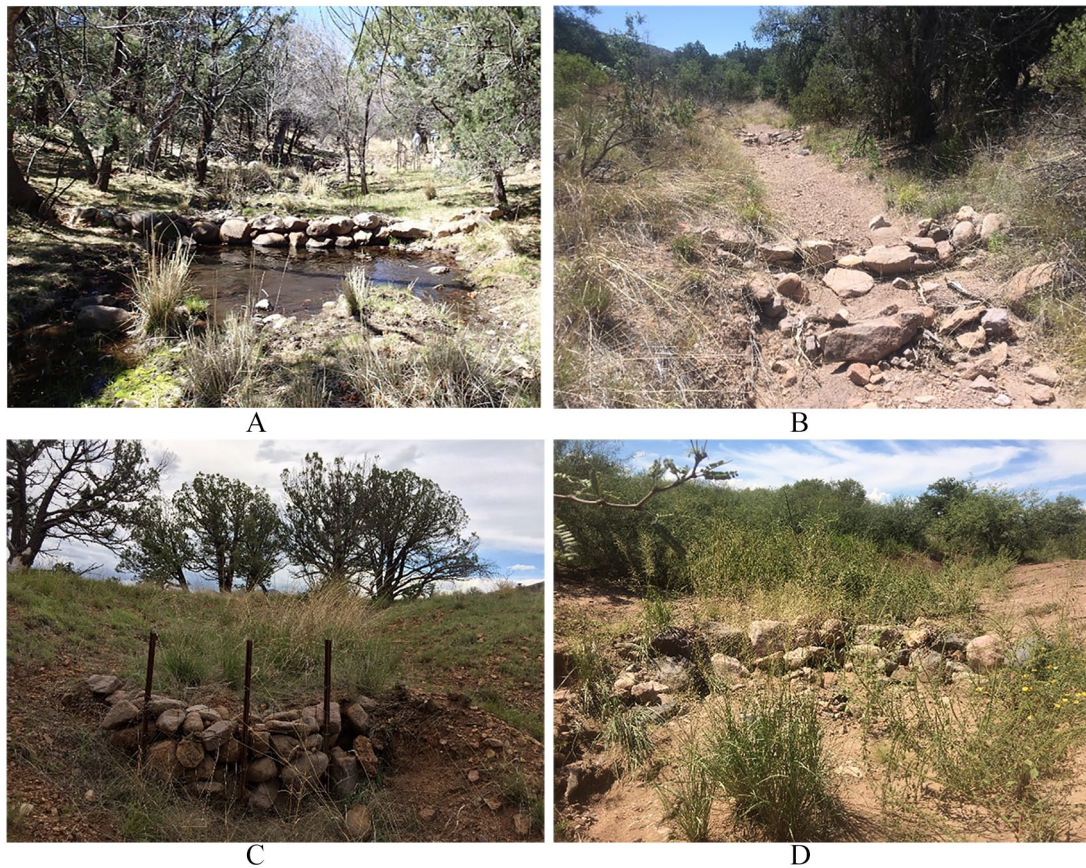
**Figure 5.** Photos of small structures at (A) Turkey Pen in the El Coronado Ranch, by Leila Gass, March 23, 2016)). (B) Bar Boot Allotment on the Douglas Ranger District, USFS; photo by Natalie R. Wilson, July 19, 2019)). (C) Tex Canyon on the Douglas Ranger District, USFS; photo by Natalie R. Wilson, July 14, 2015)). (D) Silver Creek on the Malpai Ranch, photo by Natalie R. Wilson (September 12, 2016). See Figure 3 for map locations.

small dams at the Bar Boot and Tex Canyon drainages (Figures 3, 5(B) and 5(C)).<sup>53</sup> In the Silver Creek drainage, the Bureau of Land Management contracted Stream Dynamics to install RDS in the Wildcat Draw tributary on the Malpai Ranch (Figures 3 and 5(D)). United States Geological Survey scientists partnered with these various practitioners and land managers to develop long- and short-term vegetation study plots to investigate vegetation changes over a 5-year period. Preliminary findings have indicated positive responses to RDS, with increases of perennial vegetation observed at most study sites.<sup>72,73</sup>

course of 30 years (Figure 5(A)), while another had been left untreated (control). A paired-watershed approach was established to analyze the impacts of check dams on hydrologic function, given the adjacent location, similar land use, geology, vegetation, and precipitation. A new stream-gauging mechanism developed for remote areas, was modified and installed to measure discharge.<sup>74,75</sup> The watershed treated with check dams had a reduced runoff response to precipitation, especially noticeable in peak flows compared with the untreated watershed. At the beginning of the season, the runoff response to precipitation in the treated watershed was negligible, but over the course of the summer “monsoon,” the response of the treated watershed increased to more than twice that of the untreated watershed, resulting in 28% more flow volume per area in the treated watershed compare to the untreated watershed (Figure 9). The cause for this delayed but increased response was hypothesized to be increased baseflow incurred from the RDS installed in arid and semiarid environments.<sup>75</sup> It was also noted that most of the check dams were still functional despite the age of construction.

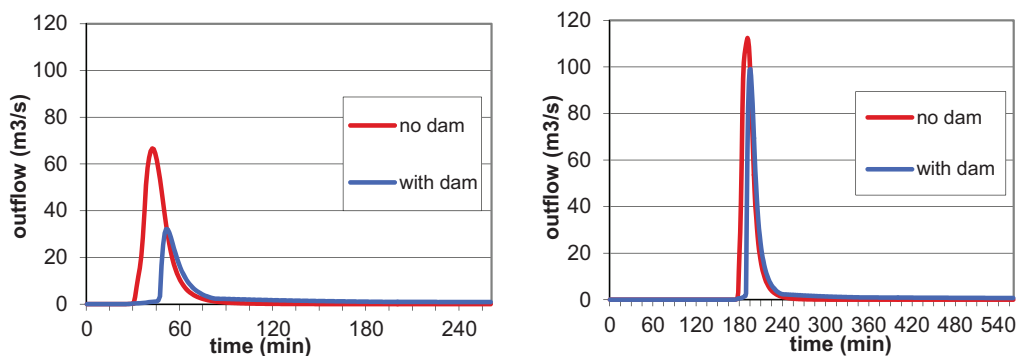
**Figure 6.** Gabion installation at the Cuesta Blanca subwatershed of Nogales, Sonora, Mexico, hydrograph results of modeling runoff response after a 10 year, 1-h storm event (left) and a larger 100 year, 6-h event (right).<sup>70</sup>

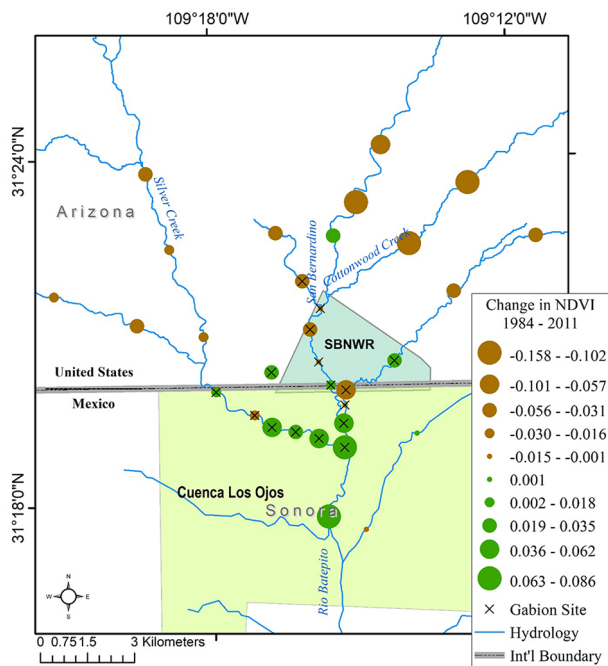
**Figure 7.** Map portrays results of 27 year satellite image analysis to track vegetation health at sites where gabions had been installed and comparing control sites (no gabions).<sup>67</sup>

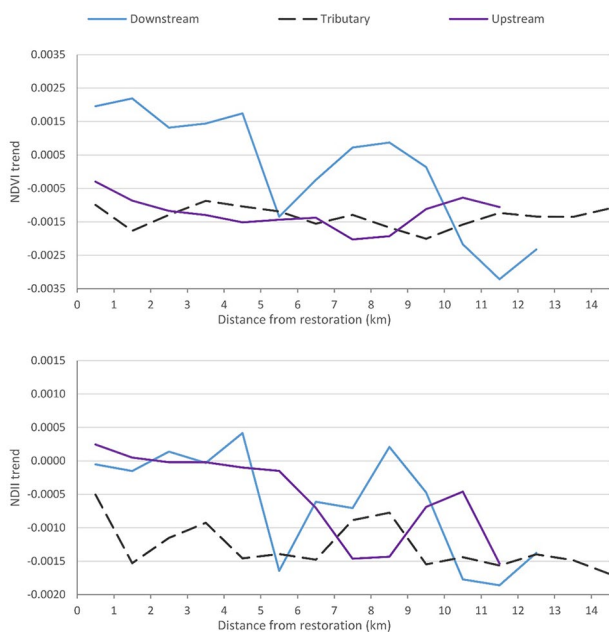
**Figure 8.** Graphs portray repeat analyses of the Normalized Difference Vegetation Index (NDVI; top) and new results from the Normalized Difference Infrared Index (NDII; bottom) accentuating impacts at distances from restoration sites, modified from Wilson and Norman.<sup>71</sup>

tributary and upland areas (Figure 8).<sup>71</sup> This analysis documented the potential of gabions to increase live green vegetation, owing to increased water availability, at locations as far as 5 km downstream and 1 km upstream.<sup>71</sup>

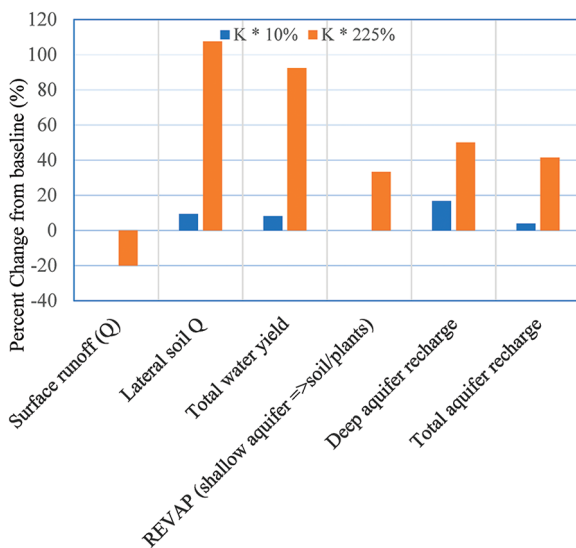
Figure 10. Chart portraying change predictions for the water budget in the future (2050) if gabions are installed throughout the watershed, where K = hydraulic conductivity.<sup>76</sup>

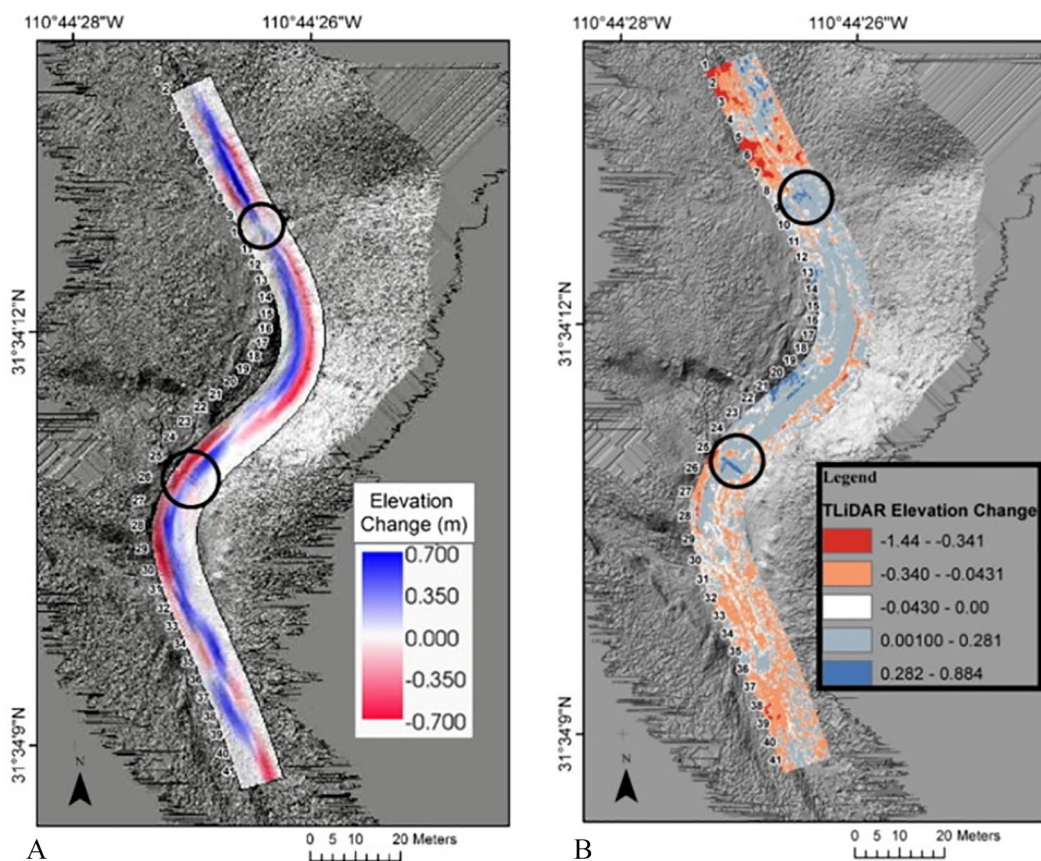
**Figure 11.** (A) Model results predict bedform shifts and geomorphology changes in the channel based on the installation of gabions, where measurements confirm accuracy of model predictions using and (B) terrestrial laser scanner surveys over a 3-year time period (before and after gabions were physically installed).<sup>25</sup>

installation. Although the TLS survey measurements indicated greater elevation losses than that predicted by the model; both TLS and model results showed similar trends in elevation changes. Trend consistency between consecutive digital elevation

model data acquisitions and uncalibrated simulations, demonstrated the potential to use models to predict hydraulics and approximate associated trends and patterns of aggradation and degradation resulting from gabions before they are installed.<sup>25</sup>
