Sand dune management problems and techniques, Spain.

Source: Journal of Coastal Research, 36(sp1) : 325-332

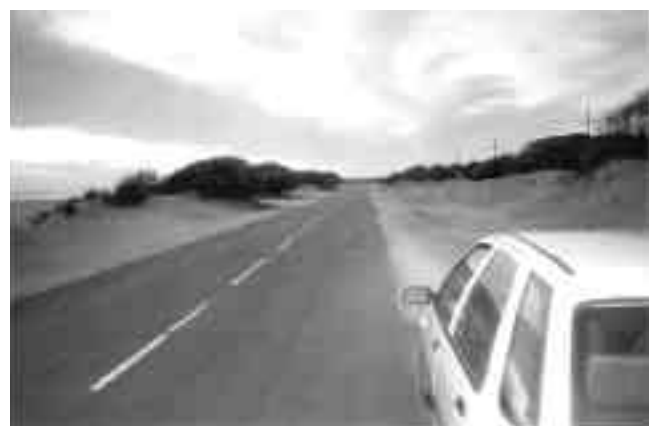
Figure 2. Existing road alongside La Bota beach (Huelva, Spain), Gómez-Pina 1997.

Figures from GÓMEZ-PINA(1999) are representative of dune degradation in La Bota beach (Huelva). Figure 1 shows a typical dune breach caused by off-road vehicles and human trampling. Figure 2 depicts the existing public road, crossing the foredunes longitudinally. The removal of this road is part of a very ambitious integrated dune management project being carried out by the National Spanish Coast Directorate, Ministry of Environment.

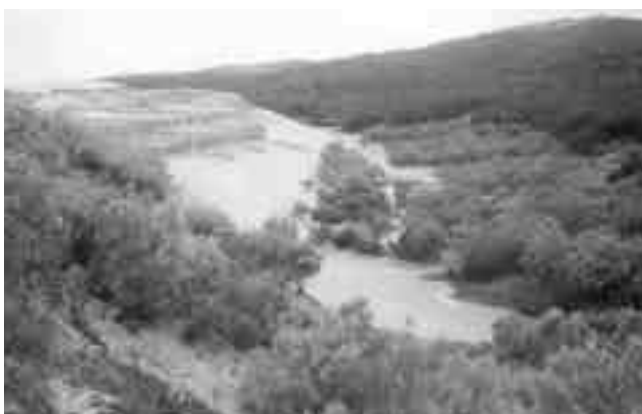
Figure 17. A view of Valdevaqueros backdune restoration (Cádiz, Spain)

Dune restoration works started with the reshaping of the dune profile in order to obtain a better aerodynamic stability complemented with the experimental use of longitudinal willow sand fences to decrease erosive surface patterns. Also experimental transplanted vegetation techniques were used along certain potentially stable areas.

Figure 16 depicts an aerial view of Valdevaqueros cove. Figure 17 shows backdune restoration near the adjacent pine grove. Figure 18 shows foredune accretion after restoration.

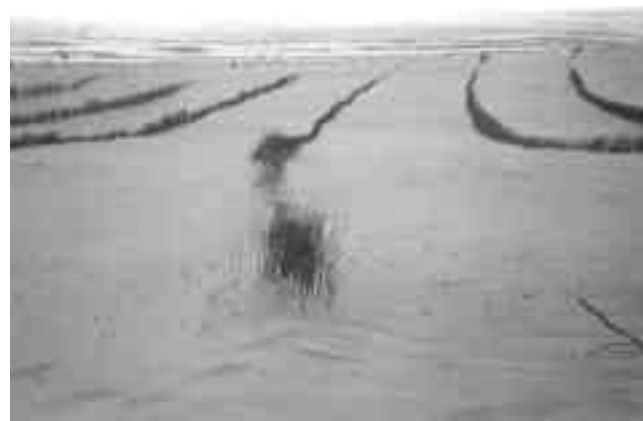
Figure 18. A view of Valdevaqueros accreted foredune after restoration (Cádiz, Spain)

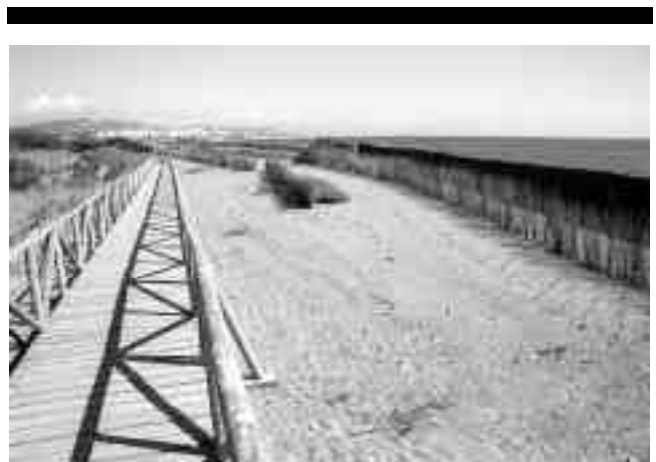
Figure 20. A detailed view of Guadalquítón dune restoration (Cádiz, Spain)

The dune restoration project was only a part of an integrated plan to improve coastal zone management aspects at the Guadiaro estuary, such as river flushing recovery, garbage cleaning, water quality improvement, wetland restoration, fencing of sensitive areas, public access improvement, sea bird observatories, beach nourishment and dune reinforcement. New sand trapping methods were experimented with as well as native transplanted vegetation under critical climatic conditions (yearly run-off is less than 250 mm)
