Sand dune management problems and techniques, Spain.

Source: Journal of Coastal Research, 36(sp1) : 325-332

The National Spanish Coastal Authority, Ministry of Environment, have been aware of this problem and undertook a strong policy on dune restoration which has been incremented yearly. In this paper the main dune problems found along the Spanish coastline are outlined, paying particular attention to the analysis of certain case studies and an overview of the different dune restoration techniques used is given. Seven representative examples in which the authors were involved are discussed.

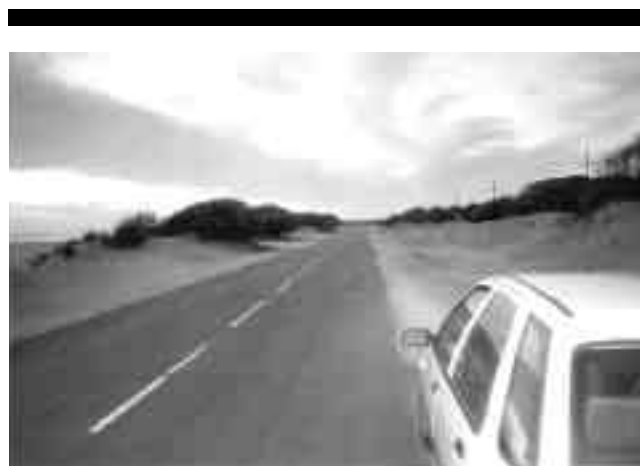
Figure 2. Existing road alongside La Bota beach (Huelva, Spain), Gómez-Pina 1997.

Figures from GÓMEZ-PINA(1999) are representative of dune degradation in La Bota beach (Huelva). Figure 1 shows a typical dune breach caused by off-road vehicles and human trampling. Figure 2 depicts the existing public road, crossing the foredunes longitudinally. The removal of this road is part of a very ambitious integrated dune management project being carried out by the National Spanish Coast Directorate, Ministry of Environment.

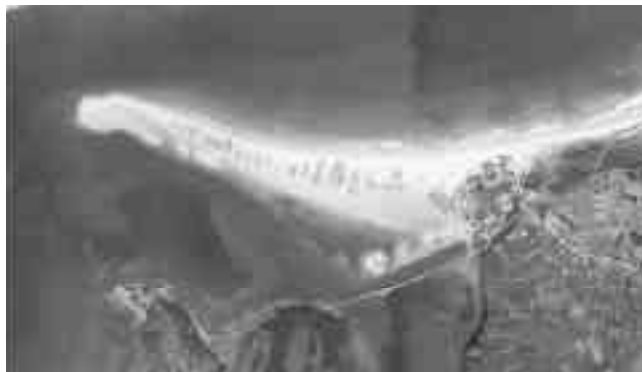
Figure 3. An aerial view of Somo spit (Cantabrian, Spain) before dune restoration.

Figures 3 and 4 show aerial views of Somo spit before and after dune restoration. In Figure 5 a detailed perspective of fencing and transplanted vegetation is displayed.
