Sand dune management problems and techniques, Spain.

Source: Journal of Coastal Research, 36(sp1) : 325-332

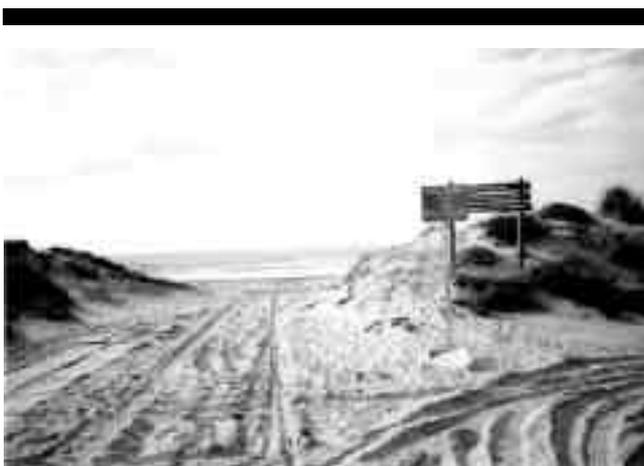
Figure 1. Typical dune breaching in La Bota (Huelva, Spain), Gómez-Pina 1997

Figures from GÓMEZ-PINA(1999) are representative of dune degradation in La Bota beach (Huelva). Figure 1 shows a typical dune breach caused by off-road vehicles and human trampling. Figure 2 depicts the existing public road, crossing the foredunes longitudinally. The removal of this road is part of a very ambitious integrated dune management project being carried out by the National Spanish Coast Directorate, Ministry of Environment.

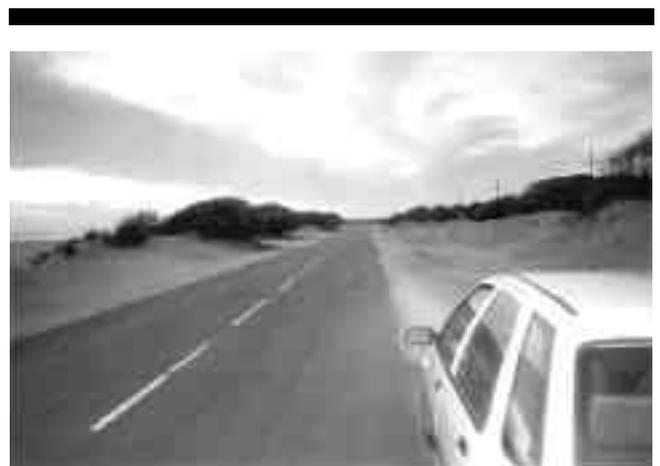
Figure 2. Existing road alongside La Bota beach (Huelva, Spain), Gómez-Pina 1997.

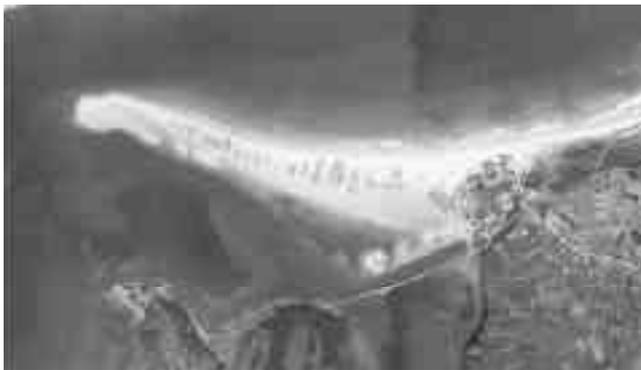
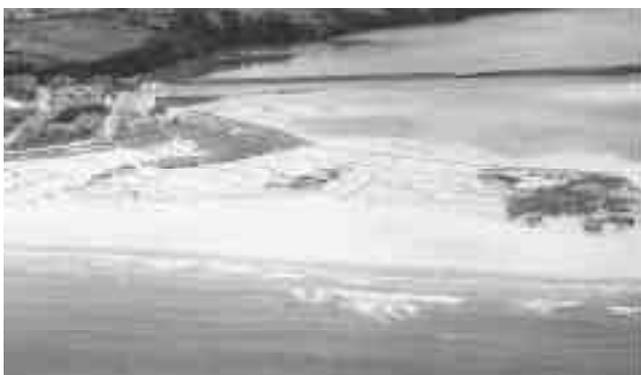
Figure 3. An aerial view of Somo spit (Cantabrian, Spain) before dune restoration.

Figure 4. An aerial view of Somo spit (Cantabrian, Spain) after dune restoration.

Since 1992 dune restoration works have been carried out in several phases consisting of the reinforcement of the deteriorated dune system by using willow sand trappers in conjunction with transplanted vegetation (*ammophila arenaria*) from the neighbouring dune plant nursery. Fencing was used in sensitive areas to reduce the effects of human trampling. Elevated dune walkovers for access to the beach were conveniently placed near parking areas, beachfront subdivisions and public facilities to avoid damage to the dunes from pedestrian traffic. Finally, information posters were placed in adequate locations to make beach visitors aware of the importance of the dunes and the restoration works in place.

Figures 3 and 4 show aerial views of Somo spit before and after dune restoration. In Figure 5 a detailed perspective of fencing and transplanted vegetation is displayed.

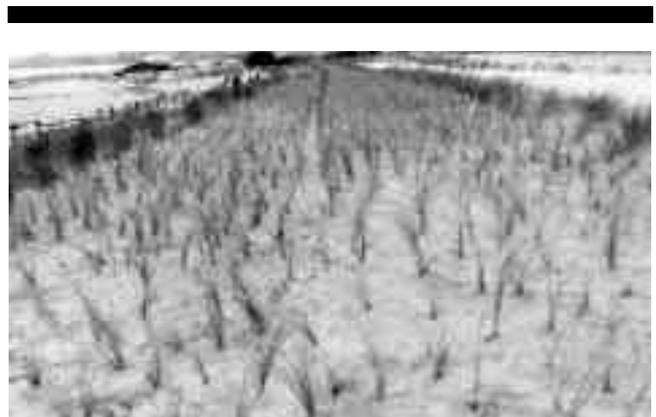
Figure 5. Fencing and transplanted vegetation in Somo spit (Cantabrian, Spain).

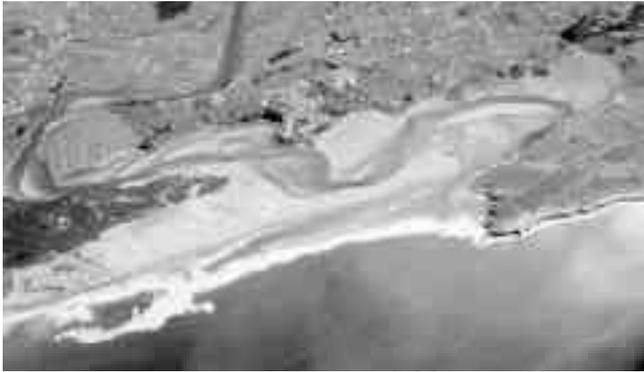
Figure 6. An aerial view of Liencres spit (Cantabrian, Spain) after breaching.

Figure 6 depicts an aerial view of Liencres spit after dune breaching. In Figure 7 sand accumulation caused by willow fences can be seen. Elevated dune walkovers and fencing are shown in Figure 8.

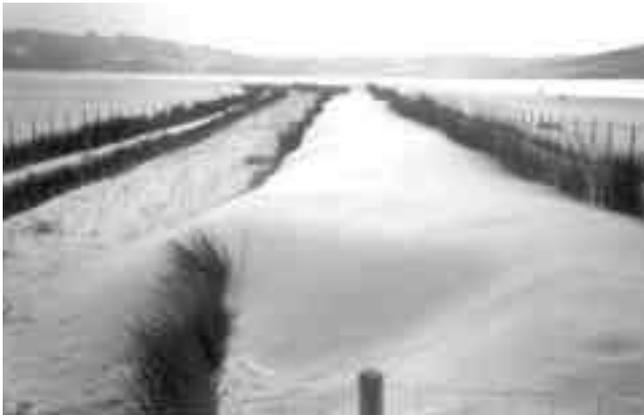
Figure 7. A detail of dune restoration in Liencres spit (Cantabrian, Spain)

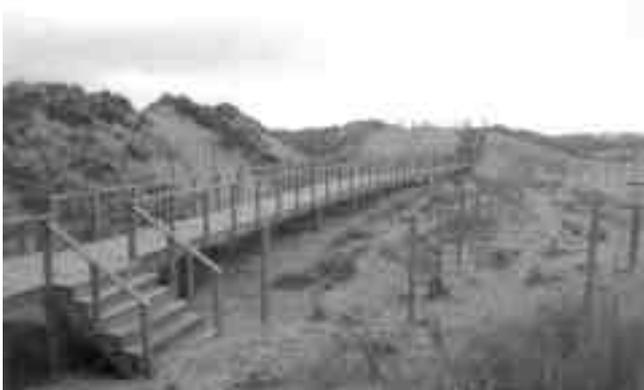
Figure 8. Dune walkover and fencing in Liencres spit (Cantabrian, Spain)

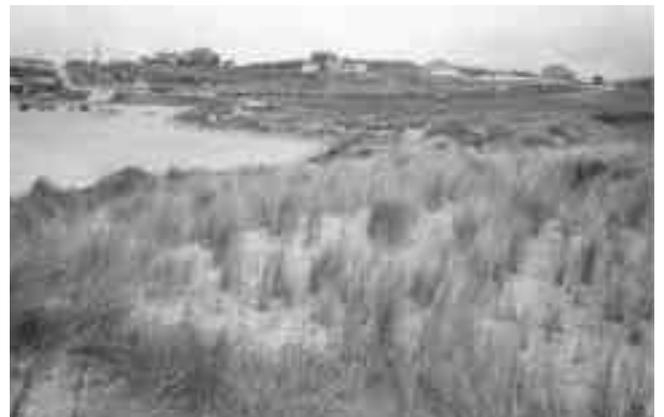
Figure 10. Cuchía beach (Cantabrian, Spain) after dune restoration

As a result of former sand mining, human trampling and disorderly garbage dumping in Cuchía beach, coppice mounds and foredunes lost all kind of dune vegetation presenting a very degrading state. After cleaning operations, foredunes were restored with adequate dredging from the neighbouring inner harbour in Suances estuary ("ría"). Finally, willow sand trappers together with transplanted vegetation were used to stabilise the foredune surface.

Figure 9 shows an aerial view of Cuchía beach and Suances estuary. A panoramic of Cuchía beach after rehabilitation is depicted in Figure 10.

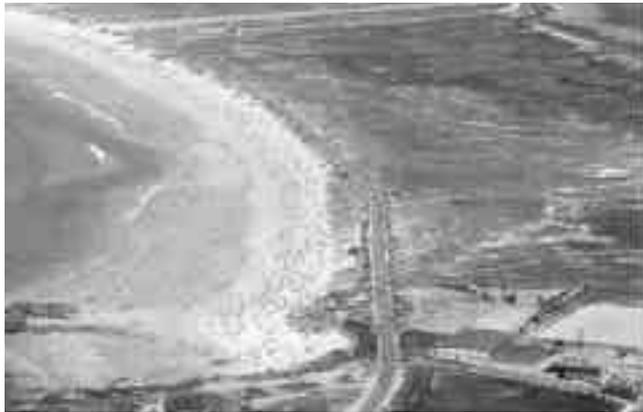
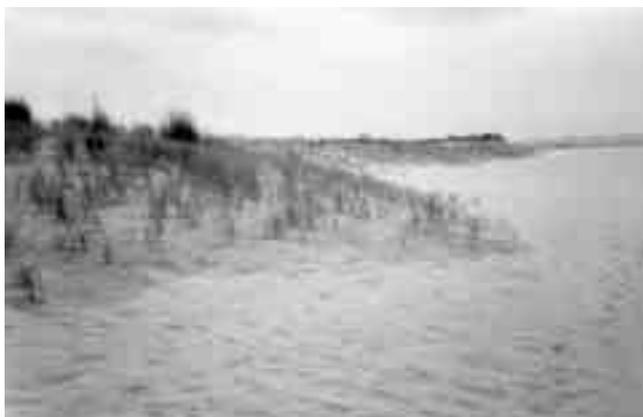
Figure 11. La Lanzada beach (Pontevedra, Spain) before dune restoration

Figure 12. La Lanzada beach (Pontevedra, Spain) after dune restoration

La Lanzada isthmus is one of the most emblematic beaches in the province of Pontevedra (North Atlantic façade). The direct burden on the beach caused by tourism and a bad commuting road system on the foredune itself made the whole dune system and beach very vulnerable. The goal of the dune restoration project was very challenging trying to both eliminate the main dune problem (the road) and reinforce the primary frontal dunes. The demolition of the existing public road across the dunes and the construction of an alternative road further inland from dunes was a controversial social issue that was, in the end, well accepted. Willow sand fencing and transplanted vegetation was used to rebuild the dune areas damaged by the road. Damage to dunes from pedestrian traffic was avoided by the use of elevated walkovers constructed parallel and perpendicular to the beach. Selective areas were

Figures 11 and 12 show aerial views of La Lanzada beach before and after dune restoration.

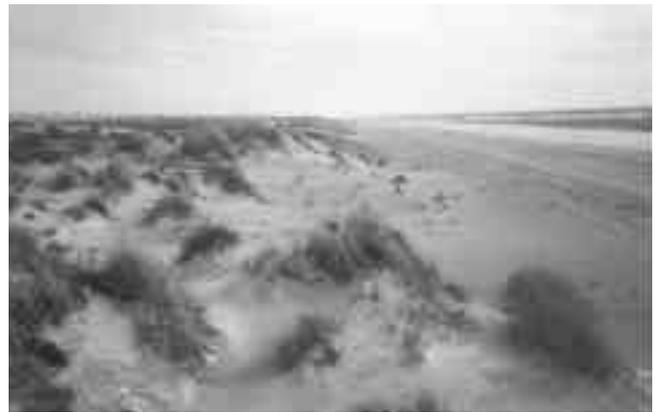
Figure 13. Dune blow-outs in Isla Cristina beach (Huelva, Spain)

Fig.13 shows typical dune blow-outs in Isla Cristina beach. Fig.14 depicts an illustrative grazing scene. Fig.15 shows dune fencing and revegetation.

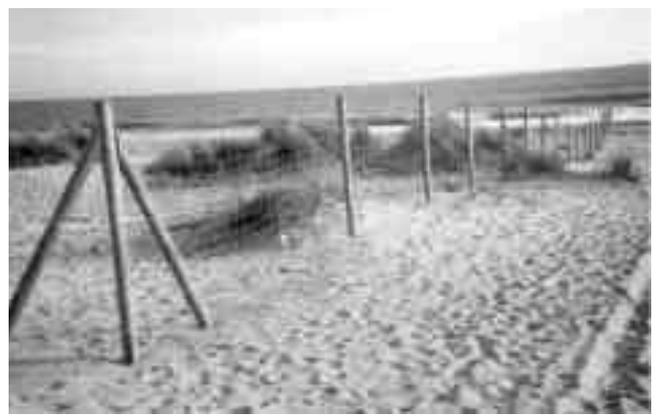
Figure 15. Dune fencing and revegetation in Isla Cristina beach (Huelva, Spain)

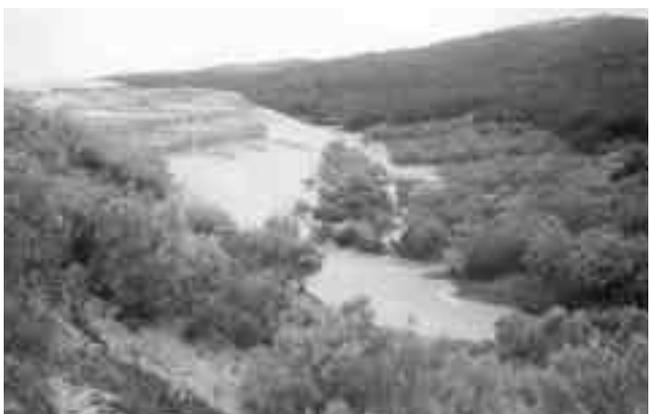
Figure 17. A view of Valdevaqueros backdune restoration (Cádiz, Spain)

Dune restoration works started with the reshaping of the dune profile in order to obtain a better aerodynamic stability complemented with the experimental use of longitudinal willow sand fences to decrease erosive surface patterns. Also experimental transplanted vegetation techniques were used along certain potentially stable areas.

Figure 16 depicts an aerial view of Valdevaqueros cove. Figure 17 shows backdune restoration near the adjacent pine grove. Figure 18 shows foredune accretion after restoration.

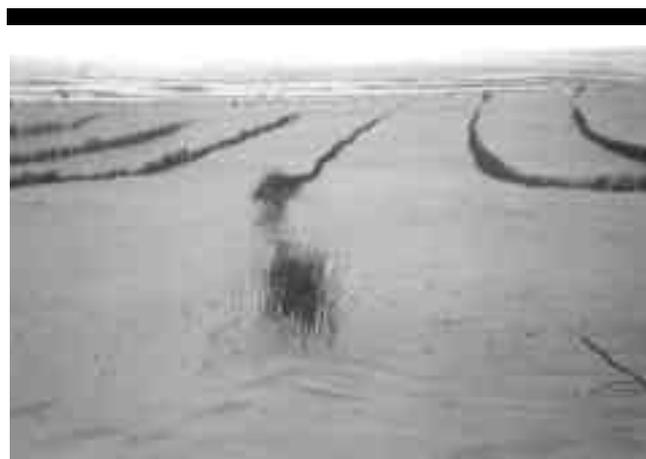
Figure 18. A view of Valdevaqueros accreted foredune after restoration (Cádiz, Spain)

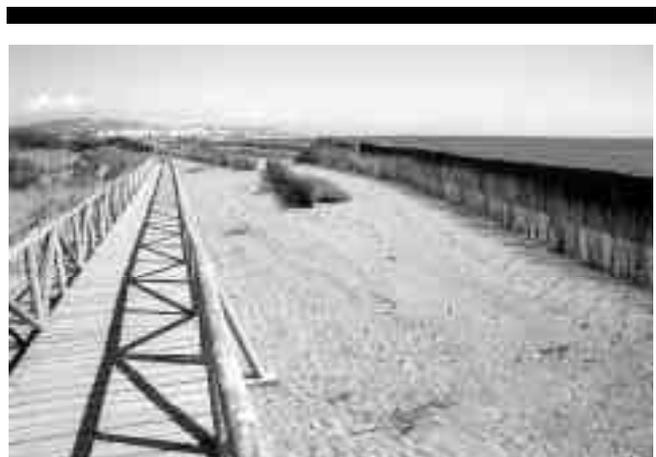
Figure 20. A detailed view of Guadalquítón dune restoration (Cádiz, Spain)

The dune restoration project was only a part of an integrated plan to improve coastal zone management aspects at the Guadiaro estuary, such as river flushing recovery, garbage cleaning, water quality improvement, wetland restoration, fencing of sensitive areas, public access improvement, sea bird observatories, beach nourishment and dune reinforcement. New sand trapping methods were experimented with as well as native transplanted vegetation under critical climatic conditions (yearly run-off is less than 250 mm)
