Effects of a Natural Dam-Break Flood on Geomorphology and Vegetation on the Elwha River, Washington, U.S.A

Authors: Acker, Steven A., Beechie, Timothy J., and Shafroth, Patrick B.

Source: Northwest Science, 82(sp1) : 210-223

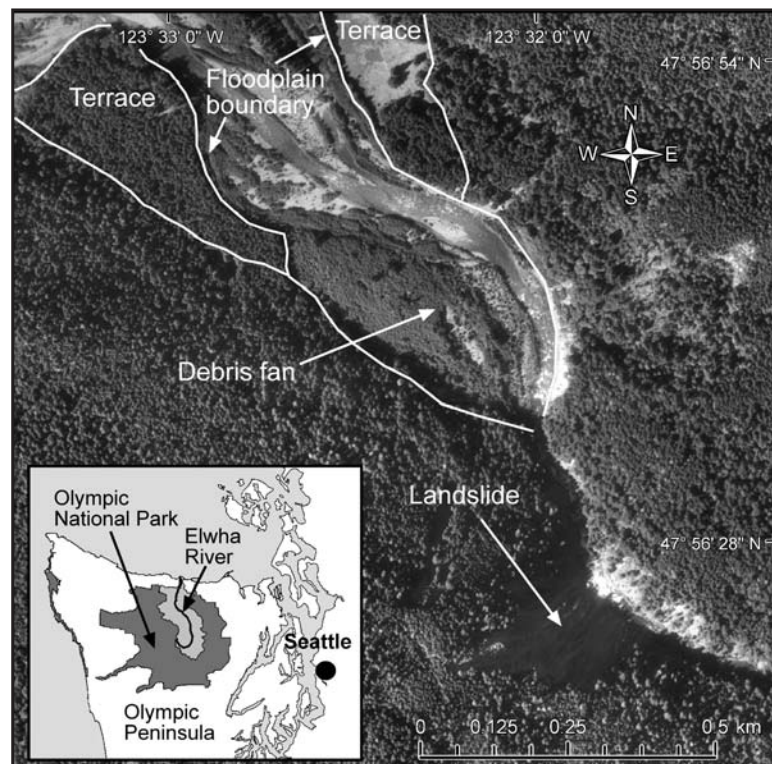
Figure 1. Geyser Valley aerial photograph (2002) showing locations of (1) landslide that likely triggered dam-break flood of 1967, (2) location of dam-break flood deposits, and (3) boundaries of the contemporary floodplain and terraces. Inset shows location of the Elwha River on the Olympic Peninsula in Washington State, USA.

The 72 km-long Elwha River flows northward out of the Olympic Mountains to the Strait of Juan de Fuca on Washington State’s Olympic Peninsula (Figure 1), draining an area of approximately 830 km² (see Duda et al. 2008 for more information on climate and hydrology of the watershed). Geyser Valley, an unregulated alluvial reach upstream of the upper dam between rkm 28 and rkm 32, may be the best model of pre-dam geomorphology for the area inundated by the upper dam on the Elwha River (Gilbert and Link 1995, DOI 1996). However, floodplain morphology and disturbance regimes are undocumented and there is little information upon which to base a strategy for restoration of floodplain forests. One of the most significant events to occur

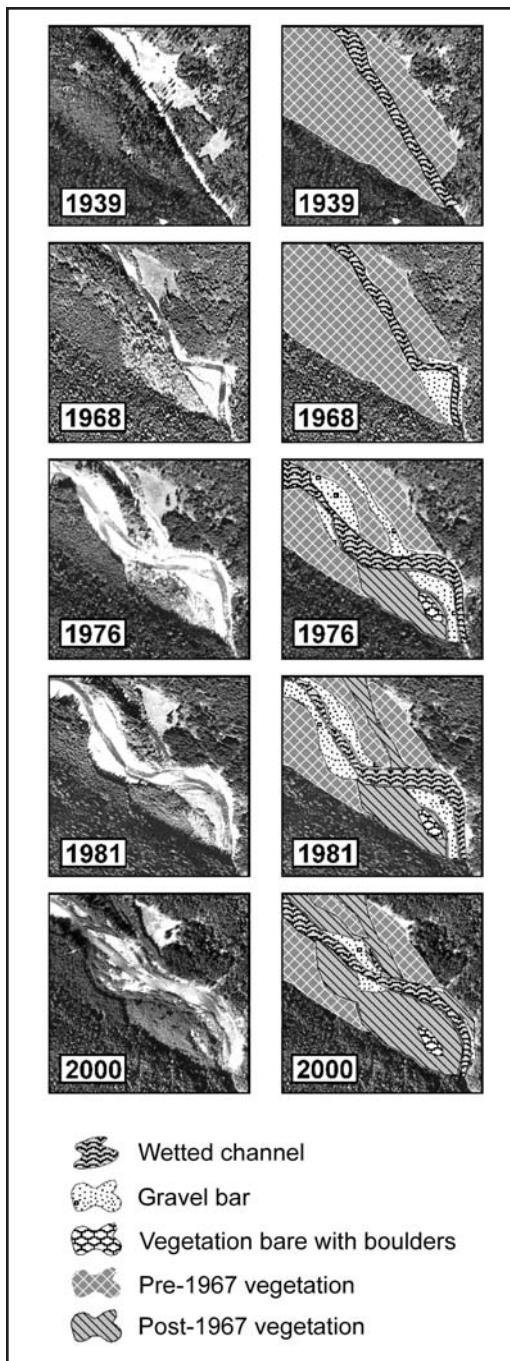
Figure 2. Aerial photograph time series of the study site illustrating straight channel prior to the dam break flood (1939), channel shift eastwards after the dam-break flood (1967), and subsequent vegetation and channel changes. The non-forested patch in the center of the upper edge of each photograph is a persistent meadow on a terrace.

Prior to the dam-break flood of 1967 the Elwha River flowed in a straight channel through the study reach, bordered by mature forest on both banks and aligned with the canyon upstream (Figure 2). In the year after the dam-break flood (1968), the flood deposit evidently filled the straight channel and forced the main channel more than 100 meters to the east. The forest on the floodplain to the west of the channel remained standing, but most trees appeared dead. By 1976, the channel had moved farther to the east, exposing a new surface deposited at the eastern edge of the 1967 flood deposits. The channel continued to erode eastward into the terrace of glacial sediments after 1976 and by 1981 had deposited a second new surface to the east of the 1967 flood deposits. By the year 2000, the study site attained the configuration mapped during this study.

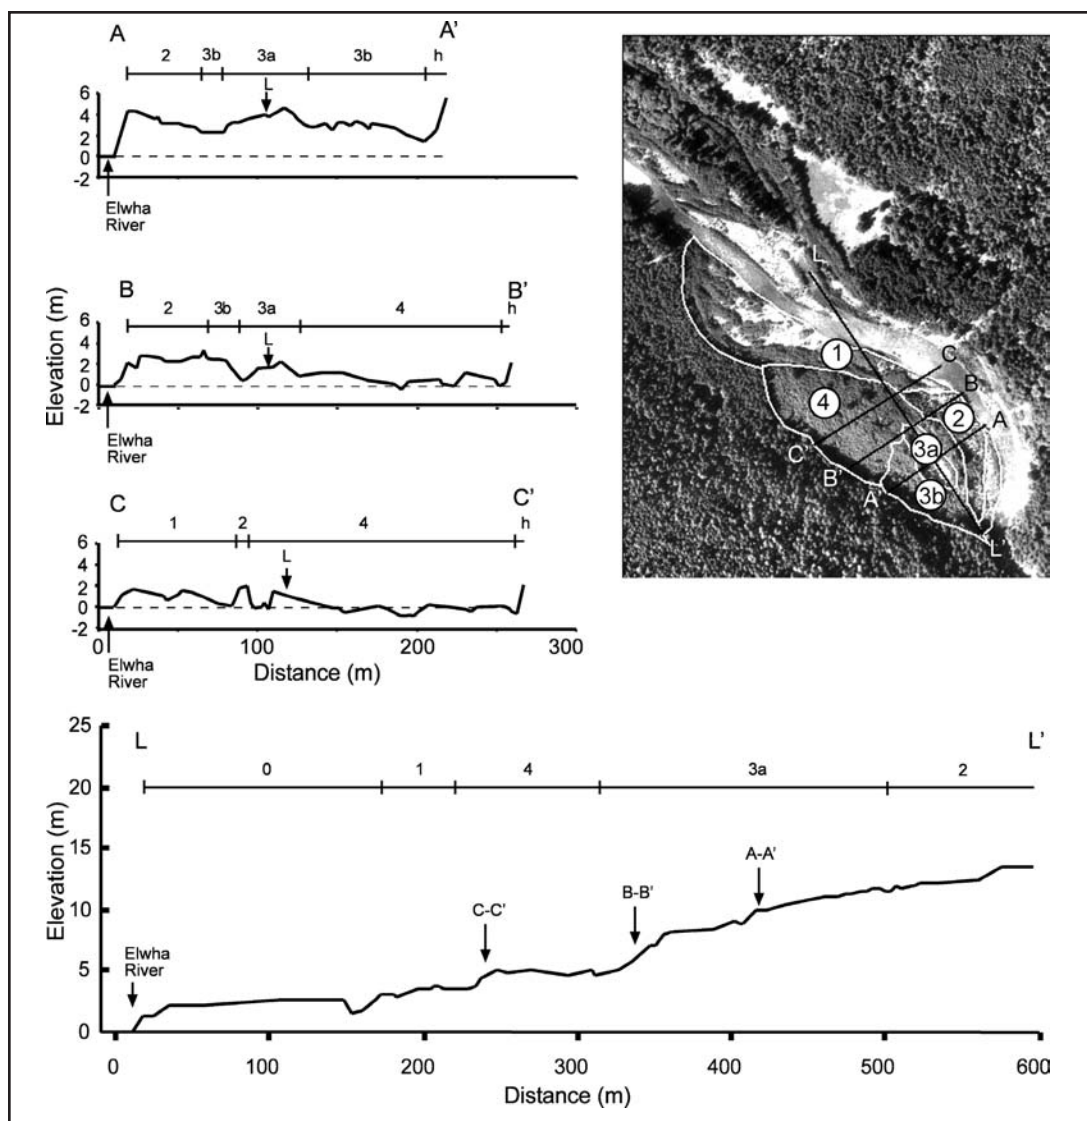
Figure 3. Cross sections (A-A', B-B', C-C') and longitudinal profile (L-L') of dam-break flood deposits located at the upstream end of Geyser Valley, Elwha River, Washington. Line above each profile illustrates locations of geomorphic surfaces. Surface 0 is the contemporary gravel bar. Surface 1 is the most recent dam-break flood deposit (dating to 1984). Surface 2 is an intermediate age dam-break flood deposit (dating to 1977). Surfaces 3a, 3b, and 4 are from the 1967 dam-break flood. Transect locations are shown on aerial photograph at upper right.

Our survey identified five major surfaces within the fan area, excluding the contemporary gravel bars of the Elwha River (Figure 3). Based on ages of the vegetation plots (Figure 4), all surfaces post-date the 1967 dam-break flood. Surfaces 3a, 3b, and 4 date approximately to the 1967 dam-break flood, with first tree establishment no later than 1971, 1970, and 1969, respectively (Table 1). The coarse boulders of surface 3a indicate a region of high energy flow oriented along the fan's long axis, and in approximate alignment with the canyon immediately upstream. There was little fine-grained sediment within this deposit, forming a substrate of large boulders with large interstitial spaces. The peak elevation of the surface was approximately 4 m above the present day river bed, or more than 2 m above contemporary bankfull floods (Figures 3 and 5). Surface 3b surrounded the upstream portion of the boulder field, and consisted of boulders within a matrix of finer gravels and sand. The elevation of surface 3b was 1 to 2 m lower than the main boulder field at transect A-A', or 2 to 3 m above the present-day river bed. Partially vegetated overflow channels that are

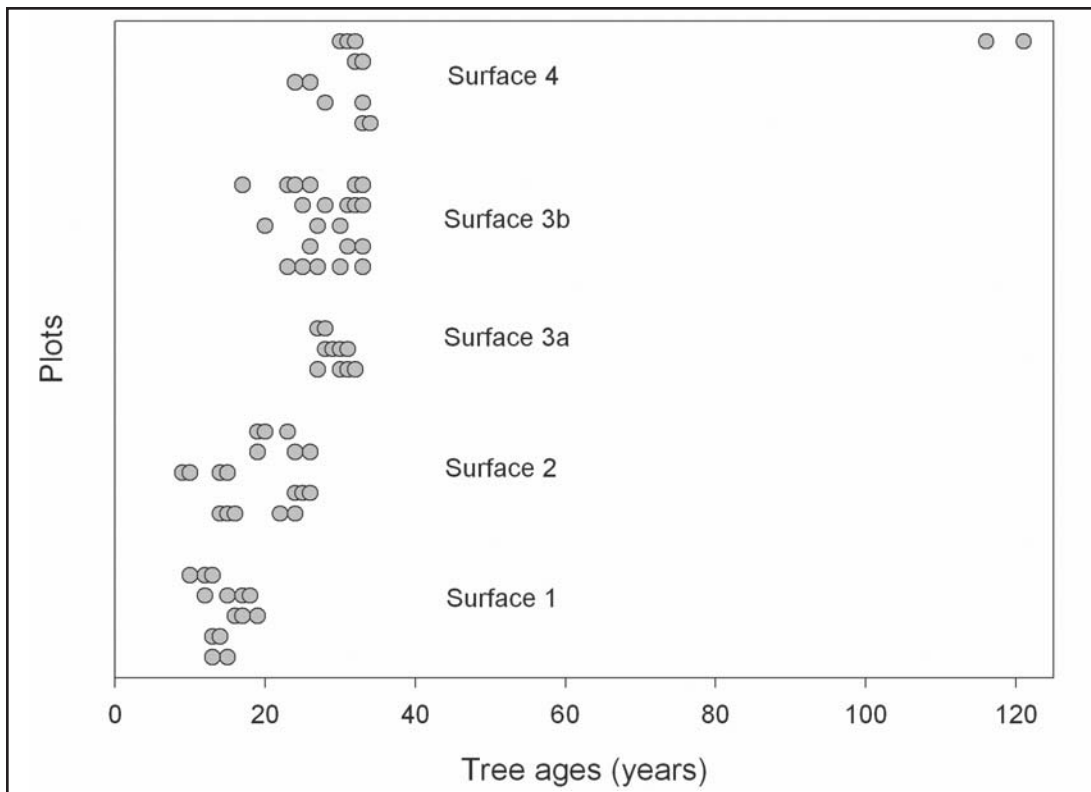
Figure 4. Ages of trees within plots, grouped by geomorphic surface. Each horizontal line of points represents one plot.

Trees began to establish on all surfaces one to four years after surface creation (Table 1). There has been a prolonged period of tree recruitment, especially on surfaces 3b and 2 (Figure 4). Present day tree species composition was generally

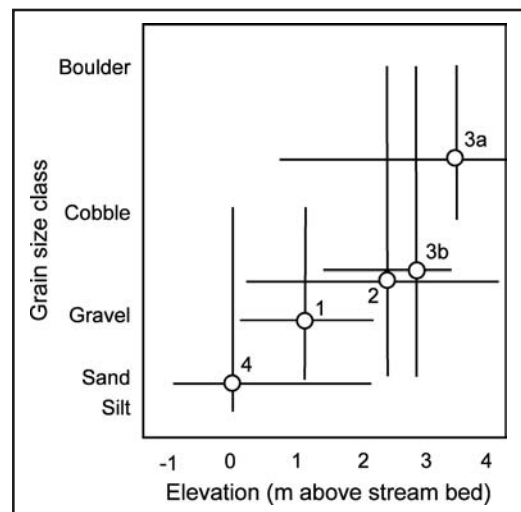
Figure 5. Elevation and grain size ranges of the five geomorphic surfaces. Points indicate median grain size class and median elevation of surface above the present stream bed measured along transects, and lines indicate the range of elevation and grain size classes of each surface.

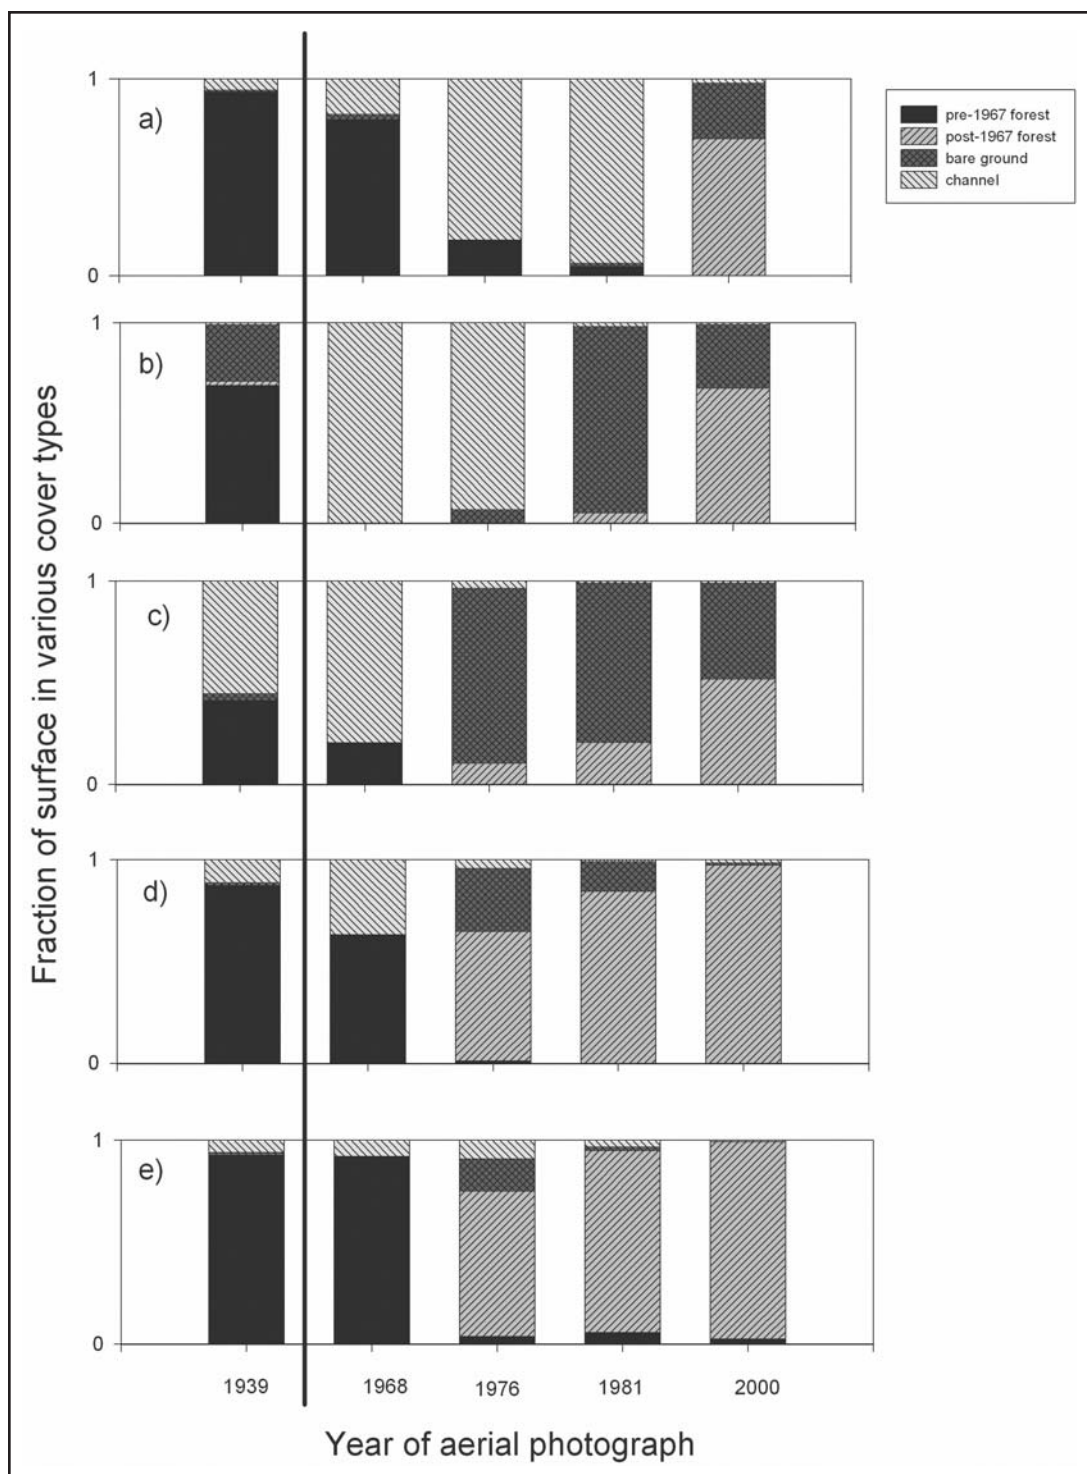
Figure 6. Proportions of area in different cover types on the geomorphic surfaces derived from the aerial photograph time series of the study site: a) surface 1; b) surface 2; c) surface 3a; d) surface 3b; e) surface 4.

between 1968 and 1976, removed more of the earlier forest from surface 1 than did the 1967 flood (Figure 6).

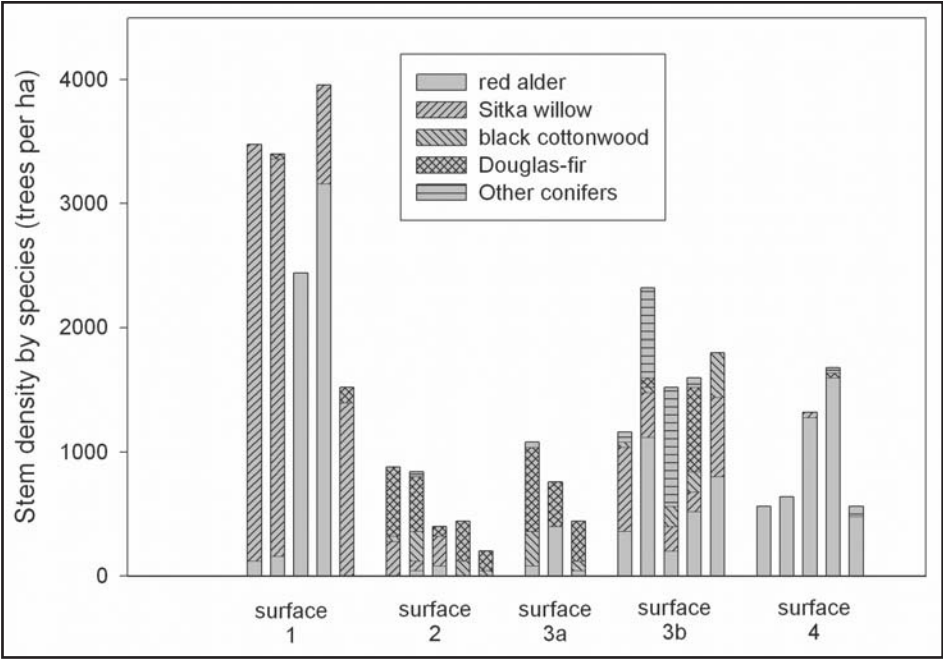
Figure 7. Stem density (numbers of trees per ha) by species for plots on the five geomorphic surfaces. Bars represent the replicate plots on each surface.

consistent among plots within each of the five surfaces; there were also similarities between some of the surfaces (Figures 7 and 8). Surface 4 was characterized by red alder and surface 1 by either Sitka willow or alder, or a mixture of both.

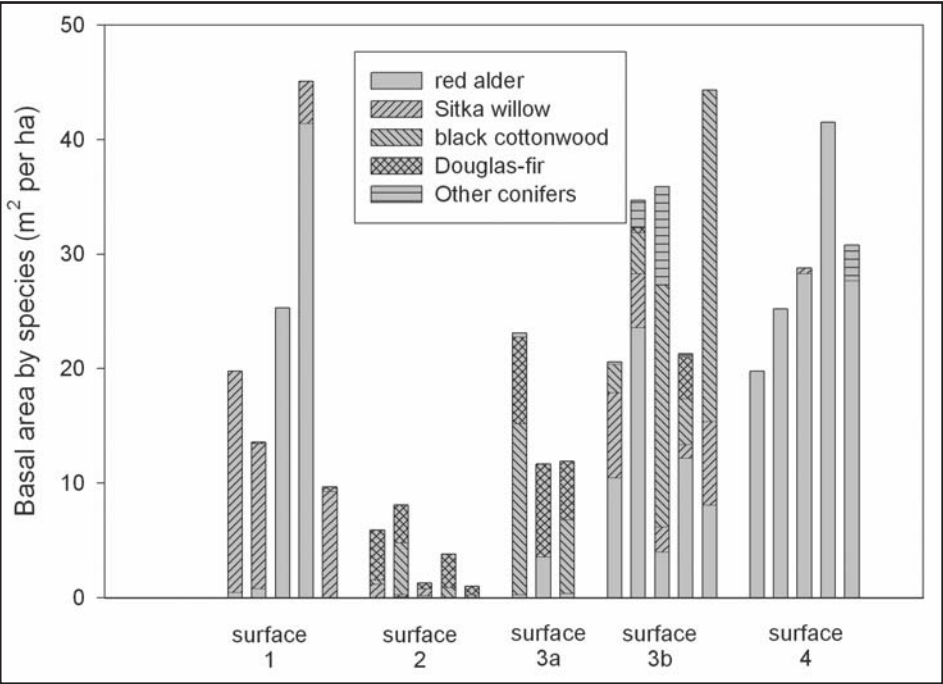
Figure 8. Basal area of trees (m² per ha) by species for plots on the five geomorphic surfaces. Bars represent the replicate plots on each surface.
