Ecosystem Services of Riparian Restoration: A Review of Rock Detention Structures in the Madrean Archipelago Ecoregion

Air, Soil and Water Research
Volume 13: 1–13
© The Author(s) 2020
Article reuse guidelines:
sagepub.com/journals-permissions
DOI: 10.1177/1178622120946337

TYPE: Case studies of a grassroots binational restoration collaborative in the Madrean Archipelago Ecoregion (2014–2019): Review

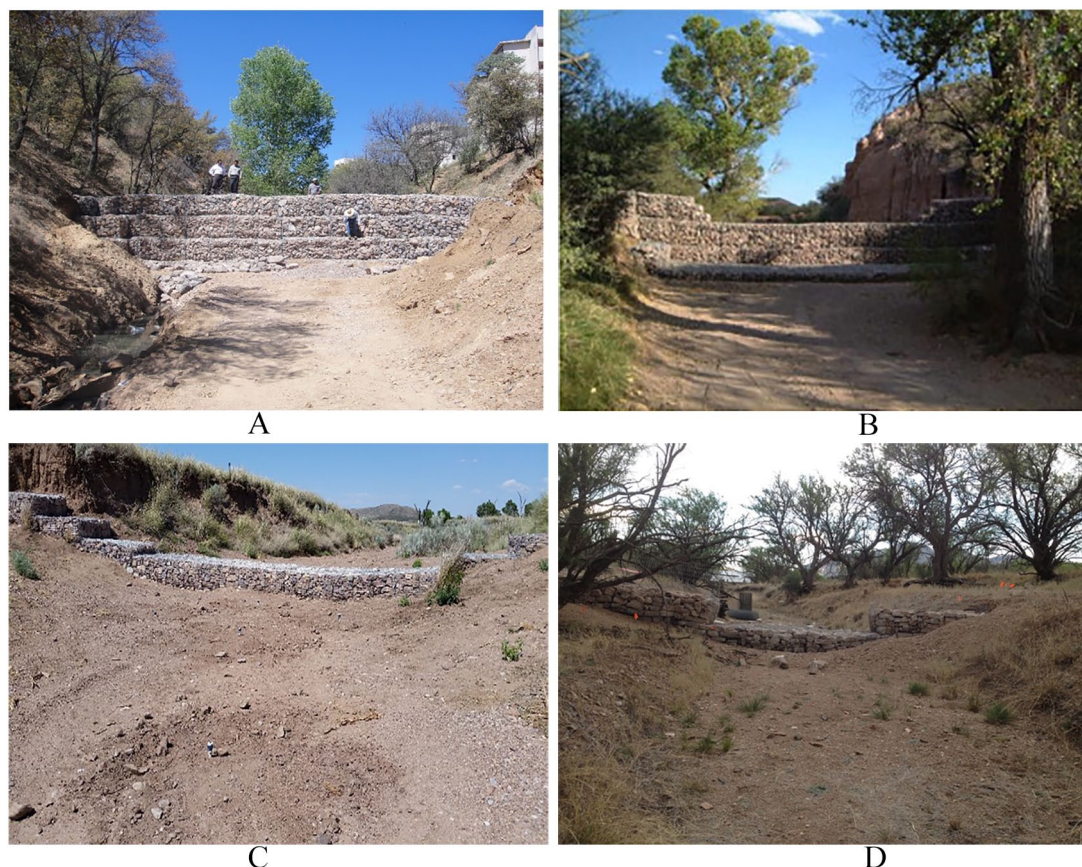
Figure 4. (A) Looking downstream at Cinco de Febrero, which experiences major flooding during monsoons, in Nogales, Sonora, Mexico (photo by Hans Huth [April 12, 2010]); (B) Gabion in Hay Hollow at Rancho San Bernardino, Sonora, Mexico (by Josiah Austin [October 27, 2001])⁶⁷; (C) Gabion in Vaughn Canyon on the Babacomari Ranch (by James Callegary June 19, 2015); and (D) Gabion installed at Bone Creek on the Deep Dirt Farm Institute (by Kate Tirion (2014). See Figure 3 for map locations.

implemented to predict the capacity of suggested gabions under various flood and urbanization scenarios (Figure 4(A)). The model predicted that some of the intended gabions would reduce peak flows in small rainfall events (ie, 10-year, 1-h storm event) but would have little impact for larger storm flows (ie, 100-year, 6-h storm event). Conversely, other gabions were predicted to have little impact from either small- or large-sized storms, depending on location, upstream contributing source area, soil, slope, and so on (Figure 6).⁶⁹ The potential for RDS to regulate flood events and help reduce hazards was documented, and structures were installed at recommended locations around Nogales, Sonora, Mexico. This work also demonstrated the additional potential for gabions to capture large amounts of sediment regardless of storm size and highlighted the need for regular maintenance therein.⁷⁰

and by the Cuenca los Ojos (CLO) Foundation over the course of 20+ years to restore surface water for native fishes (Figures 3 and 4(B)). *Cienegas*, or desert wetlands, are biodiverse yet sensitive habitats imperiled by demands for water and by changing climates.¹⁸ A remote-sensing analysis, coupled with field data, was conducted to document impacts of gabion installation over time. Using a vegetation index (ie, Normalized Difference Vegetation Index; NDVI), health and plant biomass were quantified to compare gabion and control sites over a 27-year period. Results portray live green vegetation present at most sites treated by gabion installation and at a few of the control sites, where no gabions exist (Figure 7). Field sites established within the study area between 2000 and 2012 corroborate findings of established biomass at gabions. This research documented the potential to restore riparian vegetation using gabions with the implication of increased water availability, and further suggested the potential to alleviate drought conditions in a desert *cienega*.⁶⁷

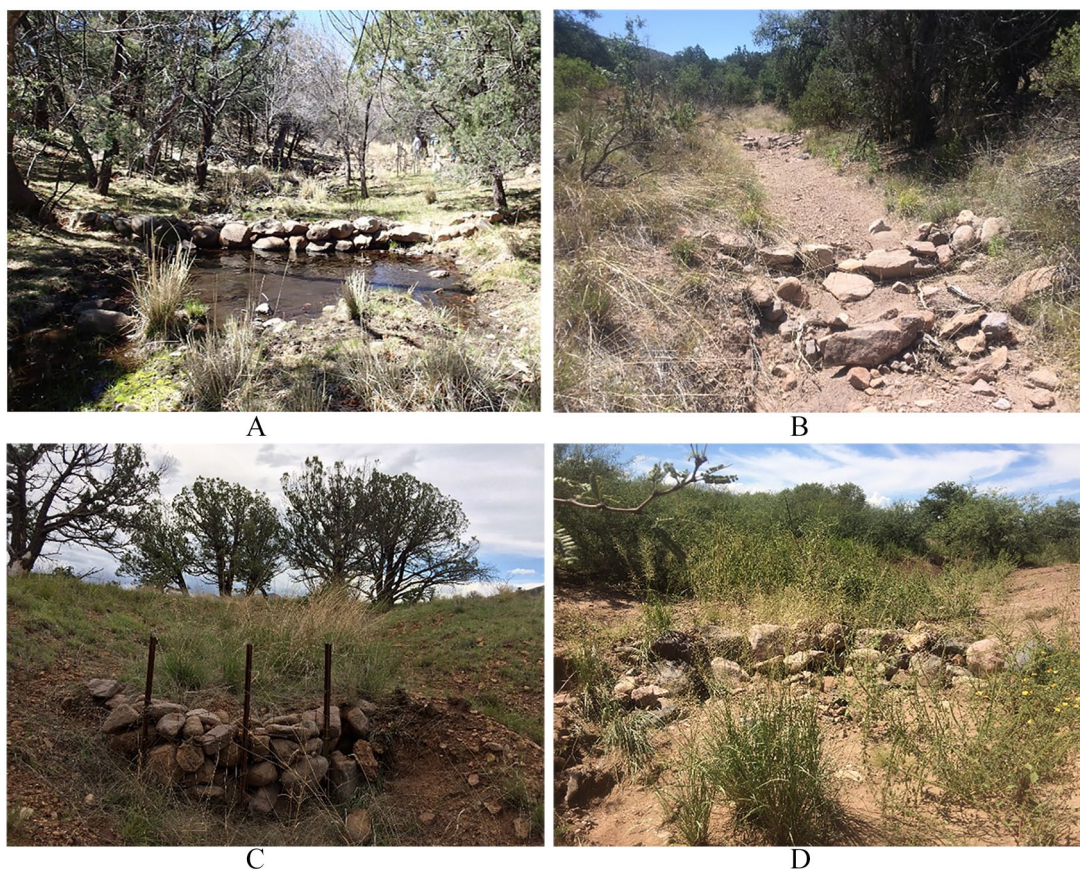
Figure 5. Photos of small structures at (A) Turkey Pen in the El Coronado Ranch, by Leila Gass, March 23, 2016)). (B) Bar Boot Allotment on the Douglas Ranger District, USFS; photo by Natalie R. Wilson, July 19, 2019)). (C) Tex Canyon on the Douglas Ranger District, USFS; photo by Natalie R. Wilson, July 14, 2015)). (D) Silver Creek on the Malpai Ranch, photo by Natalie R. Wilson (September 12, 2016). See Figure 3 for map locations.

small dams at the Bar Boot and Tex Canyon drainages (Figures 3, 5(B) and 5(C)).⁵³ In the Silver Creek drainage, the Bureau of Land Management contracted Stream Dynamics to install RDS in the Wildcat Draw tributary on the Malpai Ranch (Figures 3 and 5(D)). United States Geological Survey scientists partnered with these various practitioners and land managers to develop long- and short-term vegetation study plots to investigate vegetation changes over a 5-year period. Preliminary findings have indicated positive responses to RDS, with increases of perennial vegetation observed at most study sites.^{72,73}

course of 30 years (Figure 5(A)), while another had been left untreated (control). A paired-watershed approach was established to analyze the impacts of check dams on hydrologic function, given the adjacent location, similar land use, geology, vegetation, and precipitation. A new stream-gauging mechanism developed for remote areas, was modified and installed to measure discharge.^{74,75} The watershed treated with check dams had a reduced runoff response to precipitation, especially noticeable in peak flows compared with the untreated watershed. At the beginning of the season, the runoff response to precipitation in the treated watershed was negligible, but over the course of the summer “monsoon,” the response of the treated watershed increased to more than twice that of the untreated watershed, resulting in 28% more flow volume per area in the treated watershed compare to the untreated watershed (Figure 9). The cause for this delayed but increased response was hypothesized to be increased baseflow incurred from the RDS installed in arid and semiarid environments.⁷⁵ It was also noted that most of the check dams were still functional despite the age of construction.

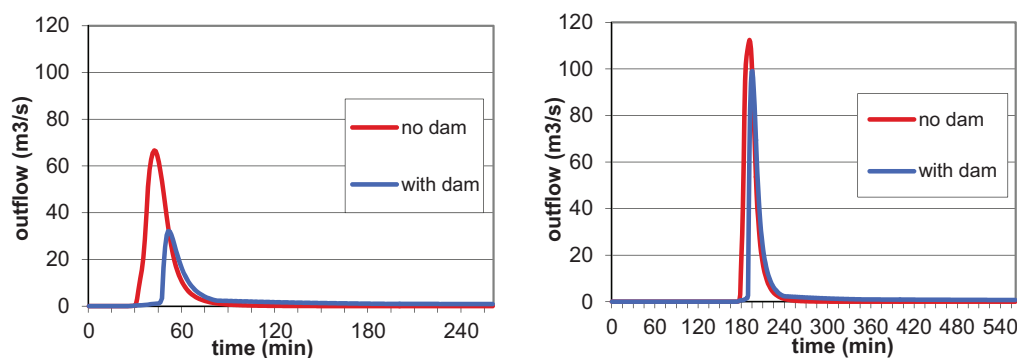
Figure 6. Gabion installation at the Cuesta Blanca subwatershed of Nogales, Sonora, Mexico, hydrograph results of modeling runoff response after a 10 year, 1-h storm event (left) and a larger 100 year, 6-h event (right)).⁷⁰

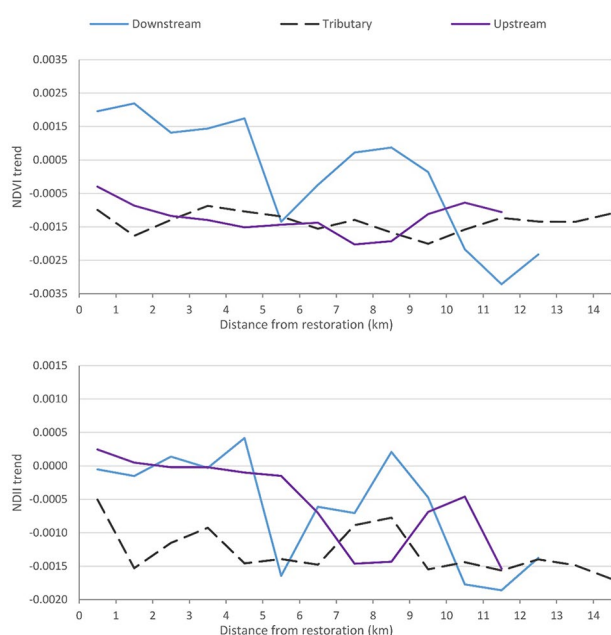
Figure 8. Graphs portray repeat analyses of the Normalized Difference Vegetation Index (NDVI; top) and new results from the Normalized Difference Infrared Index (NDII; bottom) accentuating impacts at distances from restoration sites, modified from Wilson and Norman.⁷¹

tributary and upland areas (Figure 8).⁷¹ This analysis documented the potential of gabions to increase live green vegetation, owing to increased water availability, at locations as far as 5 km downstream and 1 km upstream.⁷¹
