## **Landslide Hazard and Risk Zonation Mapping in the Río Grande Basin, Central Andes of Mendoza, Argentina**

Authors: Espizua, Lydia Elena, and Bengochea, Jorge Daniel

Source: Mountain Research and Development, 22(2) : 177-185

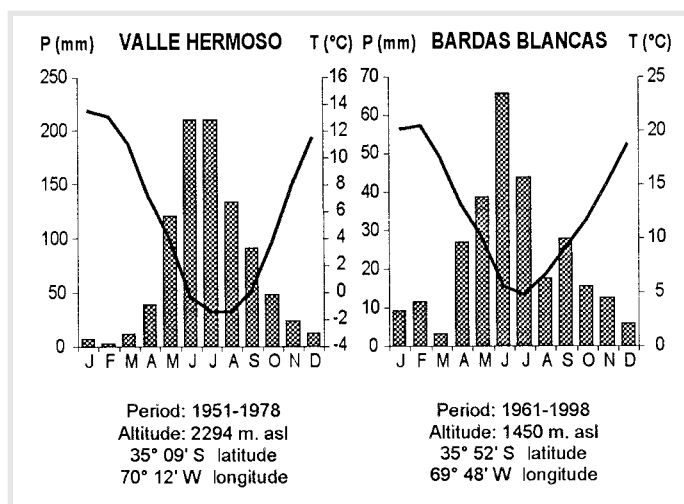
**FIGURE 2** Monthly mean precipitation and temperature in Valle Hermoso and Bardas Blancas meteorological stations.

There are 2 meteorological stations in the zone, with interrupted records: (1) Valle Hermoso (35°09'S, 70°12'W) at 2294 m, and (2) Bardas Blancas (35°52'S, 69°48'W) at 1450 m. The mean monthly precipitation and temperature records show 2 well-defined periods, one in winter and the other in summer (Figure 2). The monthly mean maximum precipitation coincides with the monthly mean minimum temperature. In Valle Hermoso the mean monthly temperature from June to August is below 0°C. At this station the higher monthly precipitation occurs in the winter as snow, whereas in Bardas Blancas it can be snow or rain and occurs from May to June. Annual mean precipitation varies from 400 mm in Bardas Blancas to 940 mm in Valle Hermoso.

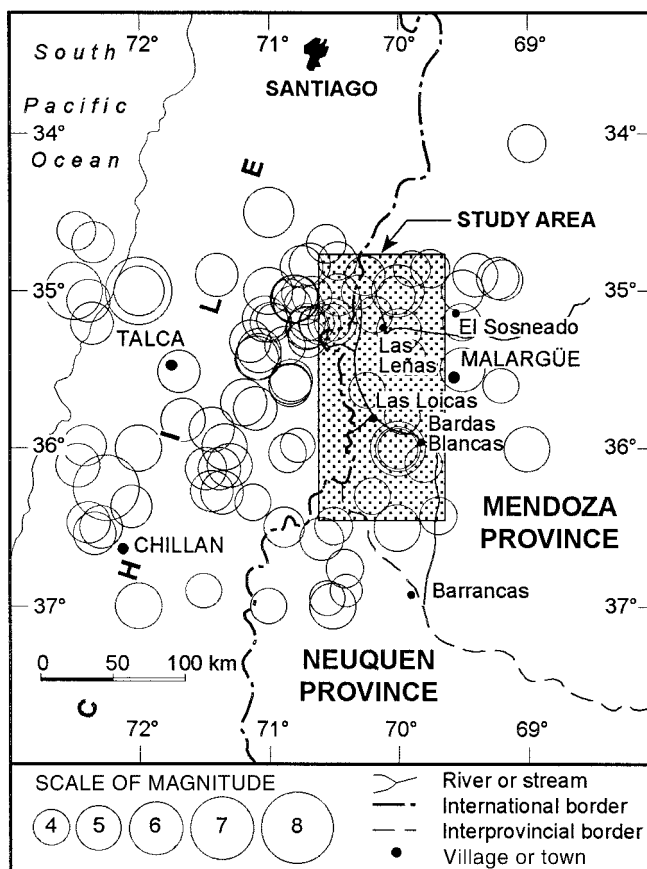
**FIGURE 3** Location of earthquakes (epicenters and magnitudes).

sity of Chile. Ninety earthquakes with magnitudes greater than 4 have occurred in the area. Figure 3 shows the location of the epicenters and magnitudes in the study area and the surrounding zones; the figure shows that there is an increase in the number of earthquakes and in their magnitudes toward the west.

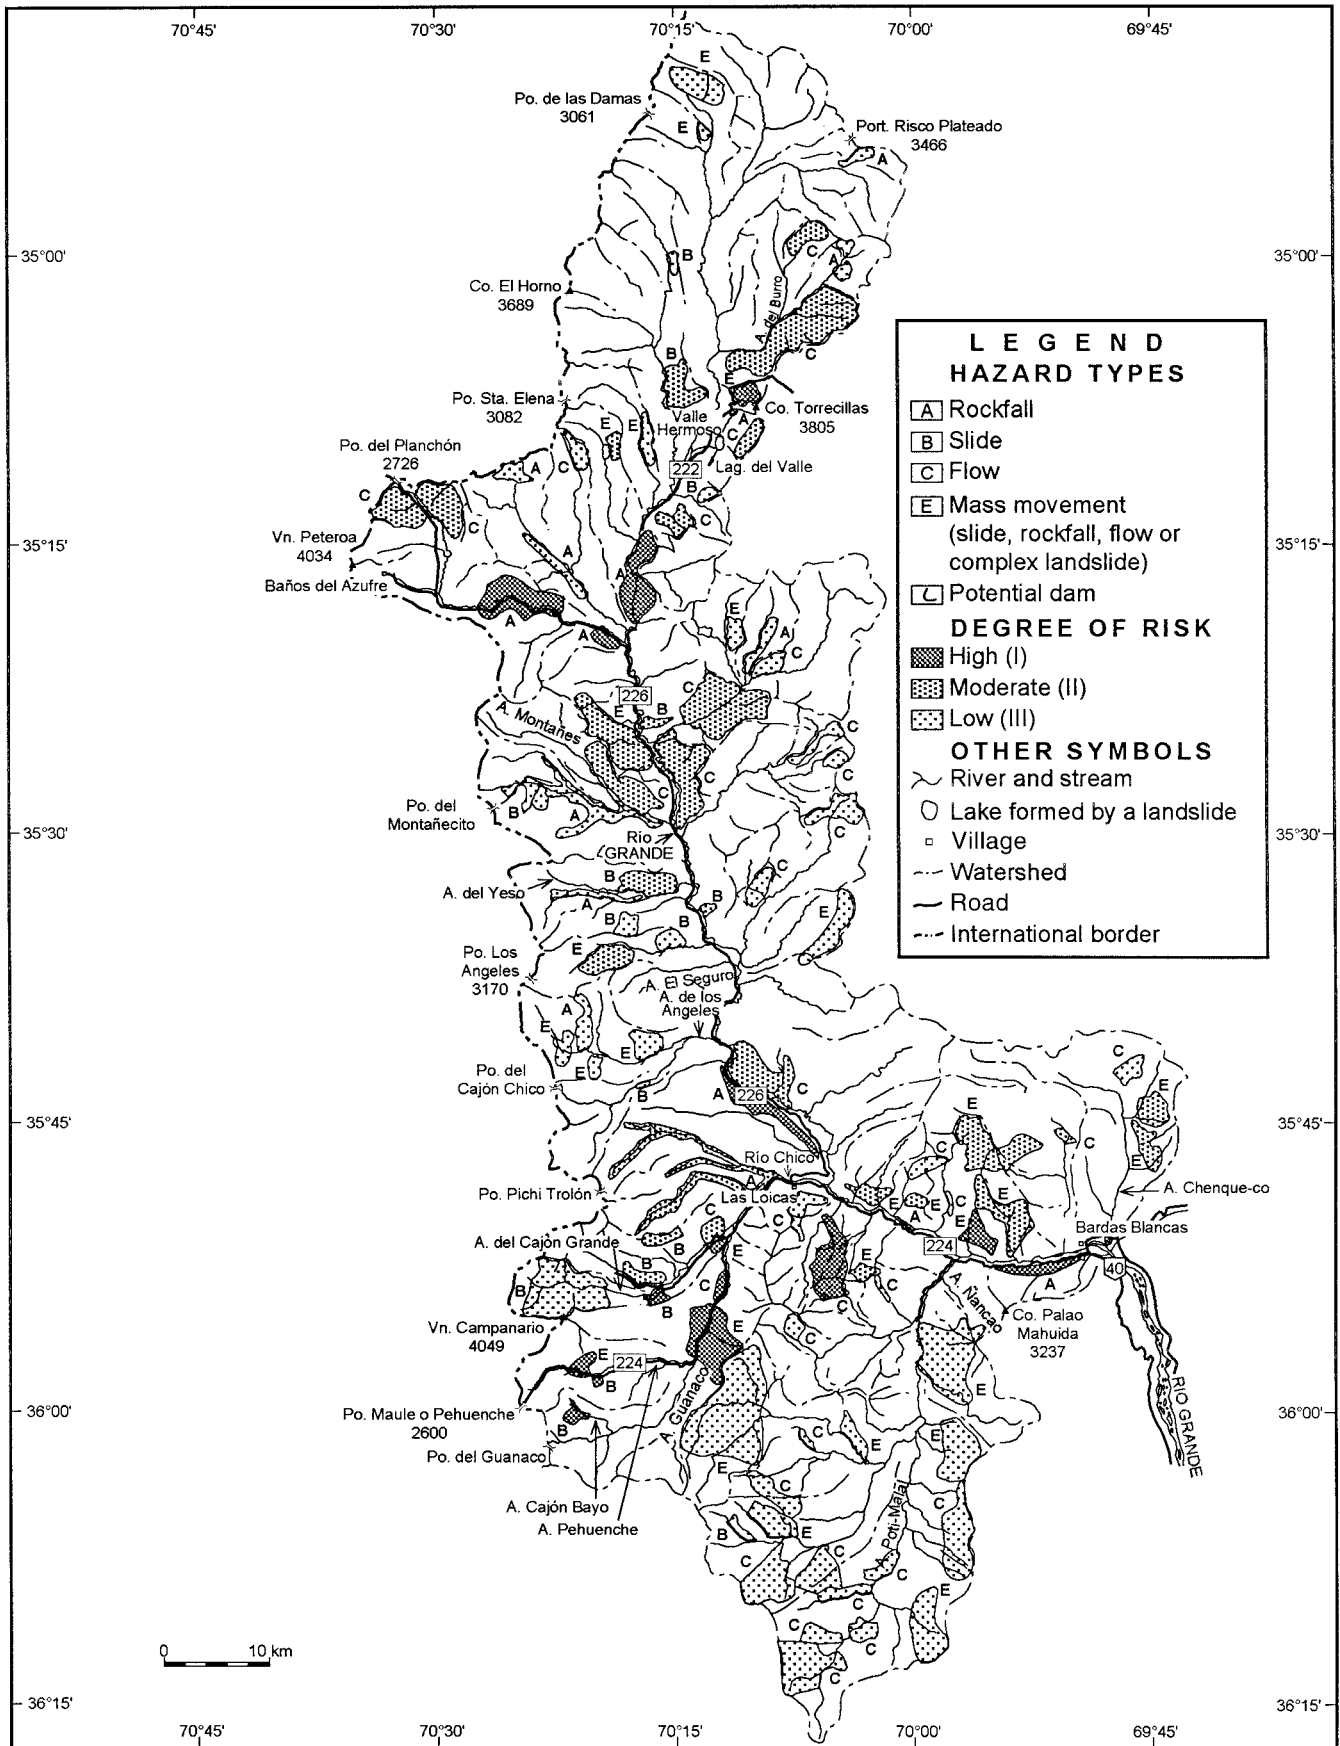
**FIGURE 6** Map of landslide hazards and risk zonation in the Río Grande basin.

We prepared 2 maps. The distribution and classification of landslides are shown on the first map (inventory map; Figure 5). The second—a landslide hazard and risk zonation map (Figure 6)—was prepared taking into account the zones subject to landslide hazard and the degree of loss to a given element or set of elements at risk in the region because of the occurrence of a particular phenomenon of a given magnitude (Coburn et al 1994).

A landslide risk map was obtained showing the hazards and elements at risk according to UNDRO/UNESCO (See Coburn et al 1994) definitions. The risk map shows that the major hazards and the greatest potential risk are concentrated along the Río Grande valley and its tributaries where the roads, routes, and settlements are located. Three risk degrees were distinguished as follows (Figure 6):

- *Degree I (high risk)*. This is the category with the highest degree of hazard and risk, where rockfalls, flows, or slides that could occur would affect Provincial routes 222 and 224, roads, bridges, or small, populated centers. Rockfalls are probably the most frequently observed mass movements in mountain areas. The areas where rockfalls occur are subject to events of lesser magnitude that occur more frequently; therefore, construction should be avoided.

- *Degree II (moderate risk)*. This category covers areas vulnerable to the potential occurrence of landslides, but the threat to infrastructure in the area is not as great because the hazard zones are far away. Through field observations in March 1996, it was possible to detect the occurrence of a debris flow that flowed from the headwaters of Arroyo Chenque-Co after a heavy rainstorm (Degrees II and III; Figure 6). Highway No. 40 and a small bridge were damaged (Degree I; Figure 6).
