Landslide Hazard and Risk Zonation Mapping in the Río Grande Basin, Central Andes of Mendoza, Argentina

Authors: Espizua, Lydia Elena, and Bengochea, Jorge Daniel

Source: Mountain Research and Development, 22(2) : 177-185

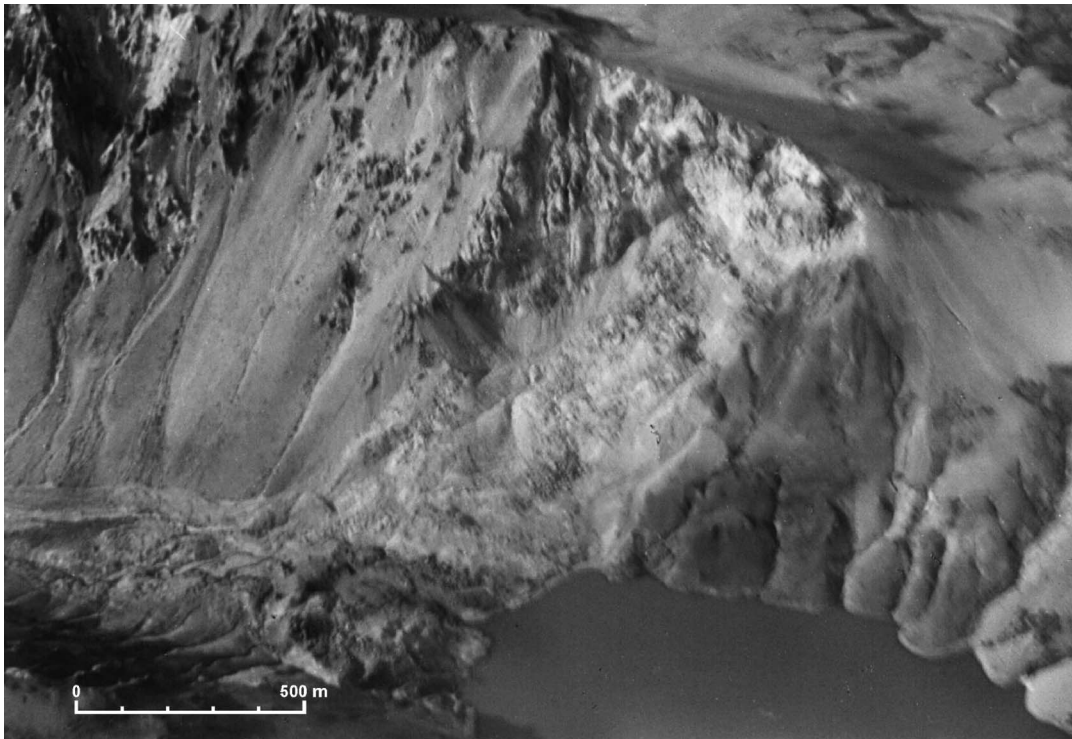
FIGURE 4 South aerial view of a landslide and the resulting dam at the headwaters of the Cajón Bayo creek in the Río Pehuenche basin. (Photo by Luis Lenzano and Carlos Aguado)

In the study area it was possible to detect a reactivated landslide (slump) at the headwaters of the Cajón Bayo creek at the Río Pehuenche basin. Tuffs of the lower Tihuelitense (lower Quaternary age) are characterized by outcrops about 300–400 m thick, in subhorizontal position, with andesitic composition arising from eruptions of Volcano Campanario. A small 600-m-long landslide that deviated the creek about 50 m to the north can be observed in the 1963 aerial photos. In the satellite image of March 1985, no change was detected in the sector. Instead, on the 1986 images, a 1500-m-long lake that formed upstream from the landslide was detected (Figure 5; slump B39). In March 1992 the region was observed from a plane. A reactivated slide had occurred in the same sector as the one before, but this time it was more important, and the mass movements crossed the valley floor and extended far up the opposite wall. A lake was formed after the landslide obstructed the Cajón Bayo valley floor in 1986 (Figure 4). In March 1992, minor drainage of the lake through the base of the mass was also observed. This characteristic, and the prevailing lithology (friable tuffs), a steep slope, and the presence of snow ablation water, are negative factors that may affect stability. It is quite probable that at some time the natural dam will break. Were the water mass to drain suddenly, catastrophic downstream flooding would affect the Pehuenche road (Provincial Route 224) and the locality of Las Loicas.
