# Managing Debris Flow Risks

Markus Zimmermann

## Security Measures for a Hazard-Prone Resort in Switzerland

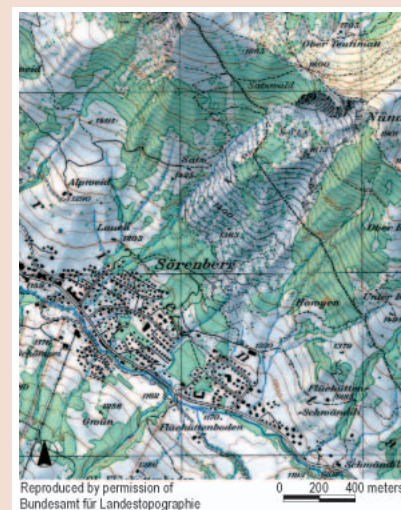
**FIGURE 3** 1993 topographic map, showing how the village has developed in the past 30 years in the area where debris flow formerly accumulated. (Map reproduced by permission of Bundesamt für Landestopographie, BA024084)

Sörenberg's development into the tourist resort that it is today took place only over the past 30 to 40 years. The 1918 map (Figure 2) clearly shows that at that time only very few buildings were located in what was once a highly active accumulation area. Today this area is completely covered by houses (Figure 3). The long period of geomorphic inactivity following the events of 1922 was interpreted as a sign of future security. An analysis by experts in 1974 proved that there was no immediate threat, but did not altogether exclude the possibility of damaging events. An indication of the uncertainty of the situation was provided by displacement measurements begun in 1978. These clearly show that the whole mass is continuously moving about 3 to 10 cm per year. The speed of this movement increased dramatically in 1999 but has slowed down again since.
