Source: Mountain Research and Development, 24(1) : 19-23

Managing Debris Flow Risks

Security Measures for a Hazard-Prone Resort in Switzerland

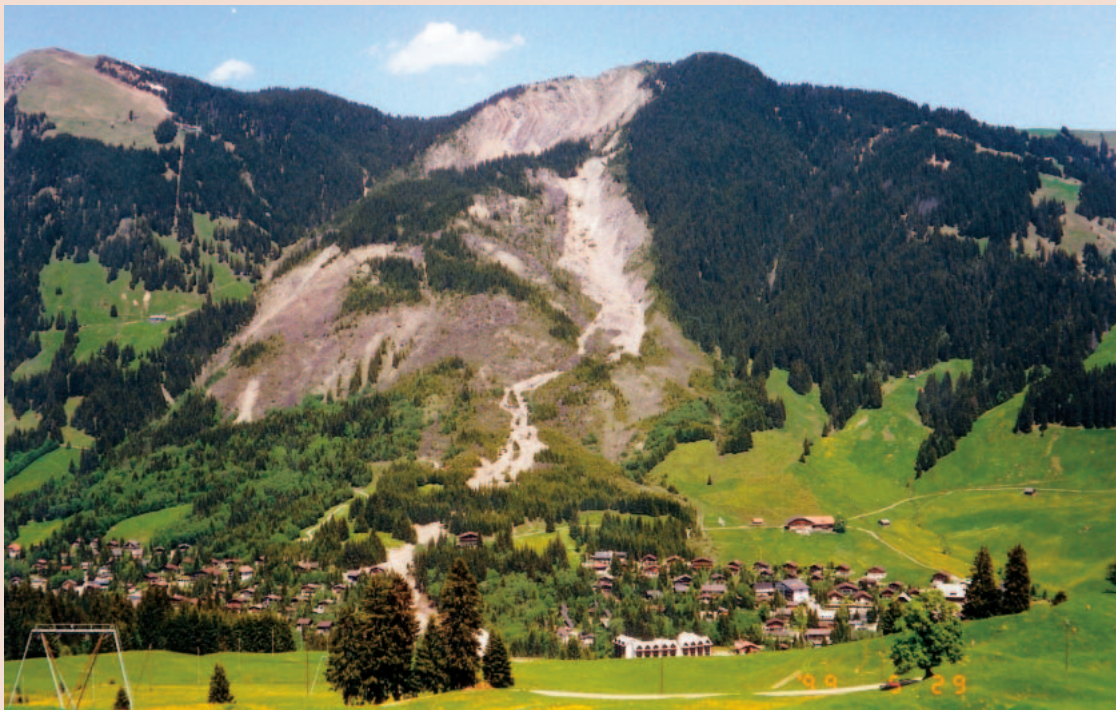
FIGURE 1 The tourist resort of Sörenberg, located in the Entlebuch Biosphere Reserve, Central Switzerland. The village is located at the foot of a deep-seated landslide complex. The bright surfaces mark the geomorphological zones active in 1999. (Photo by author)

Sörenberg is a typical small tourist resort located on the periphery of the Swiss Alps in Central Switzerland (Figure 1). The village has developed only during the last 40 years; prior to that, it was known as a spa. Today, about 800 housing units—mainly secondary homes (chalets and tourist apartments)—are situated on old debris flow deposits. In addition, a number of sports and leisure facilities have been constructed in recent years. The slopes above the village belong to a large (15 million m³)

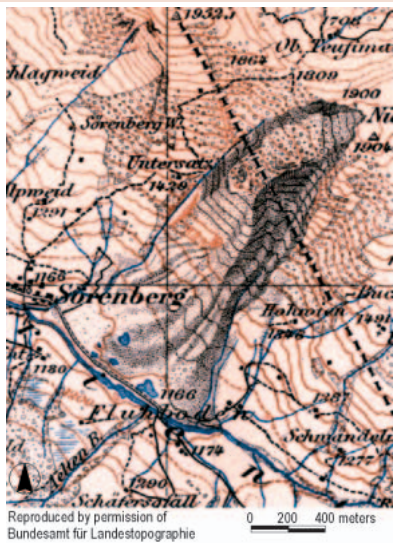
FIGURE 2 1918 topographic map, showing the open scars on either side of the mass and the typical accumulation features developed in 1910 and 1912. The few houses with the church (at the center of the village) are located in a safe place. (Map reproduced by permission of Bundesamt für Landestopographie, BA024084)

Analysis of past events makes an important contribution to the understanding of present and future hazards in a particular location. A number of historic documents such as maps (Figure 2), postcards or photographs, as well as a detailed description of the 1910 events by the famous geologist Albert Heim, provided the necessary information to reconstruct the sequence of landslide events in the 20th century. Between 1860 and 1910 the entire complex shifted downhill by more than 30 m in a large vertical movement. In 1910 another large vertical movement occurred, lasting several days and causing 2 major lateral collapses and massive debris flows of over 3 million m³. Throughout the rest of the 20th century development was irregular. Several lateral and frontal collapses occurred in 1912, 1922, and 1986, with 6 decades of geomorphic inactivity in between.

At the beginning of the 20th century the area now occupied by the village was used as grazing land. The map (Figure 2) indicates that the existing few houses in Sörenberg were arranged around the church in a safe place. Within the accumulation area of the 1910, 1912 and 1922 debris flows, only a very few isolated houses were destroyed.

Sörenberg's development into the tourist resort that it is today took place only over the past 30 to 40 years. The 1918 map (Figure 2) clearly shows that at that time only very few buildings were located in what was once a highly active accumulation area. Today this area is completely covered by houses (Figure 3). The long period of geomorphic inactivity following the events of 1922 was interpreted as a sign of future security. An analysis by experts in 1974 proved that there was no immediate threat, but did not altogether exclude the possibility of damaging events. An indication of the uncertainty of the situation was provided by displacement measurements begun in 1978. These clearly show that the whole mass is continuously moving about 3 to 10 cm per year. The speed of this movement increased dramatically in 1999 but has slowed down again since.

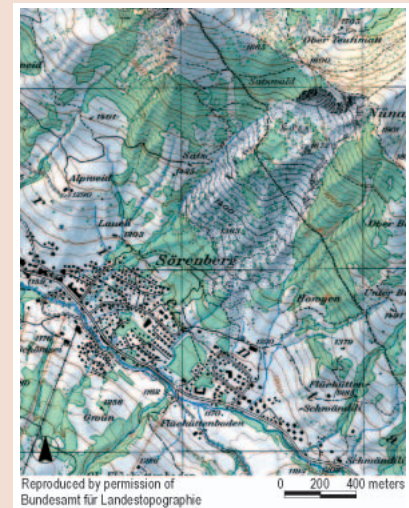
FIGURE 3 1993 topographic map, showing how the village has developed in the past 30 years in the area where debris flow formerly accumulated. (Map reproduced by permission of Bundesamt für Landestopographie, BA024084)

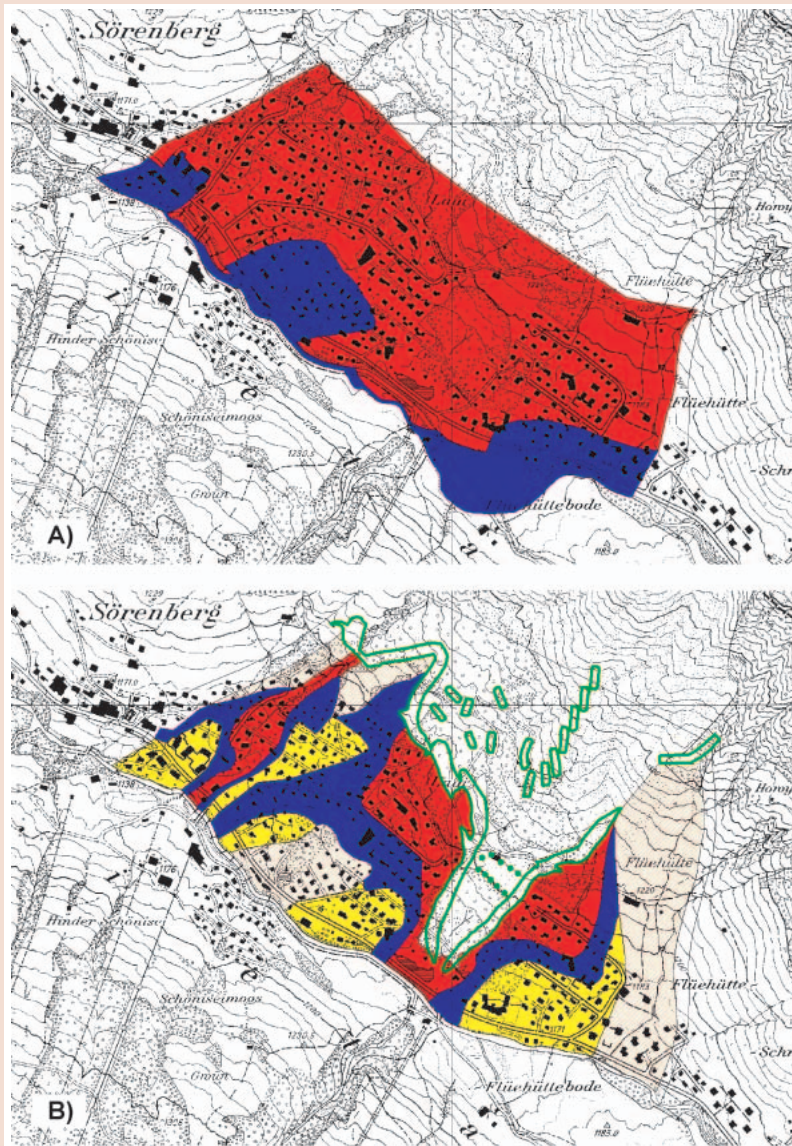
FIGURE 4, A AND B Hazard map for Sörenberg. Top (A) before, and bottom (B) after the implementation of the planned structural measures. Red: high degree of hazard; blue: moderate degree of hazard; yellow: low degree of hazard; yellow-white: hazards with a very low probability of occurrence; green: planned structural measures. (Maps reproduced by permission of swisstopo, BA035840)

Secondary processes caused by primary movement occur only after relatively long intervals. It can be concluded that Sörenberg remains at risk. The risk of further collapses and subsequent flows must be taken into account, even though conditions above the village are currently calm. However, it is assumed that large-scale events such as the ones in 1910 are no longer possible. These facts were considered in the hazard map that was prepared in 2001 (Figure 4A).

The first step towards definition of protective measures is a thorough investigation of all hazards and the creation of a hazard map. In Switzerland, such maps are based on definite probability and magnitude classes. Under present conditions, most of the village is within red and blue hazard zones (Figure 4A), ie those subject to a high or moderate risk, respectively. This constitutes a de facto ban on future economic development of the village: construction of new houses and major changes to existing houses are normally not permitted within the red zone. This, of course, was not acceptable to the municipal authorities. Solutions had to be found that would guarantee the safety of the population while at the same time allowing moderate development of the village.

- A set of regulations in the local land use plan and building code defines what is possible in red, blue and yellow zones. These regulations should curb further increase of vulnerability (see Table 1 and Figure 4B).
- In addition to village regulations, plans call for a complete ban on grazing throughout the landslide-prone area as well as an increase in forest cover.
- Municipal and cantonal authorities established a hazard map for the whole area in order to show whether adjacent areas are more suitable for village development. Unfortunately, there are only a few places that are appropriate as housing lots.

- People argued that the primary process should be stopped. Geophysical investigations showed, however, that control of the water table in this extremely fractured and fast-moving mass is hardly possible;
- A number of (reasonable) structural protection measures (Figure 4B, green markings) are planned to reduce the risks to a bearable level. But even with these protection measures, some parts of the village remain in the red danger zone. Owing to financial constraints, the state would like to minimize these measures. The local authorities, on the other hand, have an interest in reducing the red zone as much as possible. Costs of about CHF 14 million (US\$ 10 million) will be shared by the canton and the municipality, with heavy subsidies from the federal government. Home owners may also make contributions.
