A Conceptual Model for Rehabilitation of Puna Grassland Social–Ecological Systems

Authors: Mendoza-Ato, Angela, Postigo, Julio C., Choquehuayta-A, Geydi, and Diaz, Renny Daniel

Source: Mountain Research and Development, 43(4)

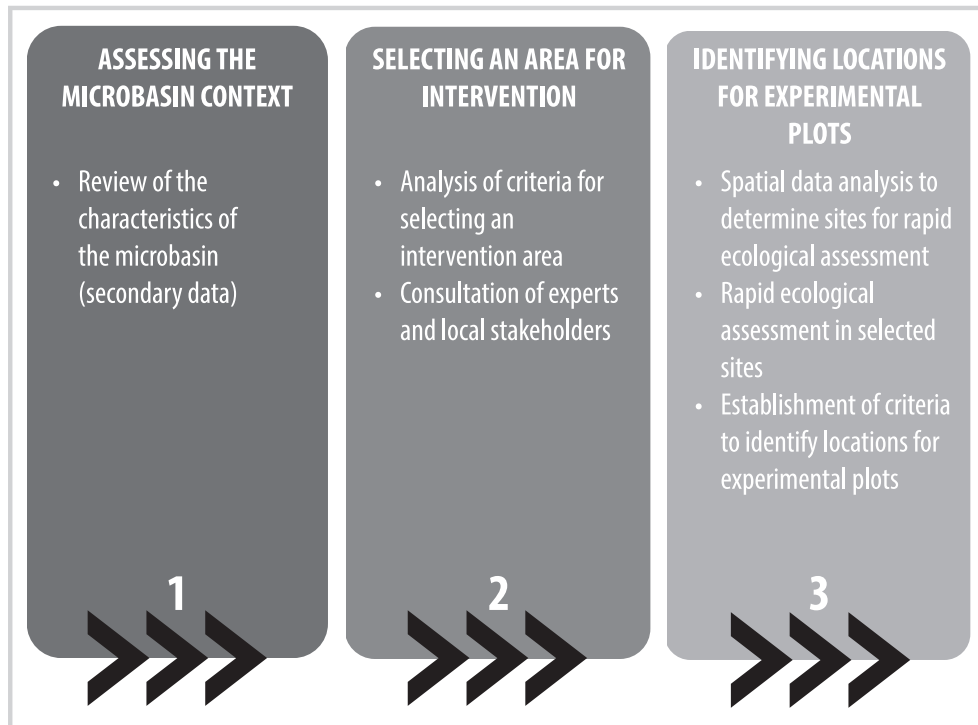
FIGURE 3 Steps to selecting sites for experimental plots to recover hydrological functions in microbasins. (Figure by Angela Mendoza-Ato)

Site selection for experimental plots: There are 3 steps in selecting sites for plots, namely assessing the biophysical context, selecting an area, and identifying specific plot locations (Figure 3). We assessed the context by analyzing primary and secondary data, such as precipitation and temperature, soil characteristics, soil humidity, and vegetation composition; all of these variables are key drivers of mountain ecosystems. Understanding the context allowed us to adjust the research and next steps at the plot scale. To select an area to set up the plots (ie the rehabilitation pilot site), the following parameters were used: slope, vegetation cover of the headwaters, and contribution of the headwaters to hydrological recharge and regulation. In our case, the area selected was the Umasbamba Valley (Quebrada Umasbamba), with slopes of less than 20°, different land covers (including a site with terraces), and an normalized difference vegetation index between 0.185 and 0.275. At this point, we approached the authorities of the Indigenous peasant community of Umasbamba to ask for a social license. After this, the authorities were involved in deciding on potential sites for a rapid ecological assessment and in applying the assessment. The rapid ecological assessment evaluated vegetation, the physical and chemical composition of soils, and soil hydrology. Three vegetation types were identified: short grasses, tussock grasses, and a mix of both (ecological

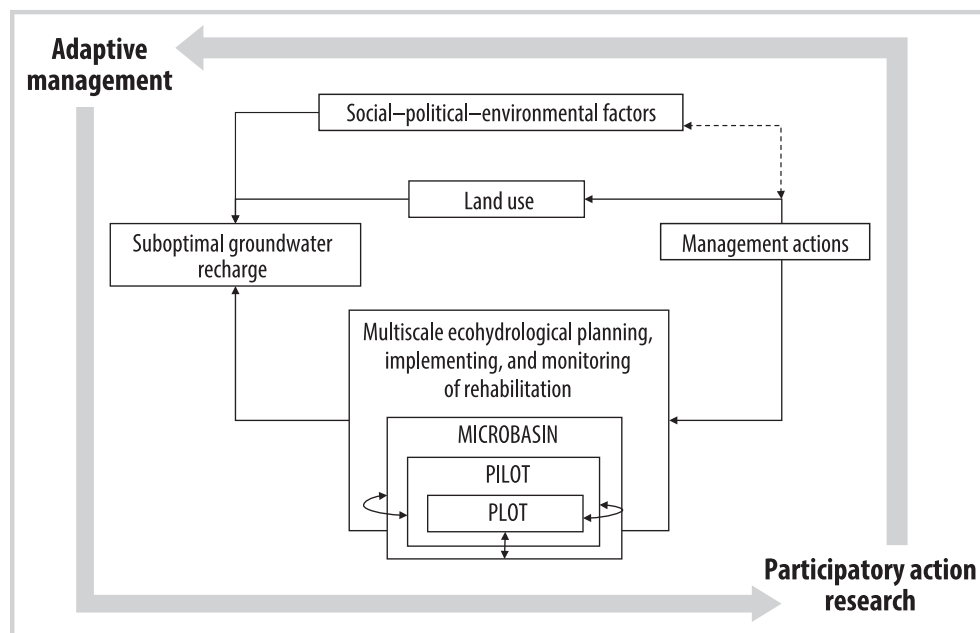
FIGURE 5 Conceptual model for rehabilitation in a microbasin with an ecohydrological approach. (Figure by Angela Mendoza-Ato and Julio C. Postigo)

Our model proposes multilevel rehabilitation of hydrological services in the puna grassland social–ecological system that begins at the plot and scales up to the microbasin (Figure 5). The spatial unit of observation and analysis is the plot. The knowledge gained at this scale provides a foundation for understanding both the condition of the ecosystem and the rehabilitation actions required. This knowledge stems from carefully identified relevant variables and systematic and consistent data collection using appropriate and calibrated instruments. Sound data analysis generates useful knowledge to select our sites and distribute our plots, covering the diverse locations and the heterogeneous mosaic of puna grassland.

The participatory approach involves the integral participation of the local stakeholders in all the stages of the rehabilitation process (Figure 5). This type of participation increases the legitimacy and sustainability of rehabilitation. In practical terms, the participatory approach entails that community members, government agencies, and

hydrological functions. Another management action mentioned in Figure 5 is land use, which does not necessarily aim to improve ecosystem functioning but will affect groundwater recharge. The model recognizes the influence of sociopolitical–environmental factors on management, and vice versa. These factors are among the causes of land degradation, which, in turn, is one of the drivers of the reduced groundwater recharge (Malik et al 2014). Addressing these factors entails management measures ranging from capacity building to participatory monitoring, as well as the involvement of all local stakeholders throughout the rehabilitation process (from planning to implementation) and in all scaling phases (from plot to microbasin scale).
