# Sand dune management problems and techniques, Spain.

Gregorio Gómez-Pina†, Juan J. Muñoz-Pérez‡, Jose L. Ramírez†, Carlos Ley∞

## ABSTRACT

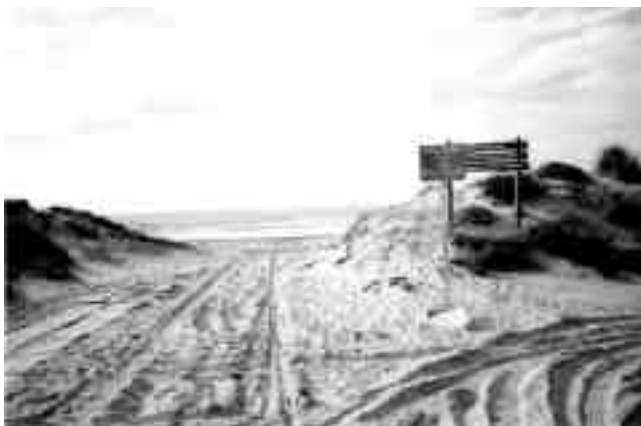
Figure 1. Typical dune breaching in La Bota (Huelva, Spain), Gómez-Pina 1997

Figures from GÓMEZ-PINA(1999) are representative of dune degradation in La Bota beach (Huelva). Figure 1 shows a typical dune breach caused by off-road vehicles and human trampling. Figure 2 depicts the existing public road, crossing the foredunes longitudinally. The removal of this road is part of a very ambitious integrated dune management project being carried out by the National Spanish Coast Directorate, Ministry of Environment.

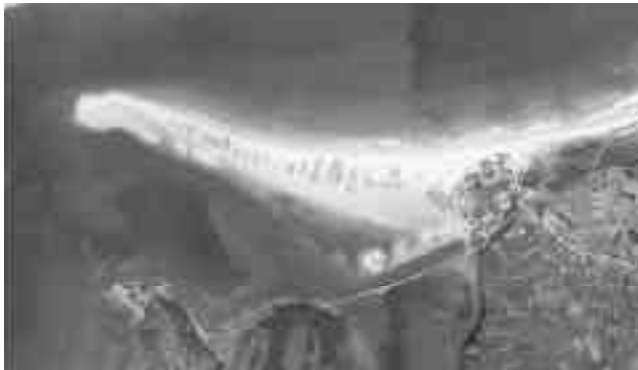
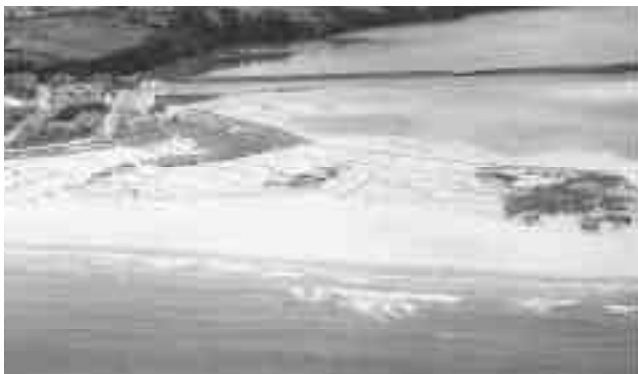
Figure 3. An aerial view of Somo spit (Cantabrian, Spain) before dune restoration.

Figure 4. An aerial view of Somo spit (Cantabrian, Spain) after dune restoration.

Figures 3 and 4 show aerial views of Somo spit before and after dune restoration. In Figure 5 a detailed perspective of fencing and transplanted vegetation is displayed.

Since 1992 dune restoration works have been carried out in several phases consisting of the reinforcement of the deteriorated dune system by using willow sand trappers in conjunction with transplanted vegetation (*ammophila arenaria*) from the neighbouring dune plant nursery. Fencing was used in sensitive areas to reduce the effects of human trampling. Elevated dune walkovers for access to the beach were conveniently placed near parking areas, beachfront subdivisions and public facilities to avoid damage to the dunes from pedestrian traffic. Finally, information posters were placed in adequate locations to make beach visitors aware of the importance of the dunes and the restoration works in place.

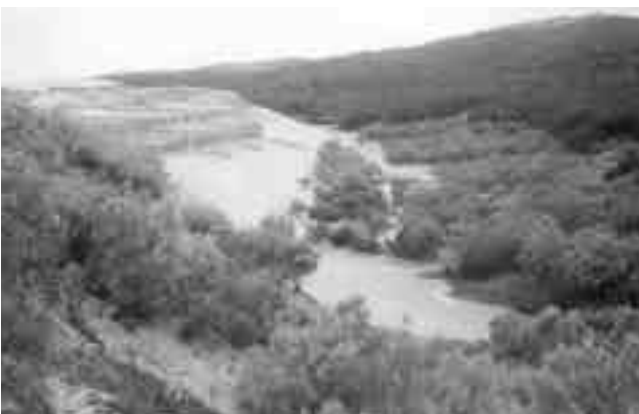
Figure 17. A view of Valdevaqueros backdune restoration (Cádiz, Spain)

Figure 16 depicts an aerial view of Valdevaqueros cove. Figure 17 shows backdune restoration near the adjacent pine grove. Figure 18 shows foredune accretion after restoration.

Dune restoration works started with the reshaping of the dune profile in order to obtain a better aerodynamic stability complemented with the experimental use of longitudinal willow sand fences to decrease erosive surface patterns. Also experimental transplanted vegetation techniques were used along certain potentially stable areas.
