Effects of a Natural Dam-Break Flood on Geomorphology and Vegetation on the Elwha River, Washington, U.S.A

Source: Northwest Science, 82(sp1) : 210-223

Effects of a Natural Dam-Break Flood on Geomorphology and Vegetation on the Elwha River, Washington, U.S.A.

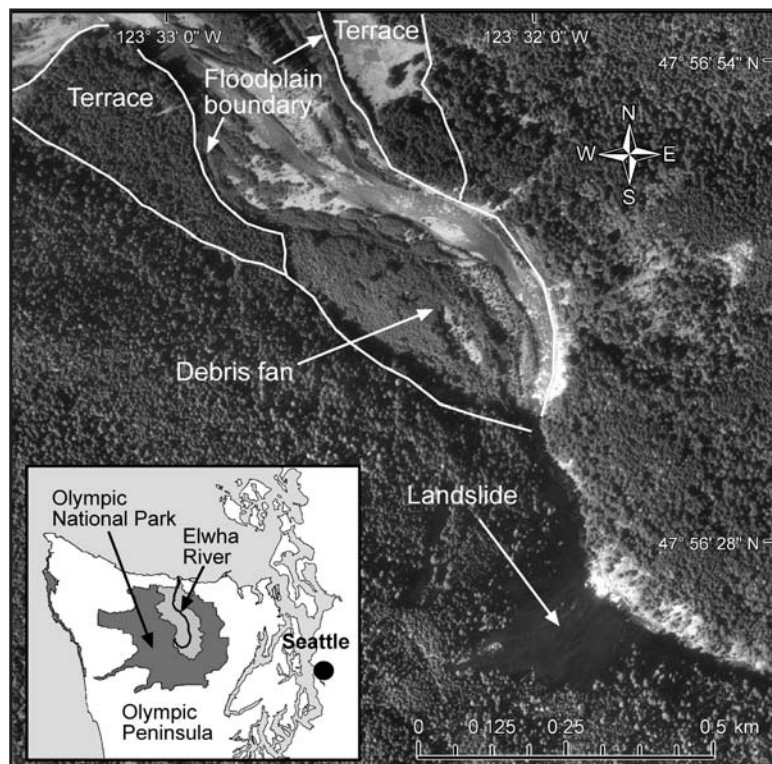
Figure 1. Geysers Valley aerial photograph (2002) showing locations of (1) landslide that likely triggered dam-break flood of 1967, (2) location of dam-break flood deposits, and (3) boundaries of the contemporary floodplain and terraces. Inset shows location of the Elwha River on the Olympic Peninsula in Washington State, USA.

The 72 km-long Elwha River flows northward out of the Olympic Mountains to the Strait of Juan de Fuca on Washington State’s Olympic Peninsula (Figure 1), draining an area of approximately 830 km² (see Duda et al. 2008 for more information on climate and hydrology of the watershed). Geysers Valley, an unregulated alluvial reach upstream of the upper dam between rkm 28 and rkm 32, may be the best model of pre-dam geomorphology for the area inundated by the upper dam on the Elwha River (Gilbert and Link 1995, DOI 1996). However, floodplain morphology and disturbance regimes are undocumented and there is little information upon which to base a strategy for restoration of floodplain forests. One of the most significant events to occur

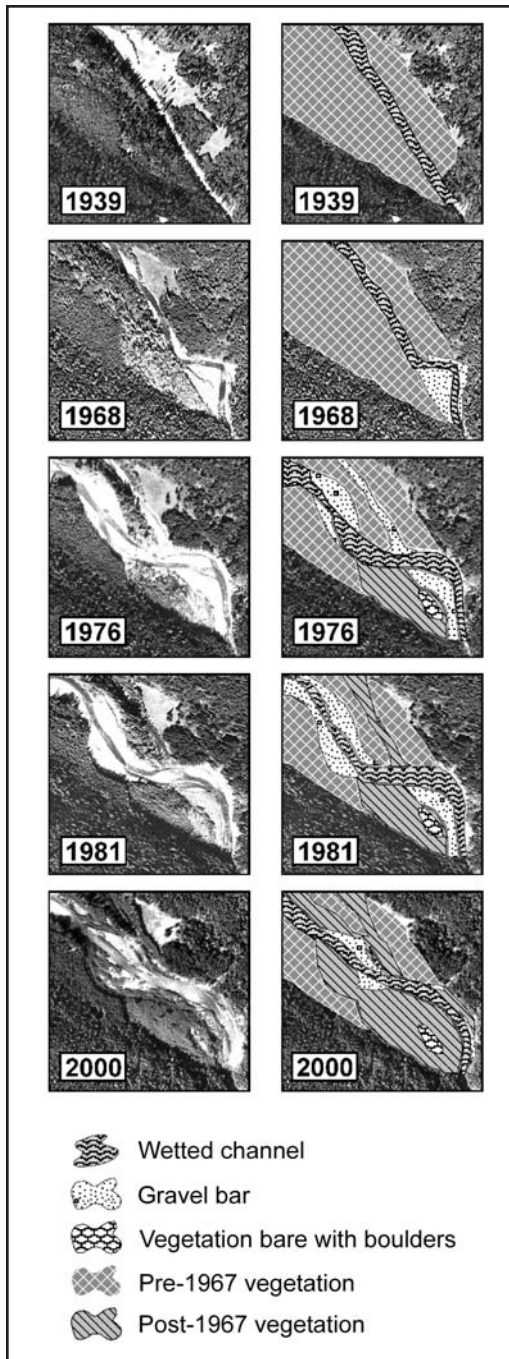
Figure 2. Aerial photograph time series of the study site illustrating straight channel prior to the dam break flood (1939), channel shift eastwards after the dam-break flood (1967), and subsequent vegetation and channel changes. The non-forested patch in the center of the upper edge of each photograph is a persistent meadow on a terrace.

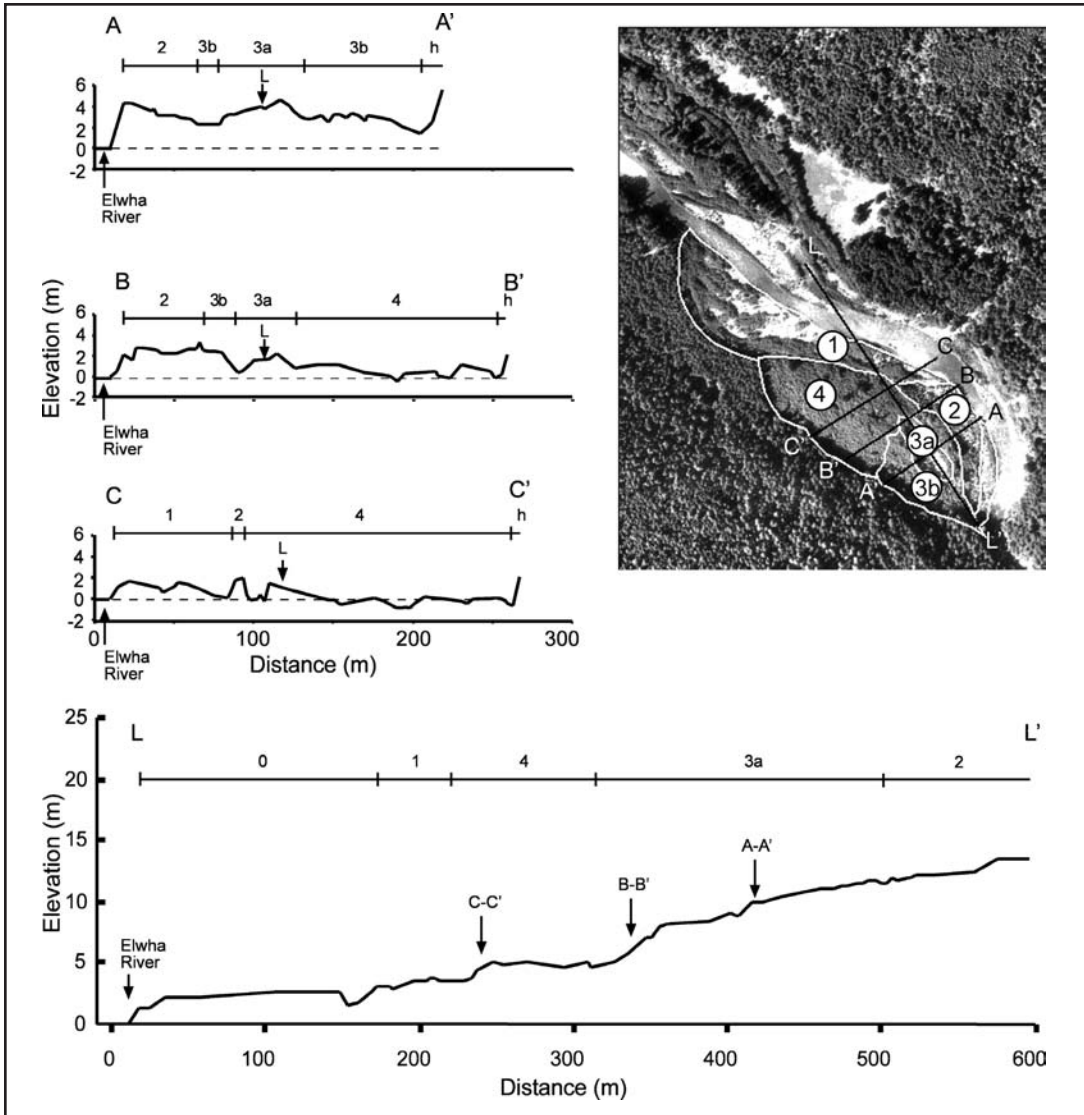
Figure 3. Cross sections (A-A', B-B', C-C') and longitudinal profile (L-L') of dam-break flood deposits located at the upstream end of Geyser Valley, Elwha River, Washington. Line above each profile illustrates locations of geomorphic surfaces. Surface 0 is the contemporary gravel bar. Surface 1 is the most recent dam-break flood deposit (dating to 1984). Surface 2 is an intermediate age dam-break flood deposit (dating to 1977). Surfaces 3a, 3b, and 4 are from the 1967 dam-break flood. Transect locations are shown on aerial photograph at upper right.

Our survey identified five major surfaces within the fan area, excluding the contemporary gravel bars of the Elwha River (Figure 3). Based on ages of the vegetation plots (Figure 4), all surfaces post-date the 1967 dam-break flood. Surfaces 3a, 3b, and 4 date approximately to the 1967 dam-break flood, with first tree establishment no later than 1971, 1970, and 1969, respectively (Table 1). The coarse boulders of surface 3a indicate a region of high energy flow oriented along the fan's long axis, and in approximate alignment with the canyon immediately upstream. There was little fine-grained sediment within this deposit, forming a substrate of large boulders with large interstitial spaces. The peak elevation of the surface was approximately 4 m above the present day river bed, or more than 2 m above contemporary bankfull floods (Figures 3 and 5). Surface 3b surrounded the upstream portion of the boulder field, and consisted of boulders within a matrix of finer gravels and sand. The elevation of surface 3b was 1 to 2 m lower than the main boulder field at transect A-A', or 2 to 3 m above the present-day river bed. Partially vegetated overflow channels that are

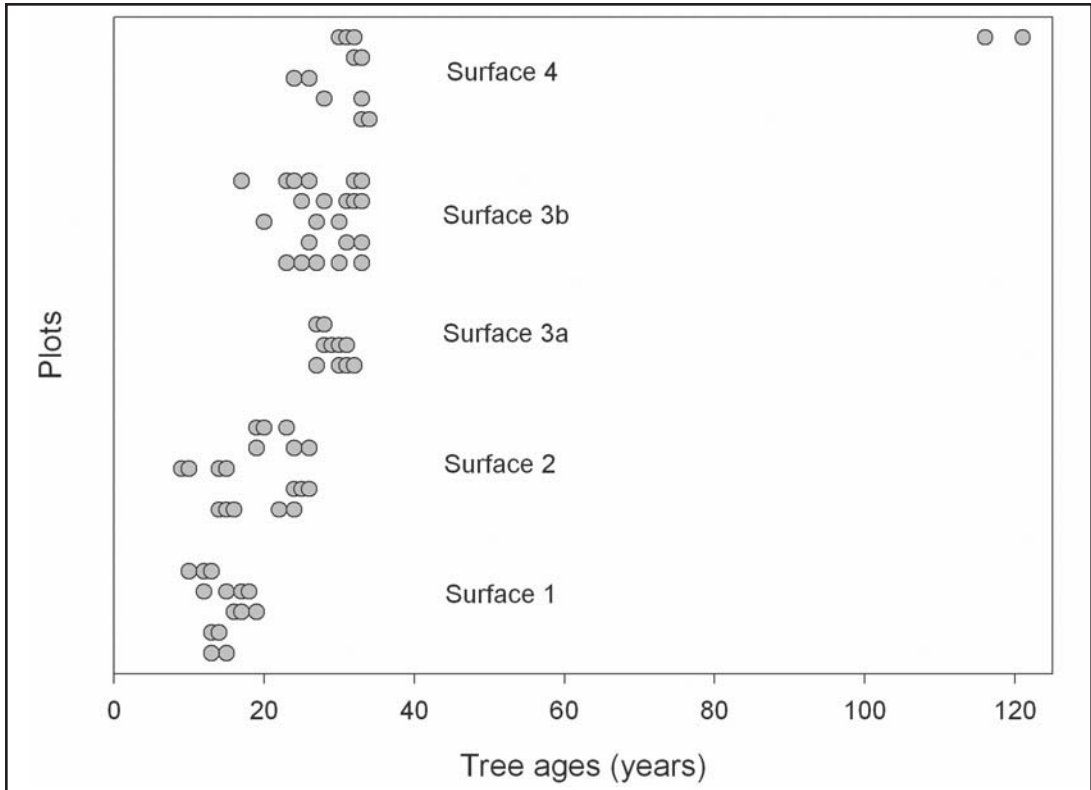
Figure 4. Ages of trees within plots, grouped by geomorphic surface. Each horizontal line of points represents one plot.

Trees began to establish on all surfaces one to four years after surface creation (Table 1). There has been a prolonged period of tree recruitment, especially on surfaces 3b and 2 (Figure 4). Present day tree species composition was generally

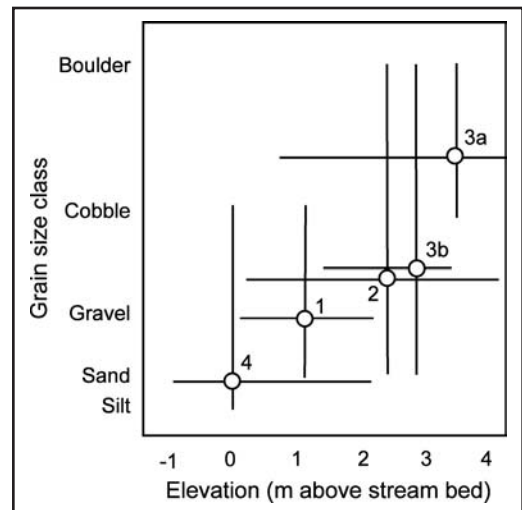
Figure 5. Elevation and grain size ranges of the five geomorphic surfaces. Points indicate median grain size class and median elevation of surface above the present stream bed measured along transects, and lines indicate the range of elevation and grain size classes of each surface.

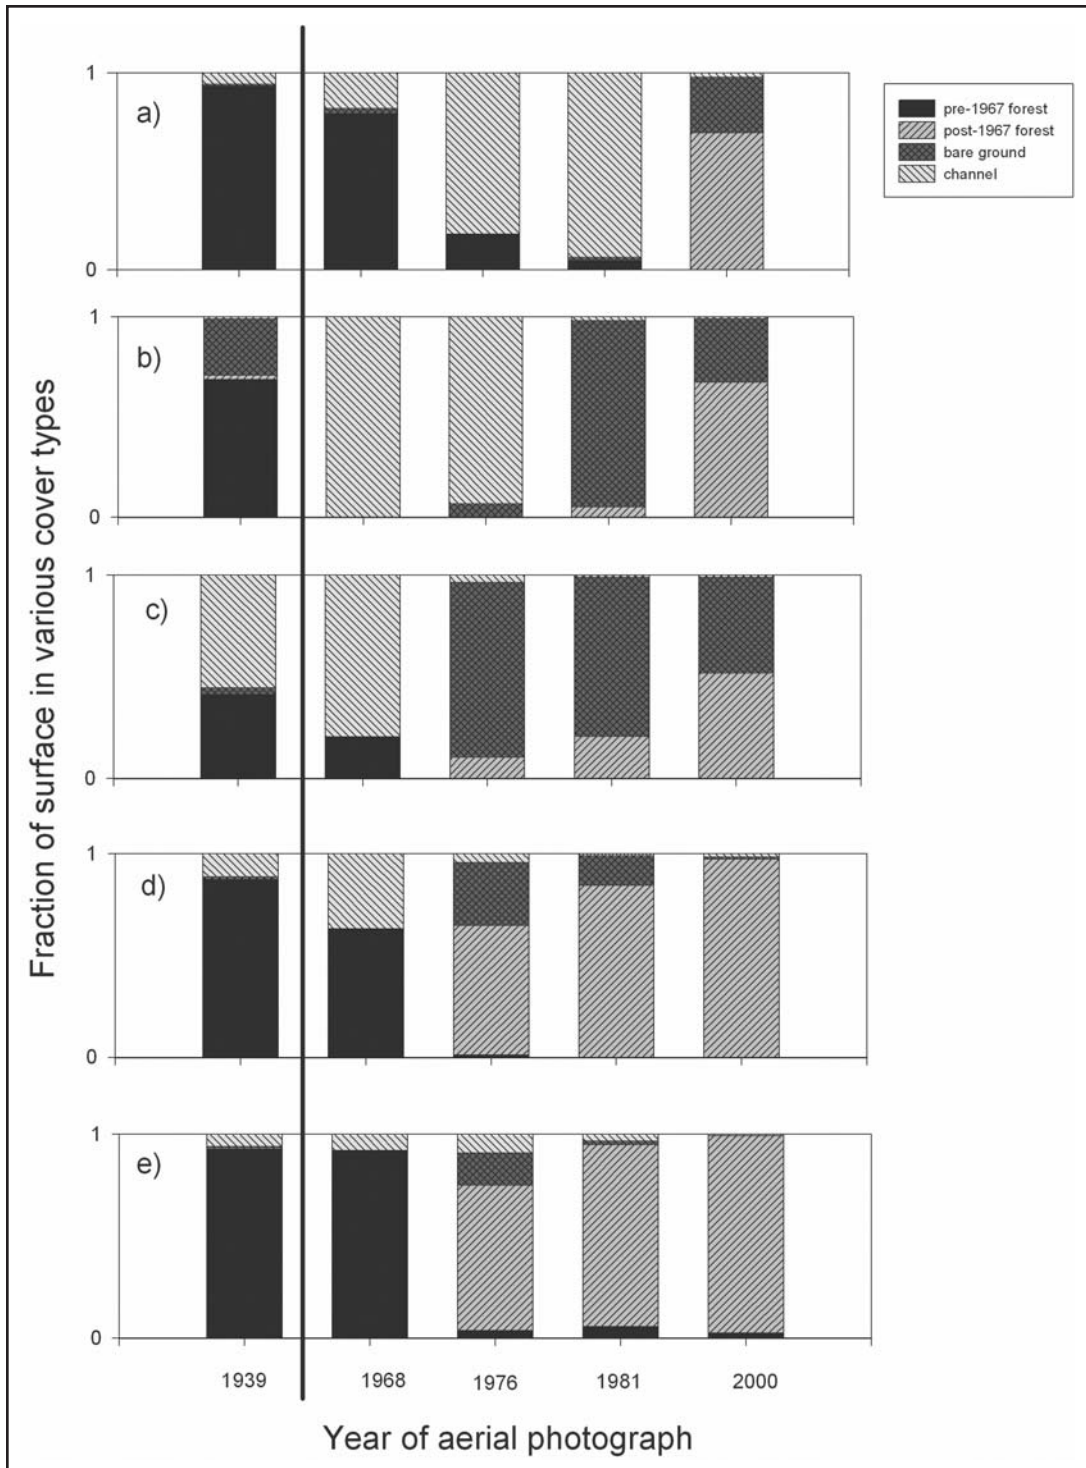
Figure 6. Proportions of area in different cover types on the geomorphic surfaces derived from the aerial photograph time series of the study site: a) surface 1; b) surface 2; c) surface 3a; d) surface 3b; e) surface 4.

between 1968 and 1976, removed more of the earlier forest from surface 1 than did the 1967 flood (Figure 6).

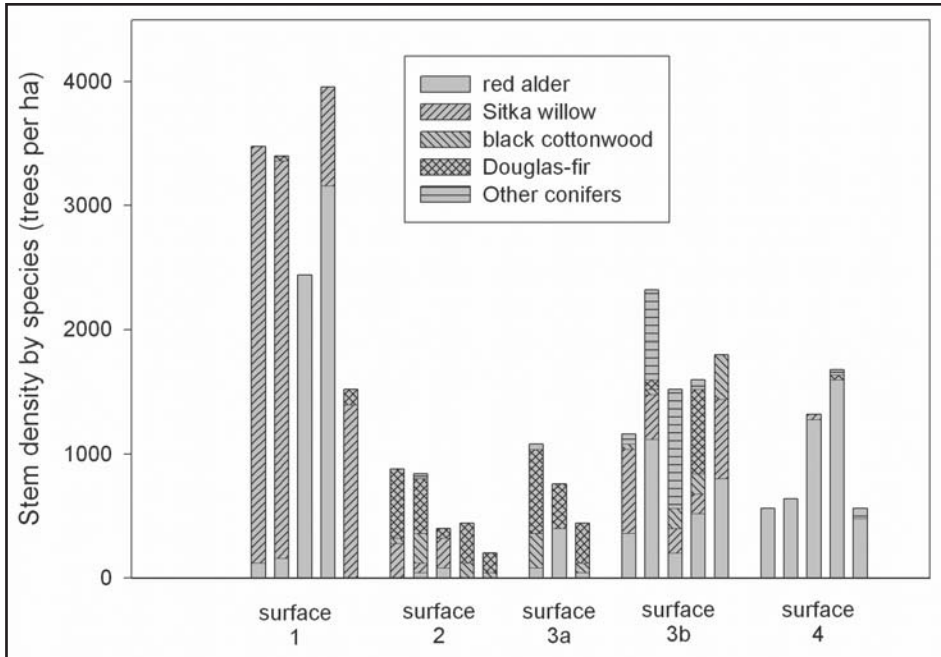
Figure 7. Stem density (numbers of trees per ha) by species for plots on the five geomorphic surfaces. Bars represent the replicate plots on each surface.

consistent among plots within each of the five surfaces; there were also similarities between some of the surfaces (Figures 7 and 8). Surface 4 was characterized by red alder and surface 1 by either Sitka willow or alder, or a mixture of both.

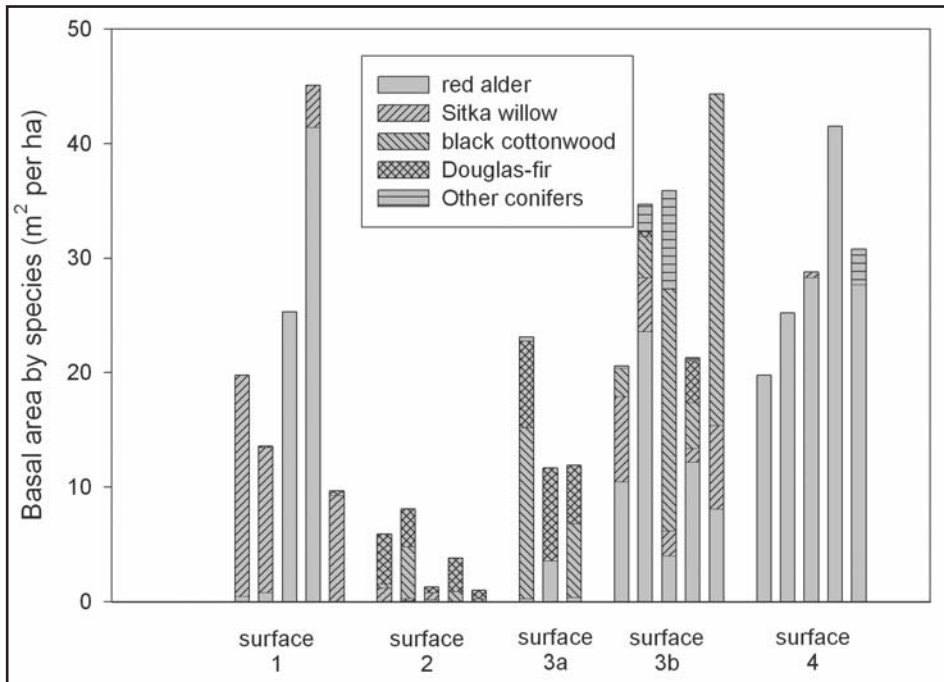
Figure 8. Basal area of trees (m^2 per ha) by species for plots on the five geomorphic surfaces. Bars represent the replicate plots on each surface.
