Effects of a Natural Dam-Break Flood on Geomorphology and Vegetation on the Elwha River, Washington, U.S.A

Authors: Acker, Steven A., Beechie, Timothy J., and Shafroth, Patrick B.

Source: Northwest Science, 82(sp1) : 210-223

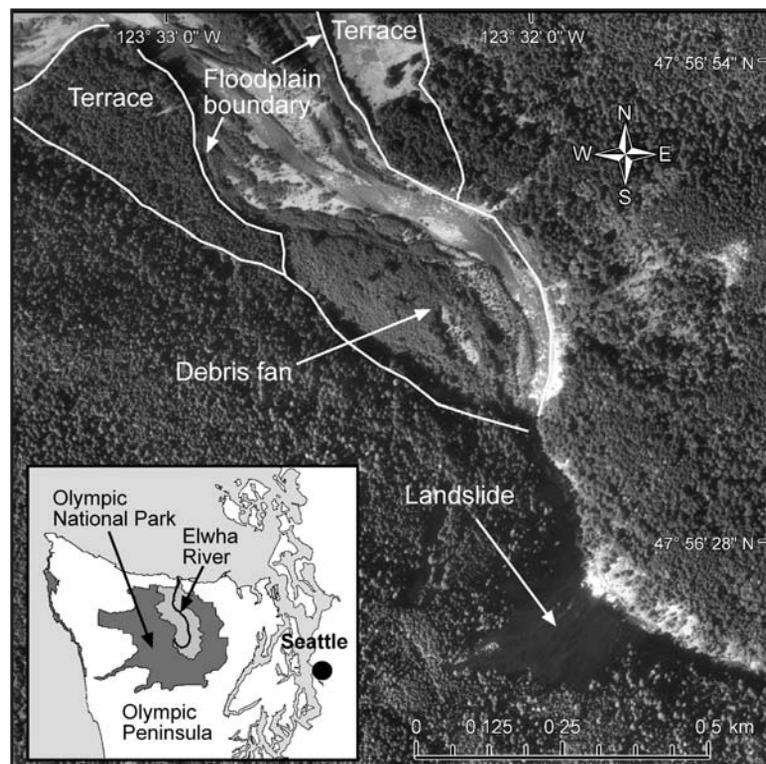
Figure 1. Geysers Valley aerial photograph (2002) showing locations of (1) landslide that likely triggered dam-break flood of 1967, (2) location of dam-break flood deposits, and (3) boundaries of the contemporary floodplain and terraces. Inset shows location of the Elwha River on the Olympic Peninsula in Washington State, USA.

The 72 km-long Elwha River flows northward out of the Olympic Mountains to the Strait of Juan de Fuca on Washington State’s Olympic Peninsula (Figure 1), draining an area of approximately 830 km² (see Duda et al. 2008 for more information on climate and hydrology of the watershed). Geysers Valley, an unregulated alluvial reach upstream of the upper dam between rkm 28 and rkm 32, may be the best model of pre-dam geomorphology for the area inundated by the upper dam on the Elwha River (Gilbert and Link 1995, DOI 1996). However, floodplain morphology and disturbance regimes are undocumented and there is little information upon which to base a strategy for restoration of floodplain forests. One of the most significant events to occur

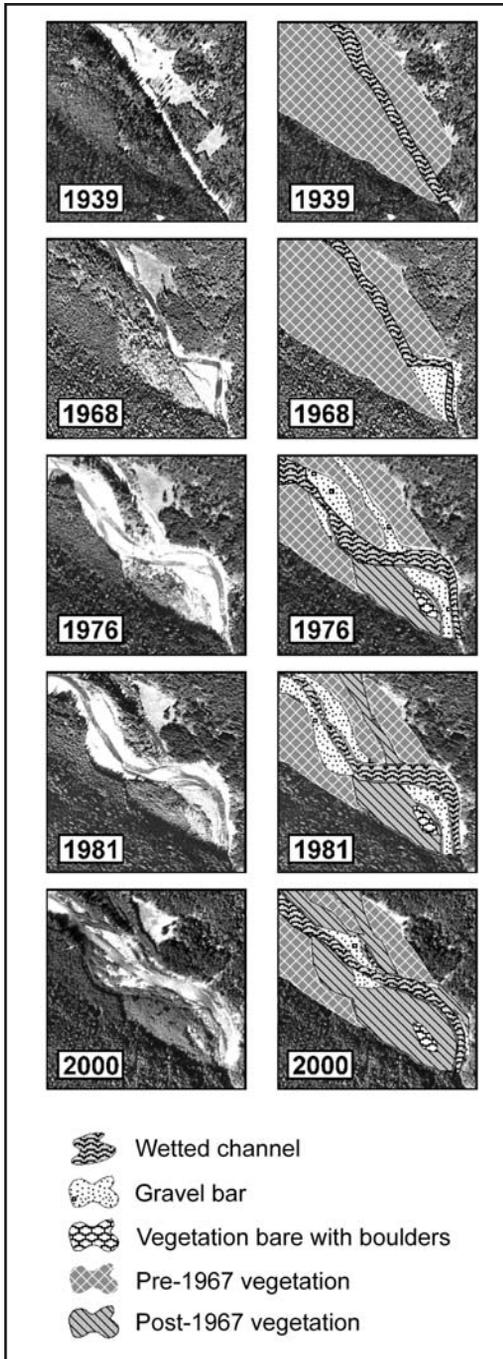
Figure 2. Aerial photograph time series of the study site illustrating straight channel prior to the dam break flood (1939), channel shift eastwards after the dam-break flood (1967), and subsequent vegetation and channel changes. The non-forested patch in the center of the upper edge of each photograph is a persistent meadow on a terrace.

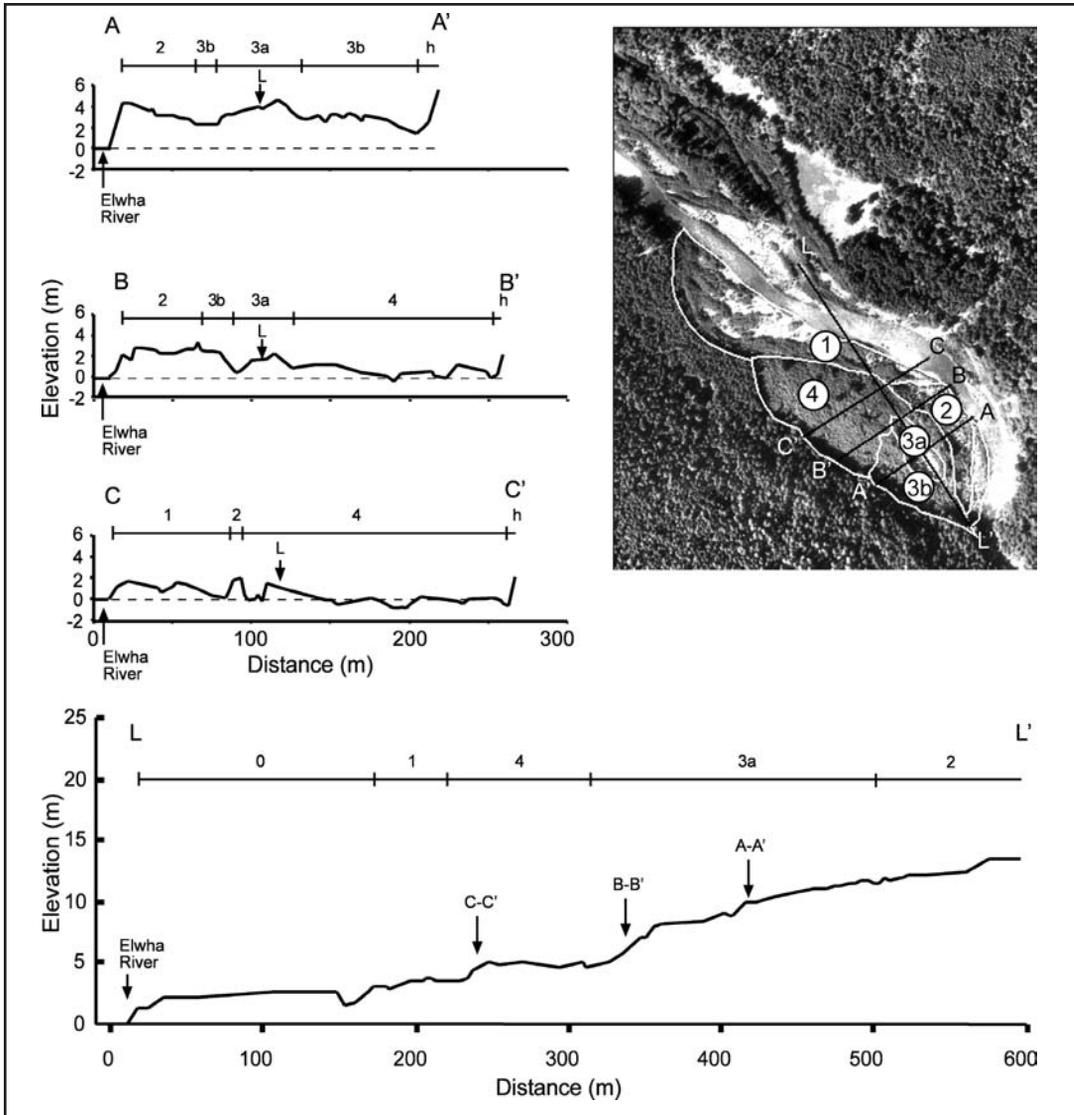
Figure 3. Cross sections (A-A', B-B', C-C') and longitudinal profile (L-L') of dam-break flood deposits located at the upstream end of Geyser Valley, Elwha River, Washington. Line above each profile illustrates locations of geomorphic surfaces. Surface 0 is the contemporary gravel bar. Surface 1 is the most recent dam-break flood deposit (dating to 1984). Surface 2 is an intermediate age dam-break flood deposit (dating to 1977). Surfaces 3a, 3b, and 4 are from the 1967 dam-break flood. Transect locations are shown on aerial photograph at upper right.

Our survey identified five major surfaces within the fan area, excluding the contemporary gravel bars of the Elwha River (Figure 3). Based on ages of the vegetation plots (Figure 4), all surfaces post-date the 1967 dam-break flood. Surfaces 3a, 3b, and 4 date approximately to the 1967 dam-break flood, with first tree establishment no later than 1971, 1970, and 1969, respectively (Table 1). The coarse boulders of surface 3a indicate a region of high energy flow oriented along the fan's long axis, and in approximate alignment with the canyon immediately upstream. There was little fine-grained sediment within this deposit, forming a substrate of large boulders with large interstitial spaces. The peak elevation of the surface was approximately 4 m above the present day river bed, or more than 2 m above contemporary bankfull floods (Figures 3 and 5). Surface 3b surrounded the upstream portion of the boulder field, and consisted of boulders within a matrix of finer gravels and sand. The elevation of surface 3b was 1 to 2 m lower than the main boulder field at transect A-A', or 2 to 3 m above the present-day river bed. Partially vegetated overflow channels that are

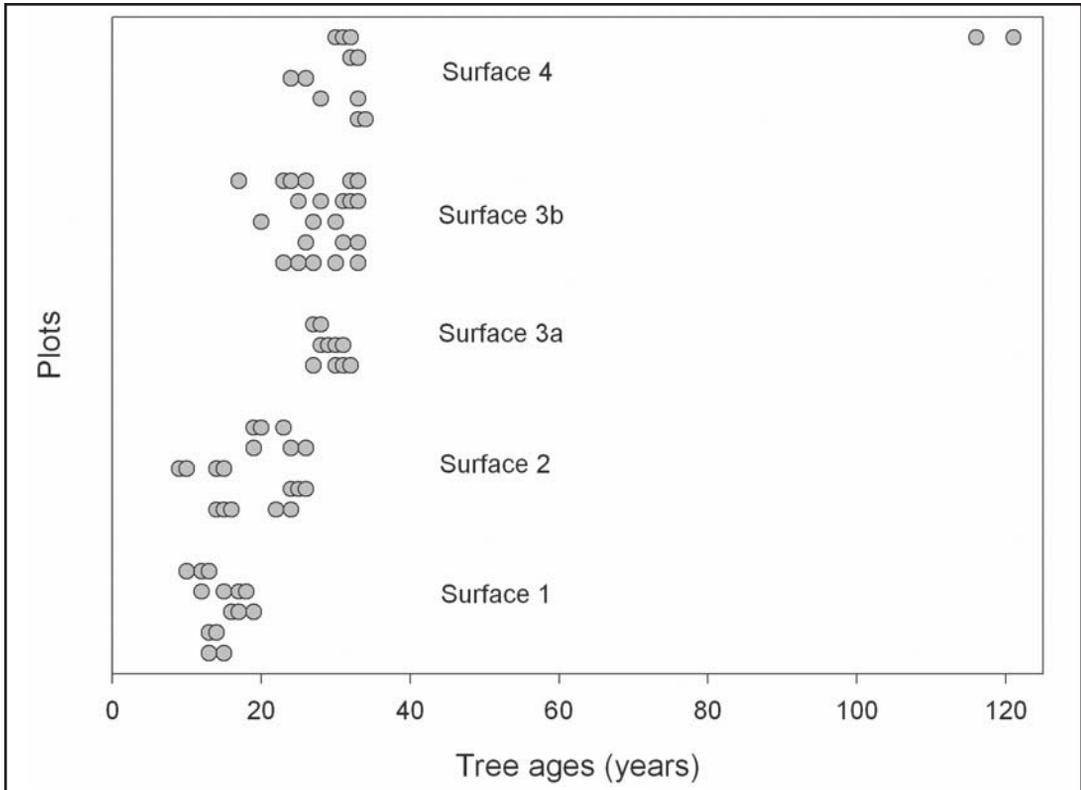
Figure 4. Ages of trees within plots, grouped by geomorphic surface. Each horizontal line of points represents one plot.

Trees began to establish on all surfaces one to four years after surface creation (Table 1). There has been a prolonged period of tree recruitment, especially on surfaces 3b and 2 (Figure 4). Present day tree species composition was generally

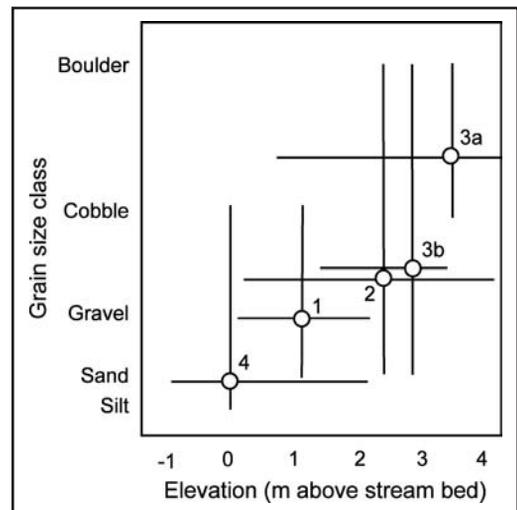
Figure 5. Elevation and grain size ranges of the five geomorphic surfaces. Points indicate median grain size class and median elevation of surface above the present stream bed measured along transects, and lines indicate the range of elevation and grain size classes of each surface.

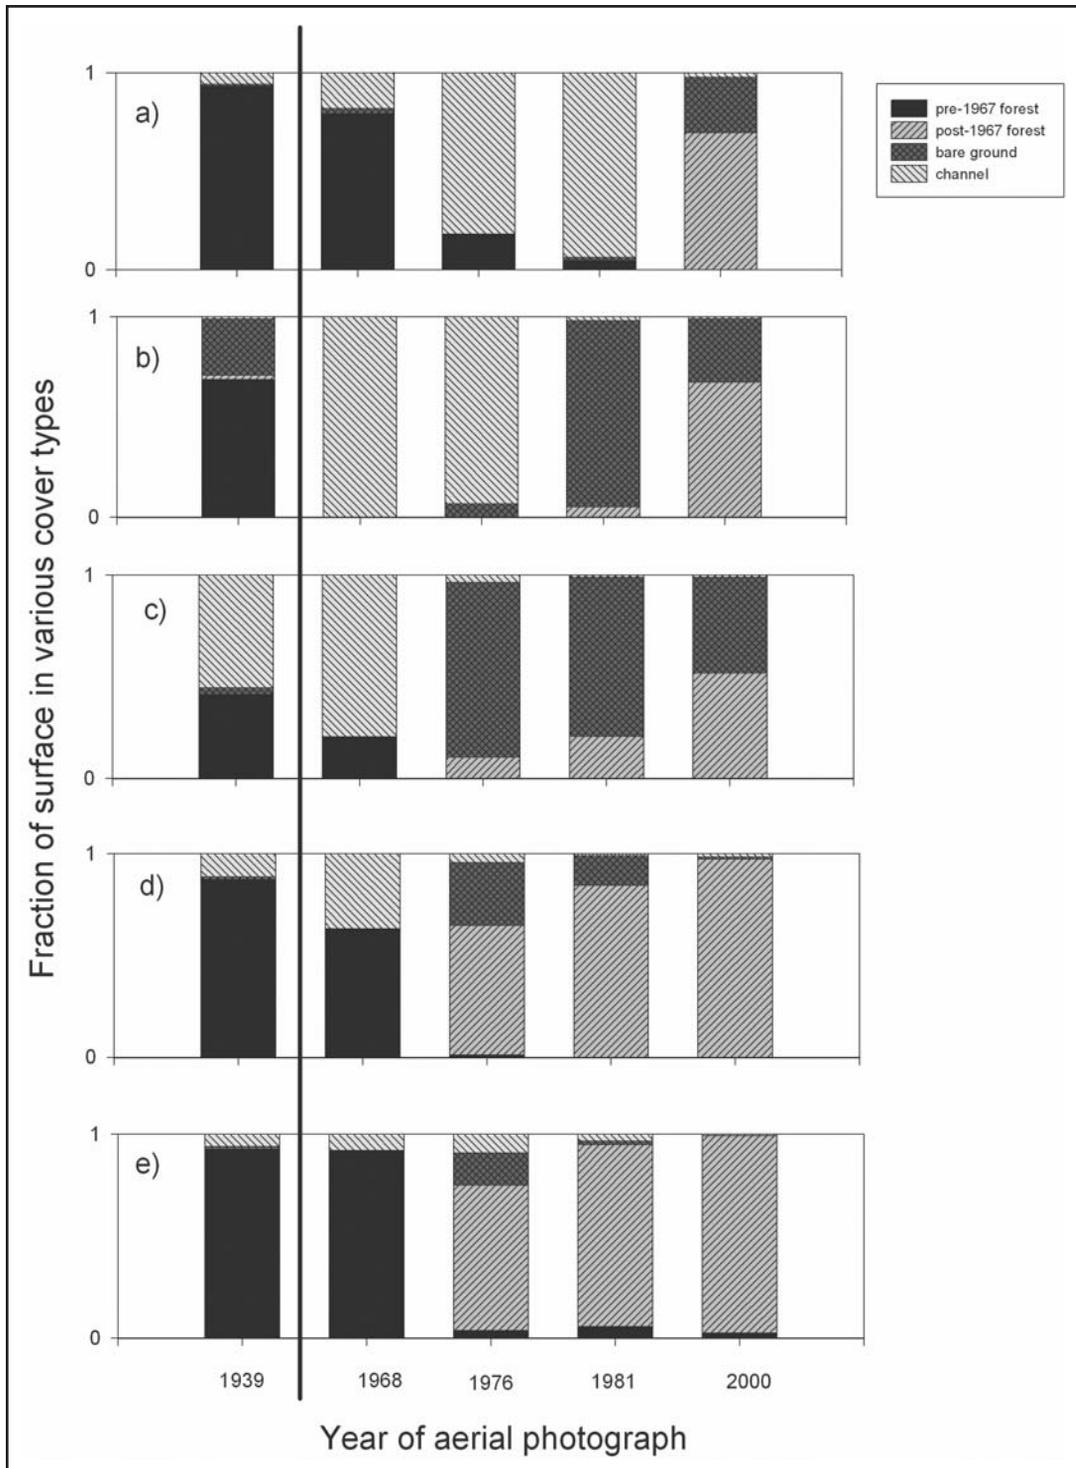
Figure 6. Proportions of area in different cover types on the geomorphic surfaces derived from the aerial photograph time series of the study site: a) surface 1; b) surface 2; c) surface 3a; d) surface 3b; e) surface 4.

between 1968 and 1976, removed more of the earlier forest from surface 1 than did the 1967 flood (Figure 6).

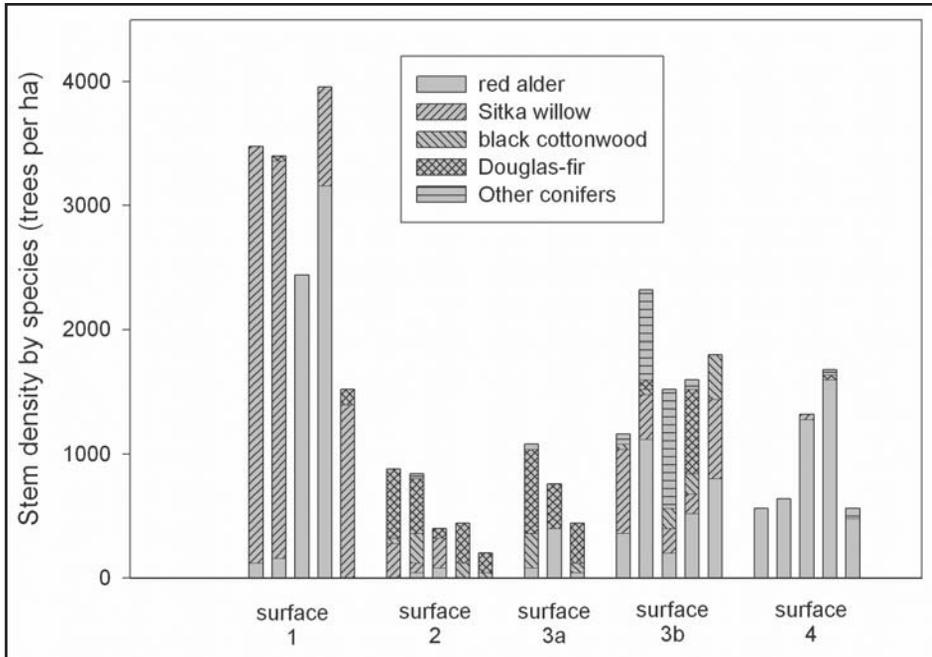
Figure 7. Stem density (numbers of trees per ha) by species for plots on the five geomorphic surfaces. Bars represent the replicate plots on each surface.

consistent among plots within each of the five surfaces; there were also similarities between some of the surfaces (Figures 7 and 8). Surface 4 was characterized by red alder and surface 1 by either Sitka willow or alder, or a mixture of both.

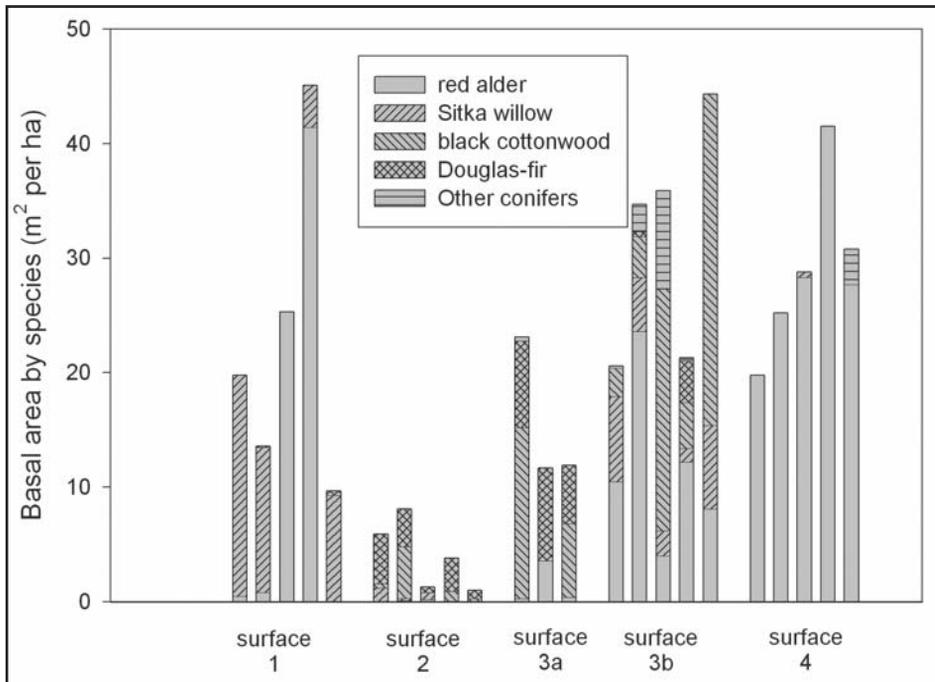
Figure 8. Basal area of trees (m² per ha) by species for plots on the five geomorphic surfaces. Bars represent the replicate plots on each surface.
