Source: Mountain Research and Development, 21(1) : 69-76

Marginal Lands and Erosion in Terraced Fields in the Mediterranean Mountains

A Case Study in the Camero Viejo (Northwestern Iberian System, Spain)

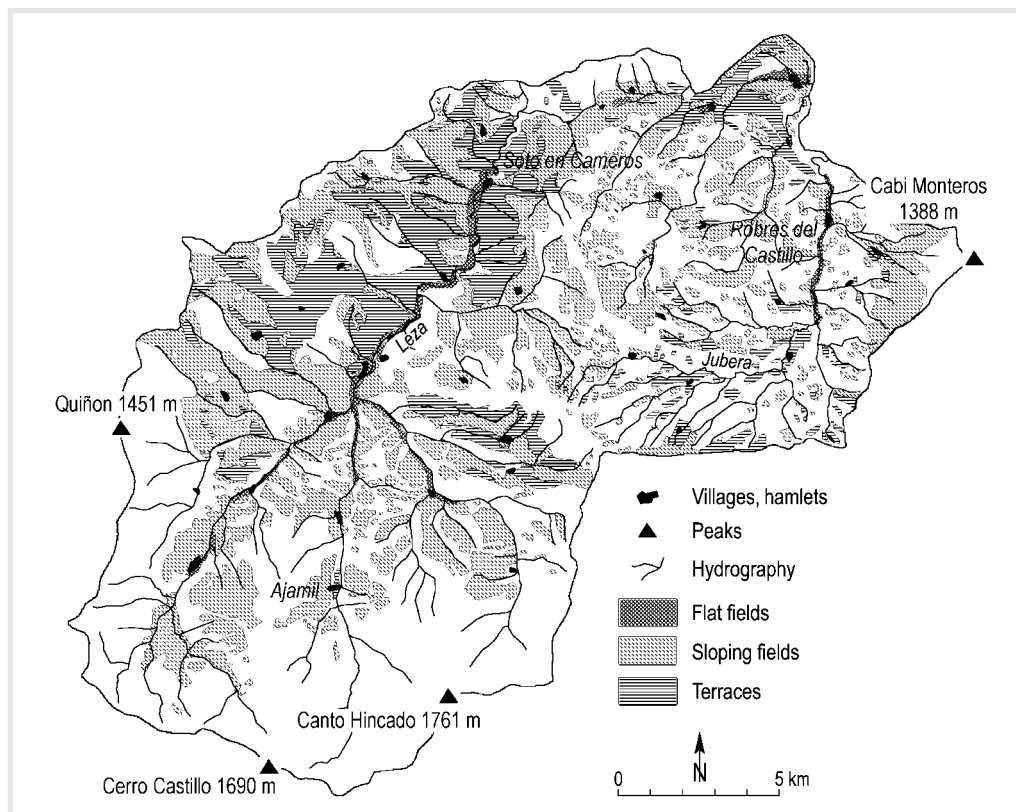
FIGURE 2 Historical farmland and types of fields in the high valleys of the Leza and Jubera (Camero Viejo). The map was drawn on the basis of aerial photographs (1956 and 1977) and was adapted by means of a GIS.

Depending on the inclination of their fields, farmers in the Camero Viejo used different cultivation methods. In 1956, flat fields represented only 3% of the total farmed area (Figure 2). They were well fertilized and irrigated. On slopes near villages, terraces were built to preserve the soil, support the infiltration of water, and increase yields. Terraces represented 28% of the total cultivated area (4412 ha). The rest of the farmed area (69%) consisted of sloping fields. Some of these fields were worked permanently (one year with cereals, the next in fallow) while others were cultivated sporadically (in times of great population growth), with long fallow periods.

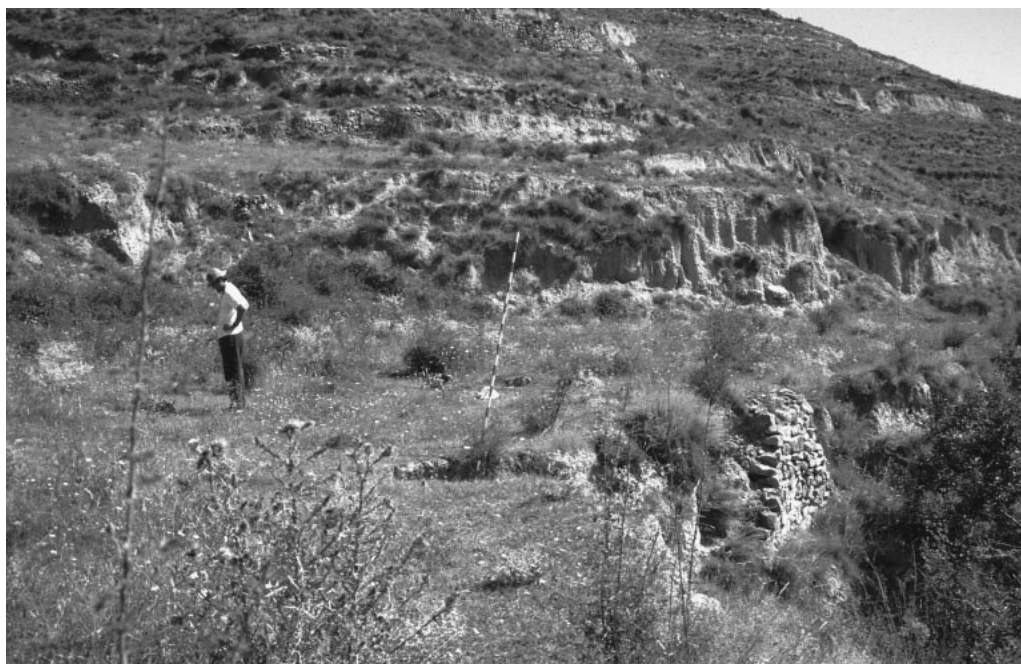
FIGURE 4 Erosion and spread of scrub on high terraces abandoned since the 1940s or 1950s. The 20–25° slope is concave. The terraces are located at a considerable distance from the village of Terroba, Leza Valley. (Photo by L. Ortigosa)

Previously cultivated land was definitively abandoned and started being recolonized by scrub (Figure 4). Some abandoned fields and hillslopes were afforested with *Pinus sylvestris* for the control of hydro-

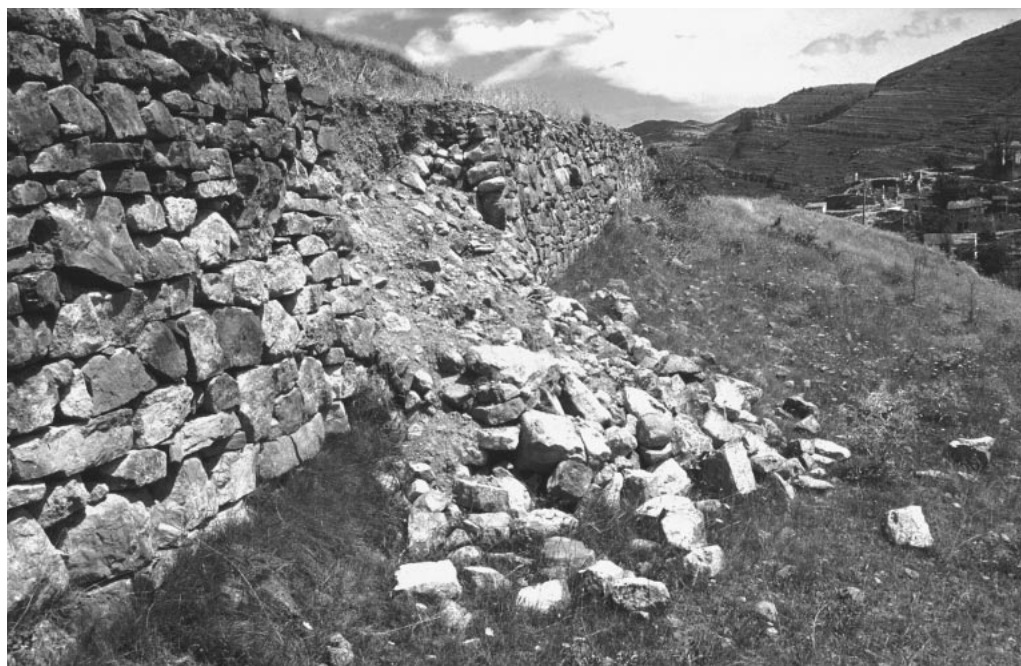
FIGURE 5 Collapse of a terrace wall at the foot of a hill near a village resulting from hydrological pressure higher up (Soto en Cameros, Leza Valley). Fields in this gently sloping area were only abandoned within the last 10 years. (Photo by L. Ortigosa)

The most important erosion process observed on terraced fields was the collapse of terrace walls as a consequence of massive soil movement (small landslides; see Figure 5). Landslides generate an arcuate surface failure and leave the small scarp of the terrace unprotected and susceptible to erosion. On average, each slide was found to move 3.31 m³ of soil and terrace wall. The volume of soil moved was calculated to be 38.80 m³/100 m of wall.

increasing the volume of accumulated soil and its tendency to slide down the slope. However, the most influential factor in this erosion process seems to be the slope's hydrological function. The highest landslide rate (72.8 m³/100 m of terrace wall) was observed on concave slopes, particularly on the lower part of hillslopes (Table 1). Terraces located in these areas receive water from the upper part of the hillslopes. Moreover, their deep and loam-sandy soils retain more moisture. The more a soil's weight increases due to its absorption of water, the greater the likelihood is that a landslide will be triggered (Arnáez et al 1992).

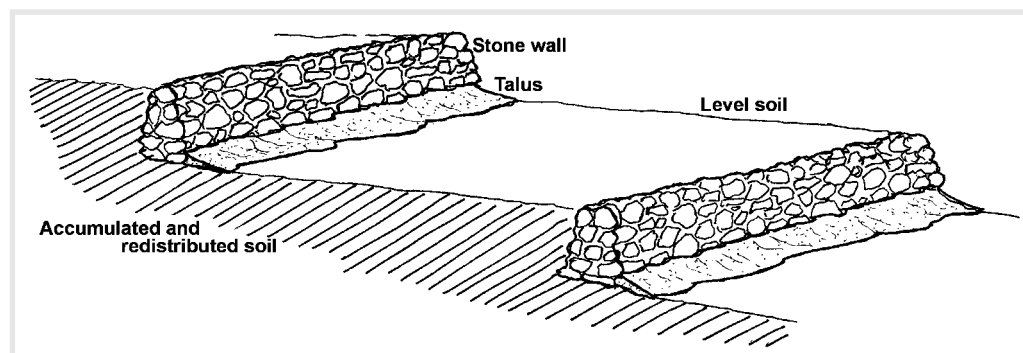
**FIGURE 7** Sectors of an abandoned terrace. (Drawing by Karl Herweg)

terrace (Figure 7) was affected and how the field was used. The talus at the foot of a terrace wall (accumulation of material that has been eroded from fields above) produced high runoff coefficient values (49.7%) and had low wetting front values (12.7 cm as an average). These areas were very prone to erosion: the erosion rate obtained by means of the rainfall simulation test was 25 g/m²/h. This hydromorphological behavior was caused by the talus gradient and the scarce plant cover in this section of terraces. Where the soil was level on a terrace, erosion rates were more moderate (Table 2).
