Landslide Hazard and Risk Zonation Mapping in the Río Grande Basin, Central Andes of Mendoza, Argentina

Source: Mountain Research and Development, 22(2) : 177-185

This paper presents an inventory of landslides and hazard and risk zonation mapping along the Río Grande basin in the Central Andes of Mendoza. The mapping was based on field work combined

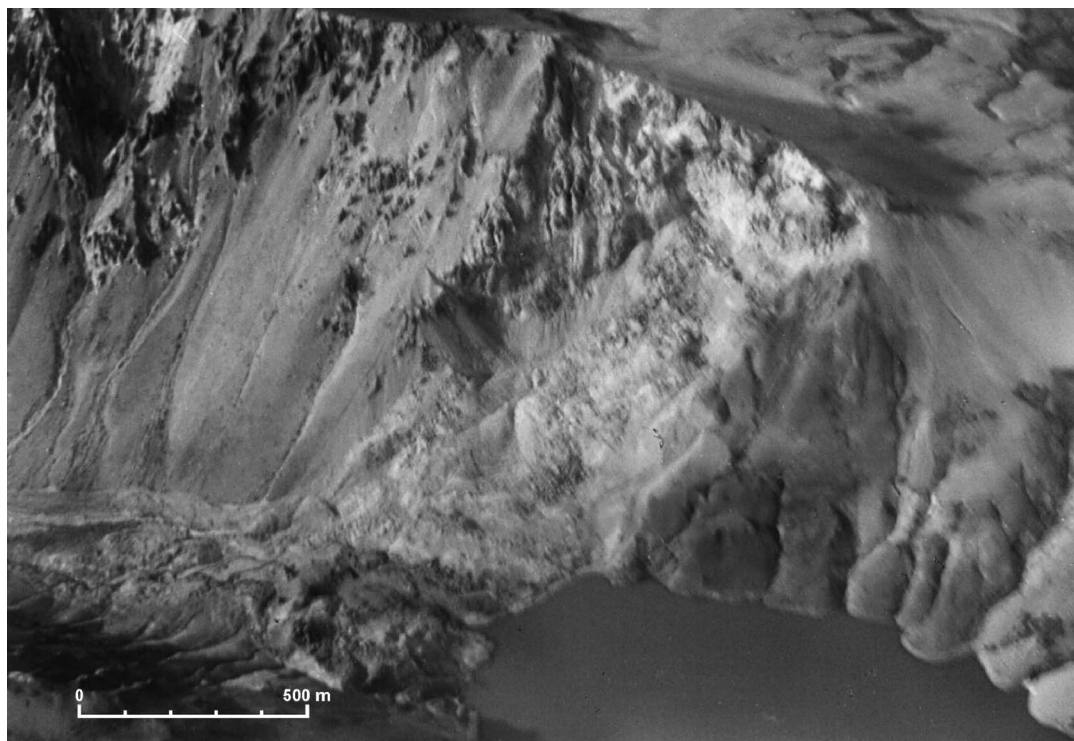
FIGURE 4 South aerial view of a landslide and the resulting dam at the headwaters of the Cajón Bayo creek in the Río Pehuenche basin. (Photo by Luis Lenzano and Carlos Aguado)

In the study area it was possible to detect a reactivated landslide (slump) at the headwaters of the Cajón Bayo creek at the Río Pehuenche basin. Tuffs of the lower Tilhuelitense (lower Quaternary age) are characterized by outcrops about 300–400 m thick, in subhorizontal position, with andesitic composition arising from eruptions of Volcano Campanario. A small 600-m-long landslide that deviated the creek about 50 m to the north can be observed in the 1963 aerial photos. In the satellite image of March 1985, no change was detected in the sector. Instead, on the 1986 images, a 1500-m-long lake that formed upstream from the landslide was detected (Figure 5; slump B39). In March 1992 the region was observed from a plane. A reactivated slide had occurred in the same sector as the one before, but this time it was more important, and the mass movements crossed the valley floor and extended far up the opposite wall. A lake was formed after the landslide obstructed the Cajón Bayo valley floor in 1986 (Figure 4). In March 1992, minor drainage of the lake through the base of the mass was also observed. This characteristic, and the prevailing lithology (friable tuffs), a steep slope, and the presence of snow ablation water, are negative factors that may affect stability. It is quite probable that at some time the natural dam will break. Were the water mass to drain suddenly, catastrophic downstream flooding would affect the Pehuenche road (Provincial Route 224) and the locality of Las Loicas.

waters of the Cajón Bayo creek, in the Pehuenche river basin, a reactivated landslide occurred, forming a lake upstream. The landslide may have been triggered by 7 earthquakes (Richter magnitude > 5) and occurred during 1985 in the general vicinity of the Cajón Bayo area
