## **Landslide Hazard and Risk Zonation Mapping in the Río Grande Basin, Central Andes of Mendoza, Argentina**

Source: Mountain Research and Development, 22(2) : 177-185

This paper presents an inventory of landslides and hazard and risk zonation mapping along the Río Grande basin in the Central Andes of Mendoza. The mapping was based on field work combined

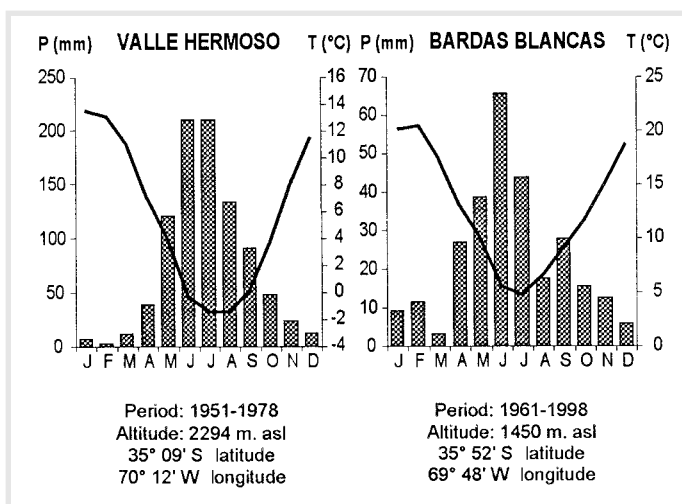
**FIGURE 2** Monthly mean precipitation and temperature in Valle Hermoso and Bardas Blancas meteorological stations.

There are 2 meteorological stations in the zone, with interrupted records: (1) Valle Hermoso (35°09'S, 70°12'W) at 2294 m, and (2) Bardas Blancas (35°52'S, 69°48'W) at 1450 m. The mean monthly precipitation and temperature records show 2 well-defined periods, one in winter and the other in summer (Figure 2). The monthly mean maximum precipitation coincides with the monthly mean minimum temperature. In Valle Hermoso the mean monthly temperature from June to August is below 0°C. At this station the higher monthly precipitation occurs in the winter as snow, whereas in Bardas Blancas it can be snow or rain and occurs from May to June. Annual mean precipitation varies from 400 mm in Bardas Blancas to 940 mm in Valle Hermoso.

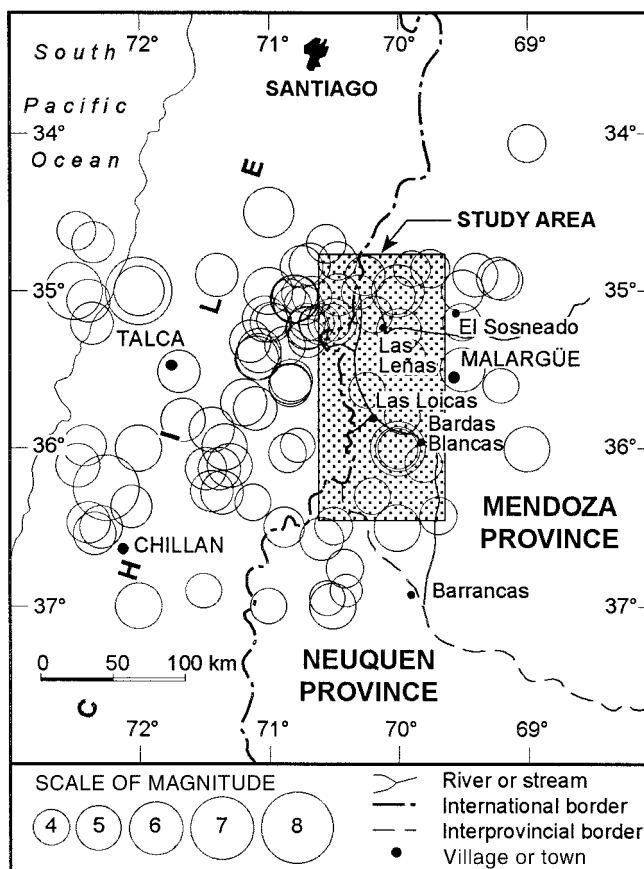
**FIGURE 3** Location of earthquakes (epicenters and magnitudes).

sity of Chile. Ninety earthquakes with magnitudes greater than 4 have occurred in the area. Figure 3 shows the location of the epicenters and magnitudes in the study area and the surrounding zones; the figure shows that there is an increase in the number of earthquakes and in their magnitudes toward the west.
