Hydropower-Induced Land Use Change in Fincha'a Watershed, Western Ethiopia: Analysis and Impacts

Authors: Tefera, Bezuayehu, and Sterk, Geert

Source: Mountain Research and Development, 28(1) : 72-80

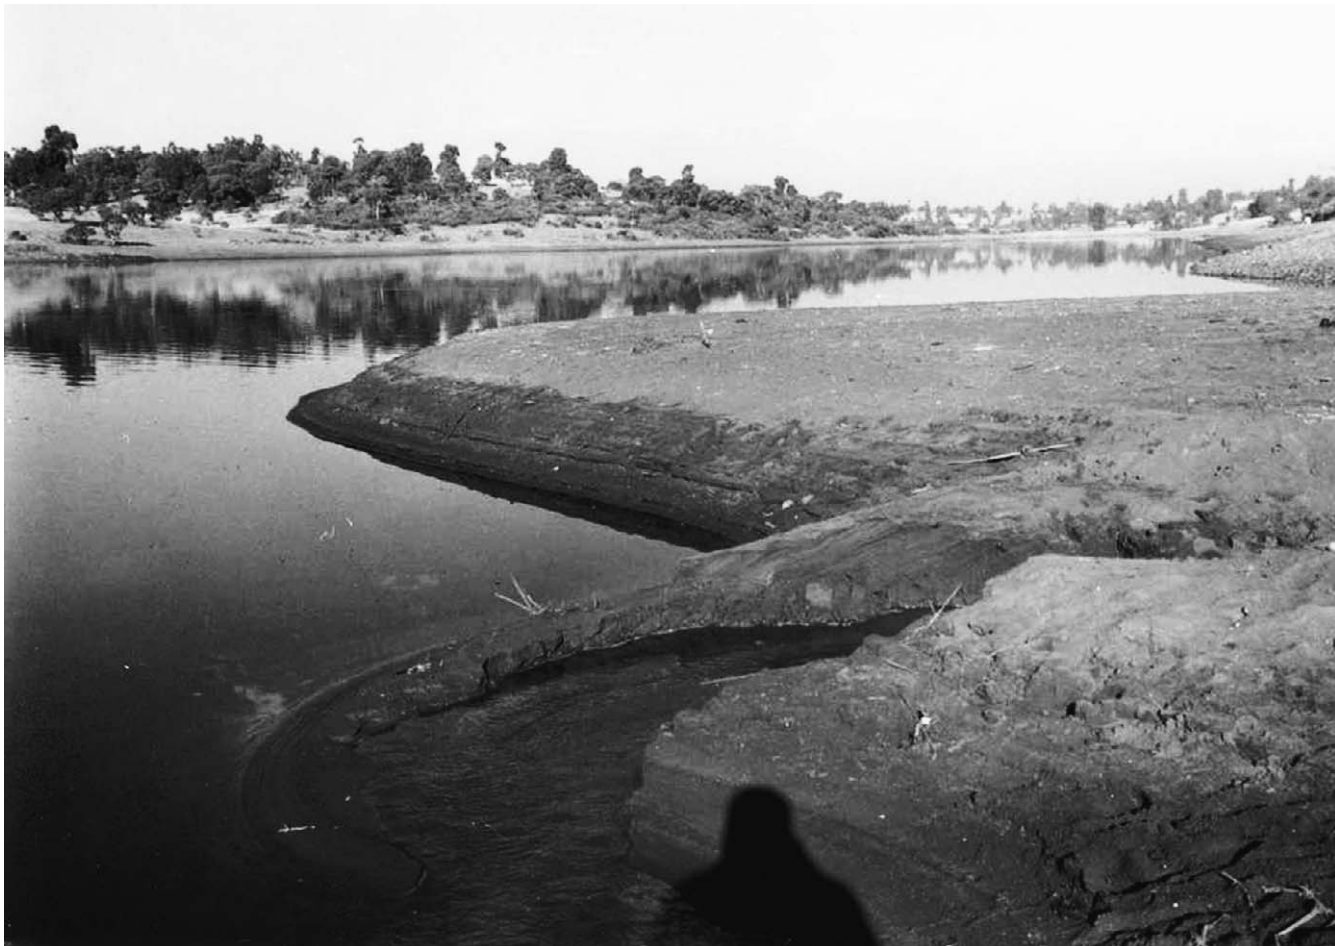
FIGURE 5 Sediment load transported by a stream into the reservoir in Fincha'a watershed, western Ethiopia, February 2003. (Photo by Bezuayehu Tefera)

Based on susceptibility to erosive rainfall, land use in Fincha'a watershed was categorized in 4 groups: 1) areas that are bare when erosive rain occurs and are exposed to accelerated erosion (ie cropland); 2) areas that have a relatively better vegetation cover but are exposed to indiscriminate tree cutting and overgrazing (ie grazing land); 3) areas with better vegetation cover all year round but subjected to limited encroachment (ie forest); and 4) the water body and swamp. Thus, the proportion of the watershed exposed to possible maximum soil loss was cropland, amounting to 31% in 1957, 36% in 1980 and 46% in 2001. This shows that the area potentially subjected to accelerated erosion increases from time to time. Indeed, rill and gully erosion are abundant forms of erosion on cropland and grazing land. Field observations showed a high sediment influx into the water body (Figure 5), which caused a reduction of the lake's surface area and volume.

Despite these signs of degradation, reforestation and soil and water conservation activities are lacking in the watershed. At the receded parts of the reservoir, many farmers have already started to grow potatoes and maize, and graze their animals. This situation was not detected using the satellite image because these practices must have started after the image was taken. The population of floating grasses growing from the floor of the lake has recently increased, perhaps due to the enhanced sediment influx. This may result in more evapotranspiration losses and reduced electric power generation.
