## **Processes Controlling Development of Erosional Hot Spots on a Beach Nourishment Project**

Authors: Benedet, L., Finkl, C. W., and Hartog, W. M.

Source: Journal of Coastal Research, 2007(231) : 33-48

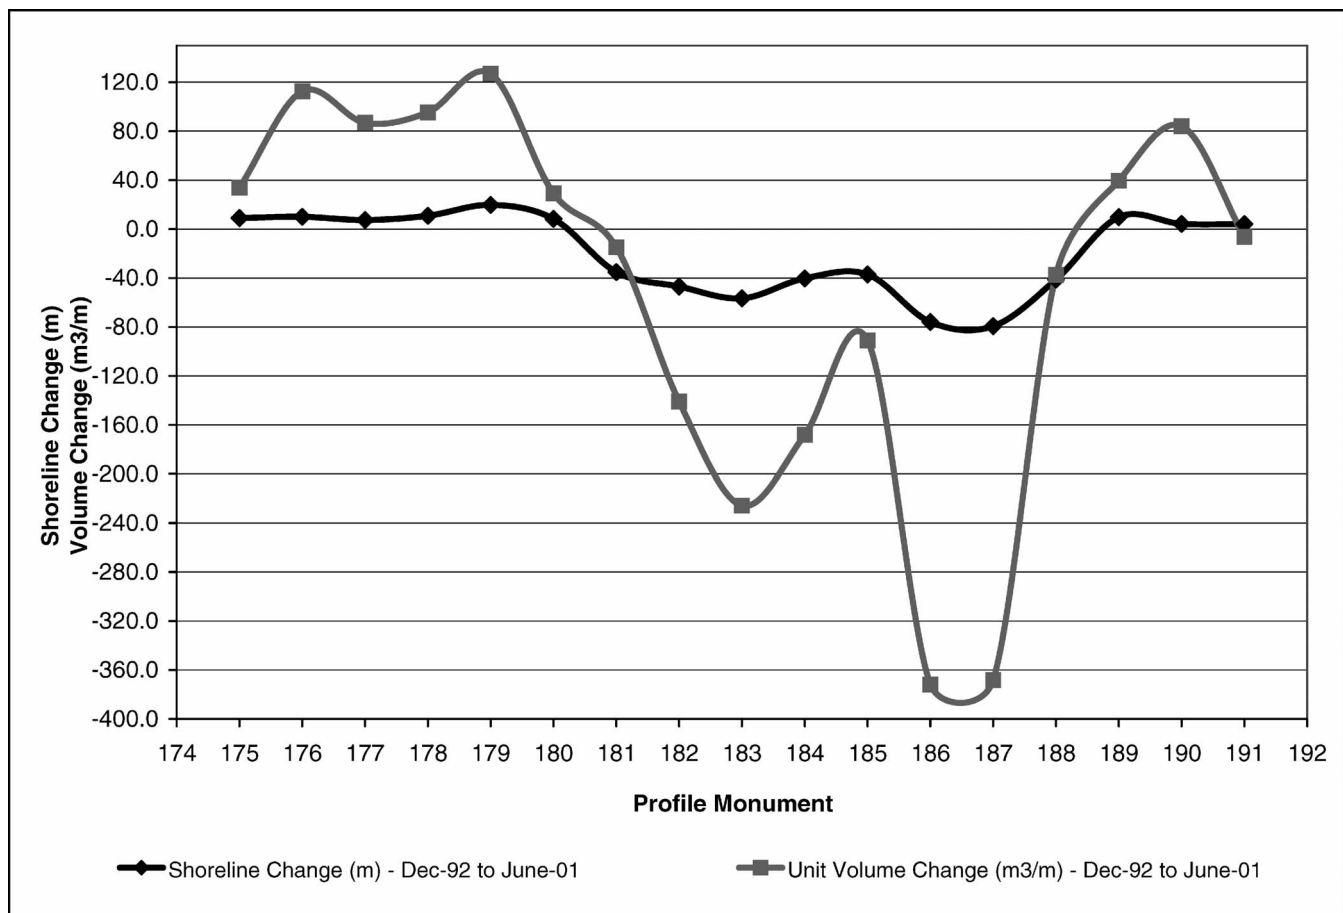
Figure 3. Shoreline changes (m) and volume changes ( $\text{m}^3 \text{m}^{-1}$ ) from the postconstruction survey (December 1992) to the last survey of the entire study area (June 2001).

accreted about 6 m during the eight and a half years evaluated (Figure 3).

Volume changes to the  $-7.5$ -m depth contour (offshore limit of the profile surveys) between 1992 and 2001 show a general trend similar to the shoreline changes (Figure 3). Total volumetric changes were estimated by multiplying the unit volume change by the distance between profile monuments. Between 1992 and 2001, a cumulative volume of about  $448,000 \text{ m}^3$  was lost from the fill limits; of this volume,  $177,000 \text{ m}^3$  (about 40%) eroded from the beach segment between profile monuments R186 and R187.

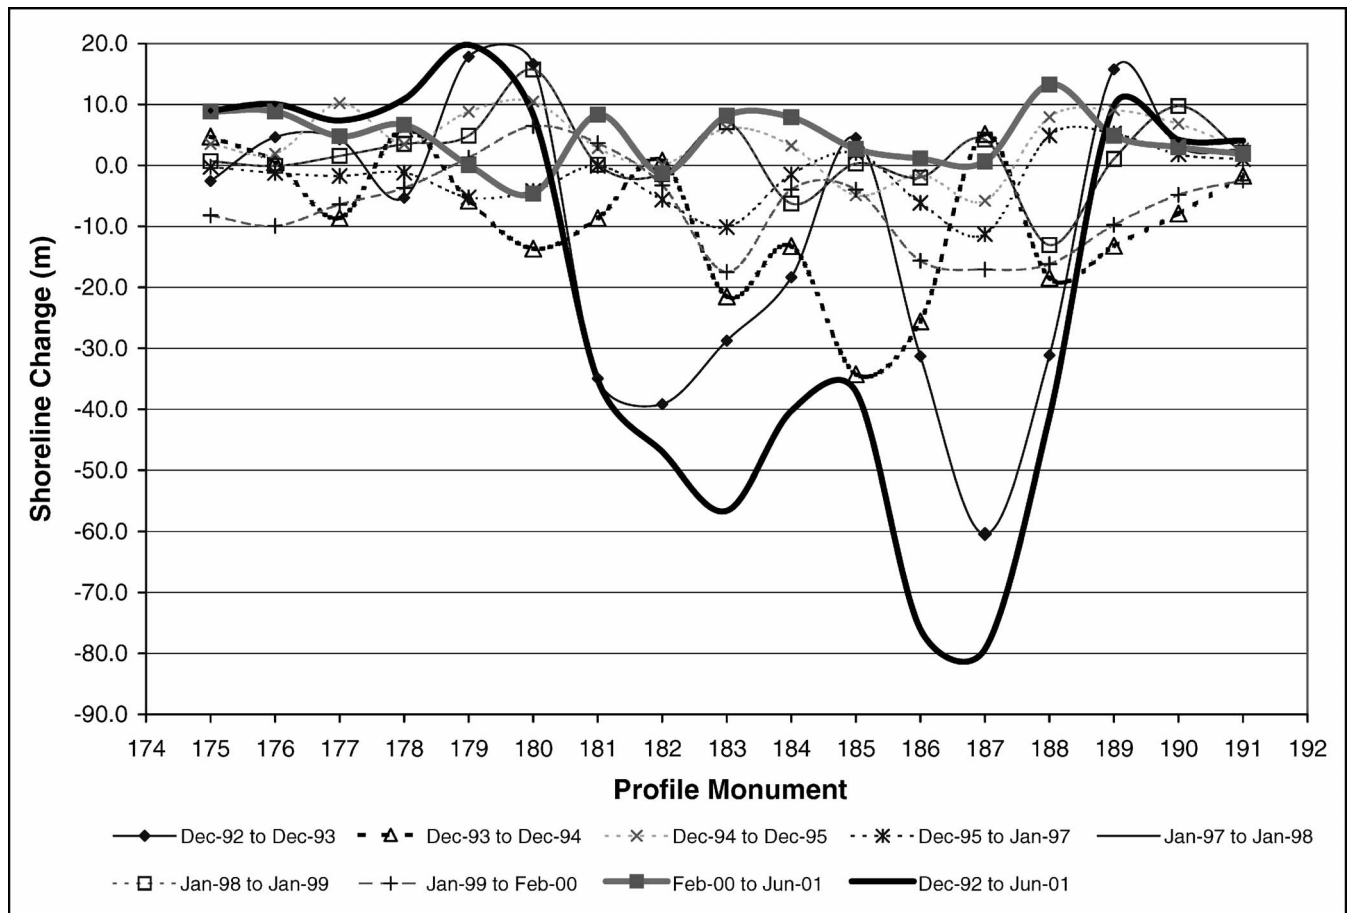
Figure 4. Shoreline changes calculated between annual survey intervals for the Delray Beach project area contrasted with the total changes from December 1992 to January 2001 (thicker black line).

Annual shoreline and volume change rates vary greatly along the study area. Although updrift and downdrift shorelines were slightly accretional for most of the time period evaluated (1992–2001) (Figures 4 and 5), these segments eroded in 1993–1994 and 1999–2000. The nourishment area eroded for most of the monitored period, but accretion was exceptionally observed between 1995 and 1997, between 1997 and 1998, and between 2000 and 2001. Periods of accretion positively correlated with mild wave conditions (*i.e.*, HARTOG, 2006). Most of the shoreline and volume change occurred during the first 2 years after construction (Figures 4 and 5) and from 1999 to 2000 when three tropical storms affected the study area. Relative high shoreline retreat and volume losses observed during the first 2 years after construction strongly influenced the shape of the shoreline and volume change curves for the entire study period.

Monuments that eroded relatively more than the rest of the fill, shown in Figures 4 and 5, include R183, R186, and R187. The shoreline on R186 and R187 retreated almost every year except for two periods (1993–1994 and 1998–1999) (Figure 4). Greater shoreline retreat also occurred near R183 for most of the time except for 1993–1994, 1998–1999, and 2000–2001 where accretion occurred (Figure 4).

Volume losses of R183, R186, and R187 were also greater than the rest of the project for most years but for two (January 1997 to January 1999) when accretion occurred on these locations. Relatively small volume gains were observed in the updrift and downdrift segments throughout most of the monitoring period simultaneous to erosion of the beach fill, indicating some alongshore spreading of fill sediments. Further analysis of beach profiles shows that accretion of about  $200 \text{ m}^3 \text{ m}^{-1}$  observed at profile R181 between 2000 and 2001 period (see Figure 5) was mostly due to sedimentation in the inner and outer bar systems; thus, although a large volumetric gain occurred, very little shoreline change was observed in this area during the same time period (see Figure 4).

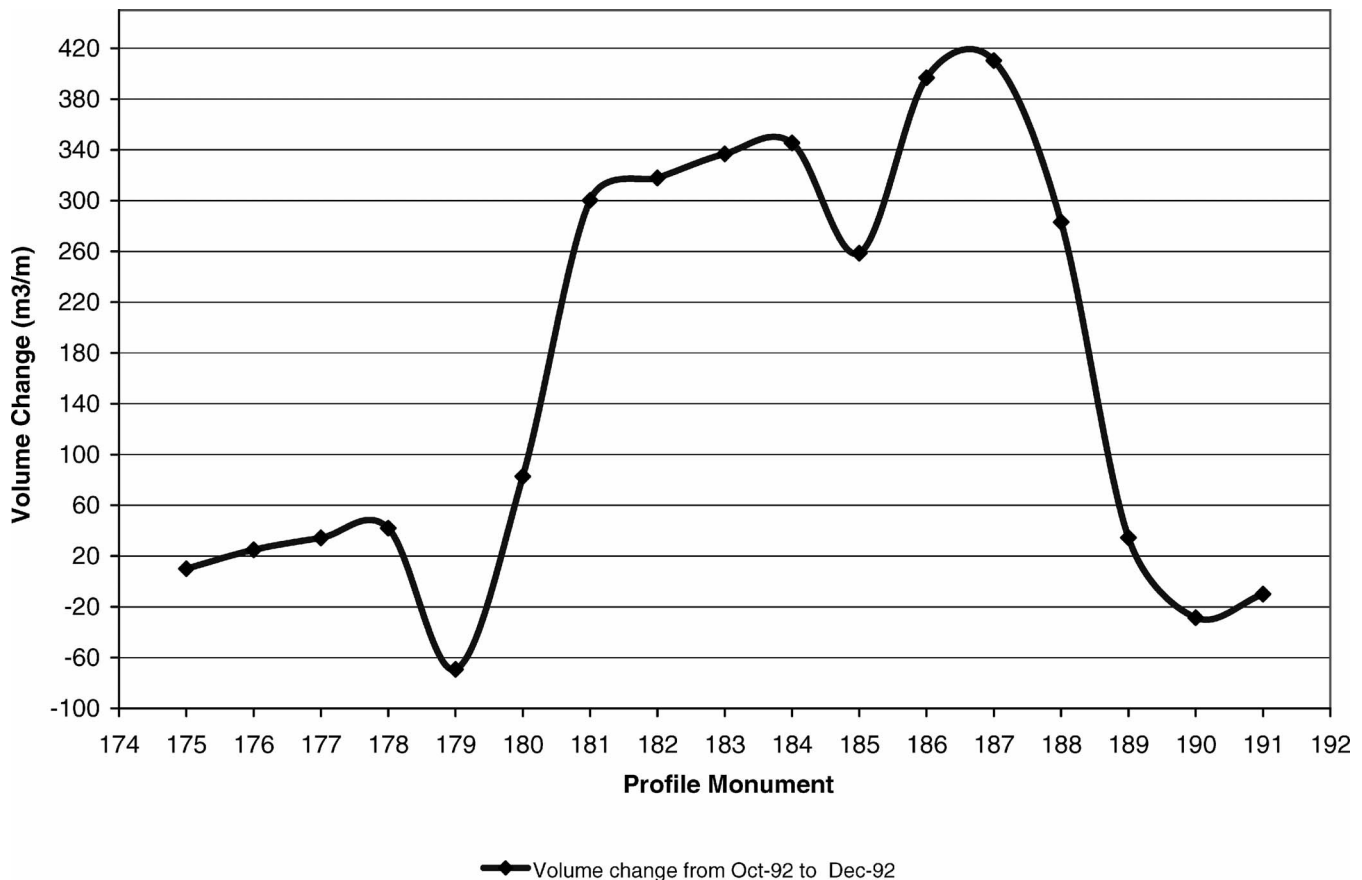
Figure 8. Volume changes from October 1992 (preconstruction survey) to December 1992 (postconstruction survey) showing distribution of fill sands. The nourishment is delimited between monument profiles R180 to R188; higher volumes were placed in the south end of the fill (profile monuments R186 and R187) to counteract higher erosion rates observed in this area after the previous fills.
