Source: Journal of Coastal Research, 36(sp1) : 148-163

# Variations in Inlet Behavior and Shoreface Sand Resources: Factors Controlling Management Decisions, Figure Eight Island, NC, USA

William J. Cleary

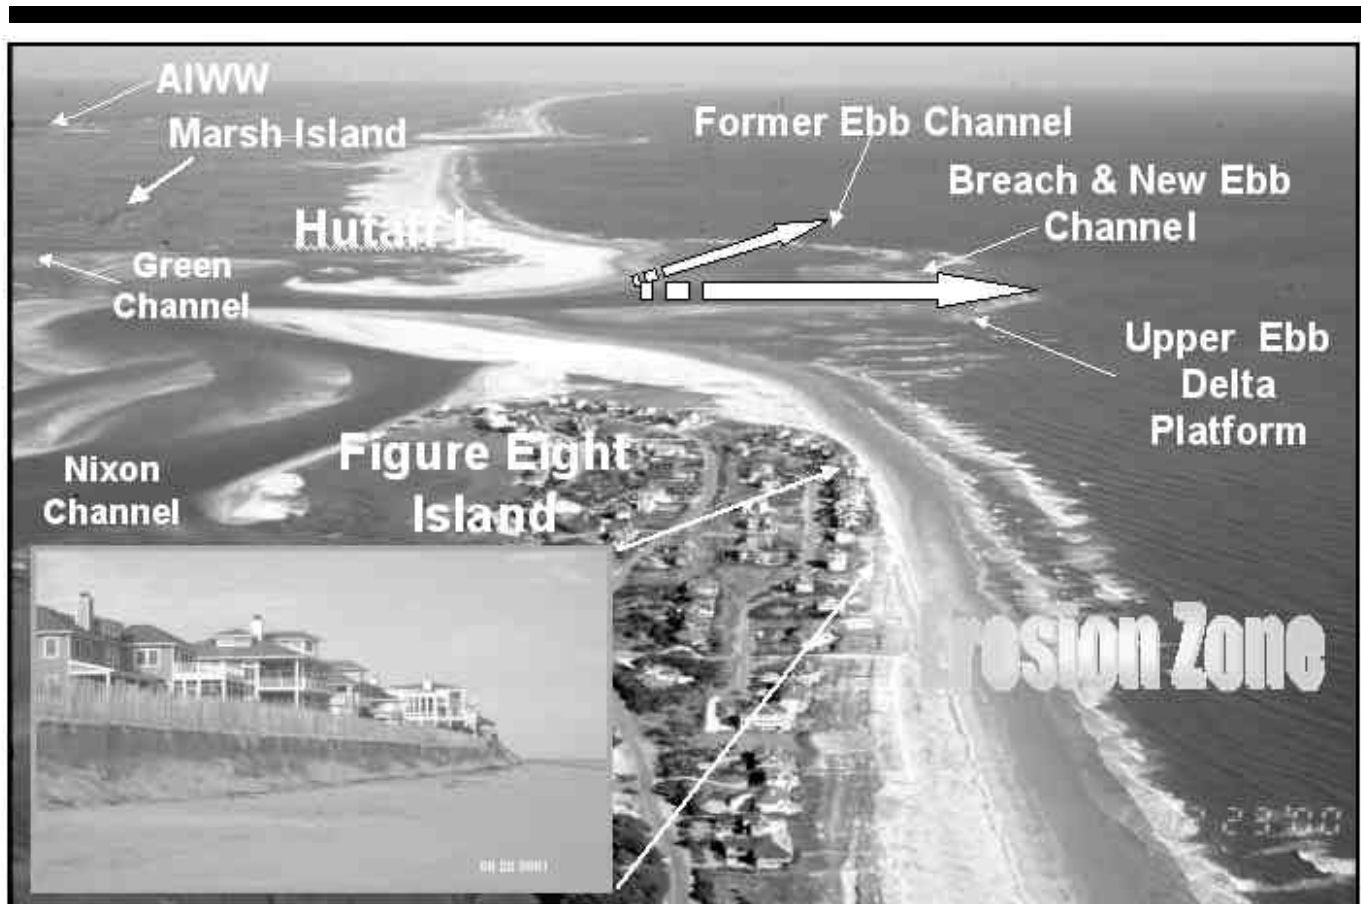
Figure 6. Oblique north view (12/00) of Rich Inlet, Figure Eight Island and Hutaff Island. Rapid erosion of oceanfront stemmed from northeasterly migration and realignment of ebb channel. Ebb delta breaching occurred several months earlier setting the stage for a southerly migration of the channel. Insert shows the current condition (9/01) of the eroding oceanfront.

Data indicate that the ebb channel has begun to track in a southerly direction; and as a result a reversal in the shoreline change patterns it will probably occur as the barrier planforms are altered accordingly. The continual repositioning of the ebb shoals to more favorable southwesterly locations will have an increasing positive impact on the Figure Eight Island shoreline. It is difficult to predict what time span is involved in the migration of the ebb channel along the 800 m long pathway to its optimum position. It may be as much as a decade or more, but there is a high probability that a breach across the narrow, low-relief spit will shorten the time lag considerably (Figs. 6, 8 D).

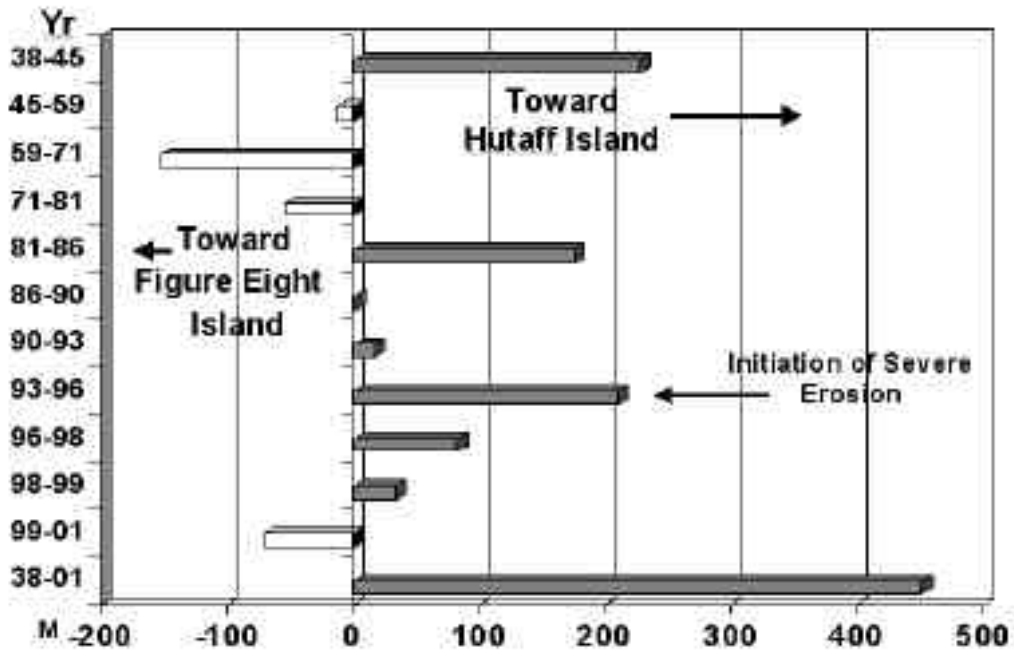
Figure 9. Bar graph depicting migration of Rich Inlet ebb channel mid-point since 1938.

Dramatic changes have also occurred in the direction and rates of inlet movement (Fig. 9). During the period 1938 to 1945 the inlet moved 226 m in a northeasterly direction. Over the next 36 years, between 1945 and 1981, the channel reversed direction and moved 280 m to the southwest. In 1981 the inlet began to migrate to the northeast, and by 1986 had migrated 174 m at average rates of  $35 \text{ m y}^{-1}$ . Over the next seven years the rate of movement decreased and averaged only  $2.6 \text{ m y}^{-1}$ . Since 1993 the channel migrated relatively rapidly ( $30$ - $70 \text{ m y}^{-1}$ ) to the NE a distance of 323 m. Additionally, in mid 1999 the channel was located approximately 520 m northeast of its 1938 position (Fig. 8). In late summer of 2000, the ebb channel reversed its northeasterly direction of migration and moved approximately 70 m to the southwest. The change in the channel position was triggered by the reorientation of the outer bar channel from  $70^\circ$  in August 2000 to  $135^\circ$  in December 2000.

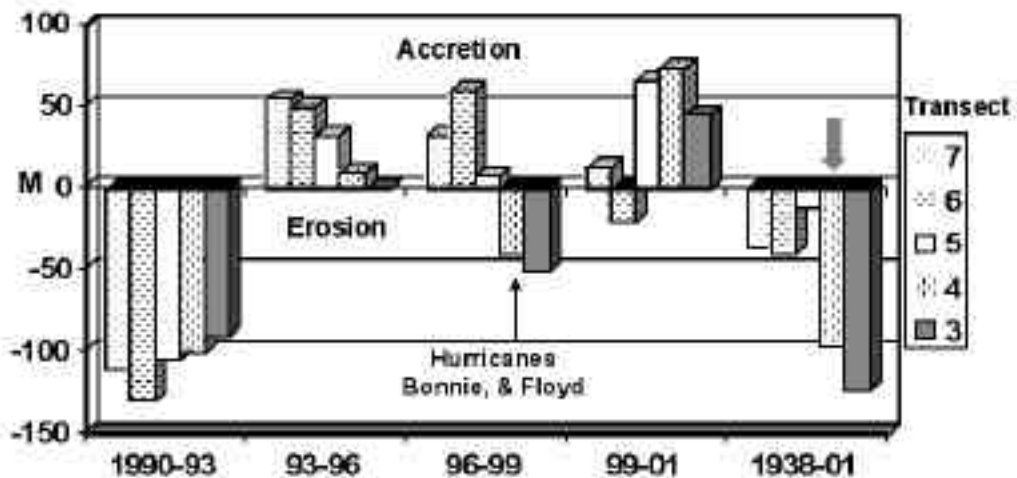
Figure 11. Graph depicting recent oceanfront shoreline changes (1999- 2001) along Hutaff Island and historic changes between 1938-2001. See Figure 7 for transect locations.

Since 1990 Hutaff Island shoreline has experienced a net loss of oceanfront (Figs. 7, 11). Figure 11 illustrates that the shoreline erosion ranged from 1-94 m. The majority of the recession occurred during a period of time when the ebb channel was aligned along the Figure Eight Island shoulder. During the period from 1993-2001, net accretion characterized the shoreline (Figs. 7, 8, 11). The buildup of the Hutaff Island oceanfront reflected the northeasterly movement and realignment of the ebb channel.
