Sand dune management problems and techniques, Spain.

Authors: Gómez-Pina, Gregorio, Muñoz-Pérez, Juan J., Ramírez, Jose L., and Ley, Carlos

Source: Journal of Coastal Research, 36(sp1) : 325-332

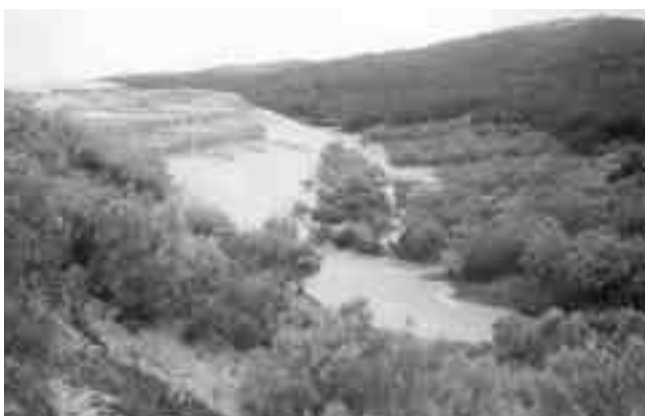
Figure 17. A view of Valdevaqueros backdune restoration (Cádiz, Spain)

Dune restoration works started with the reshaping of the dune profile in order to obtain a better aerodynamic stability complemented with the experimental use of longitudinal willow sand fences to decrease erosive surface patterns. Also experimental transplanted vegetation techniques were used along certain potentially stable areas.

Figure 16 depicts an aerial view of Valdevaqueros cove. Figure 17 shows backdune restoration near the adjacent pine grove. Figure 18 shows foredune accretion after restoration.
