Effects of a Natural Dam-Break Flood on Geomorphology and Vegetation on the Elwha River, Washington, U.S.A

Authors: Acker, Steven A., Beechie, Timothy J., and Shafroth, Patrick B.

Source: Northwest Science, 82(sp1) : 210-223

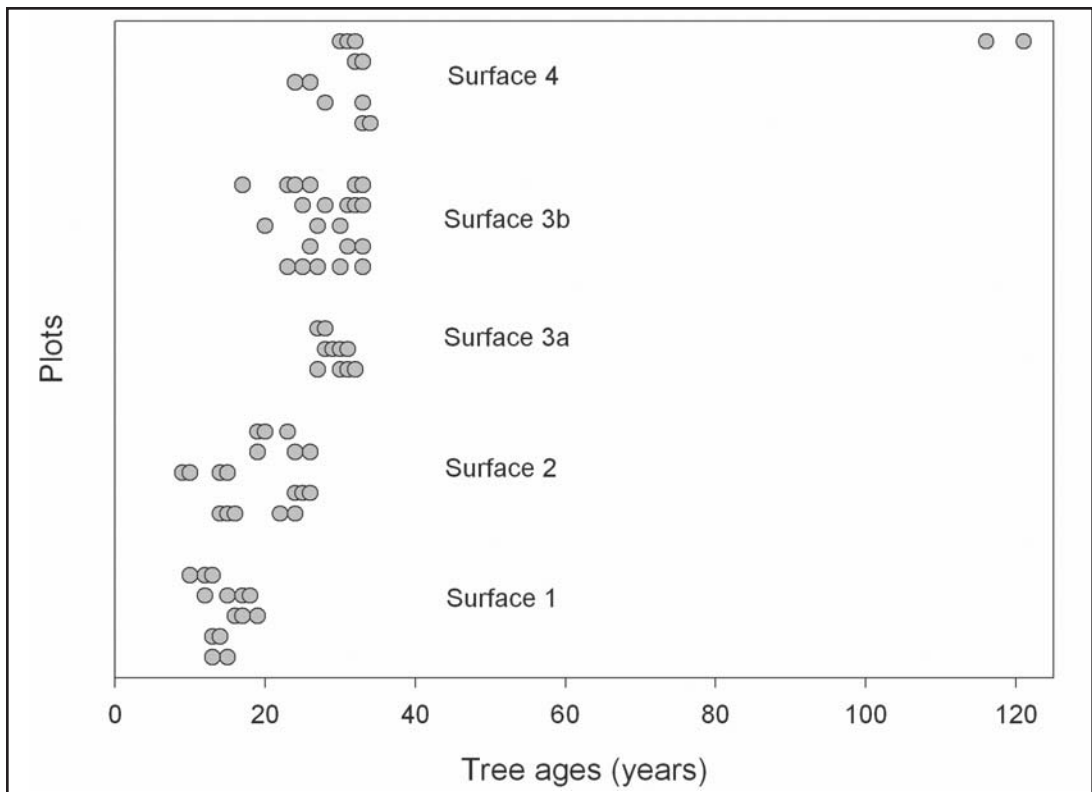
Figure 4. Ages of trees within plots, grouped by geomorphic surface. Each horizontal line of points represents one plot.

Trees began to establish on all surfaces one to four years after surface creation (Table 1). There has been a prolonged period of tree recruitment, especially on surfaces 3b and 2 (Figure 4). Present day tree species composition was generally

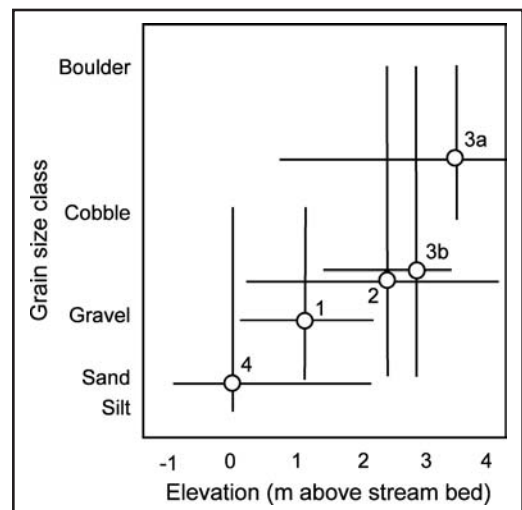
Figure 5. Elevation and grain size ranges of the five geomorphic surfaces. Points indicate median grain size class and median elevation of surface above the present stream bed measured along transects, and lines indicate the range of elevation and grain size classes of each surface.

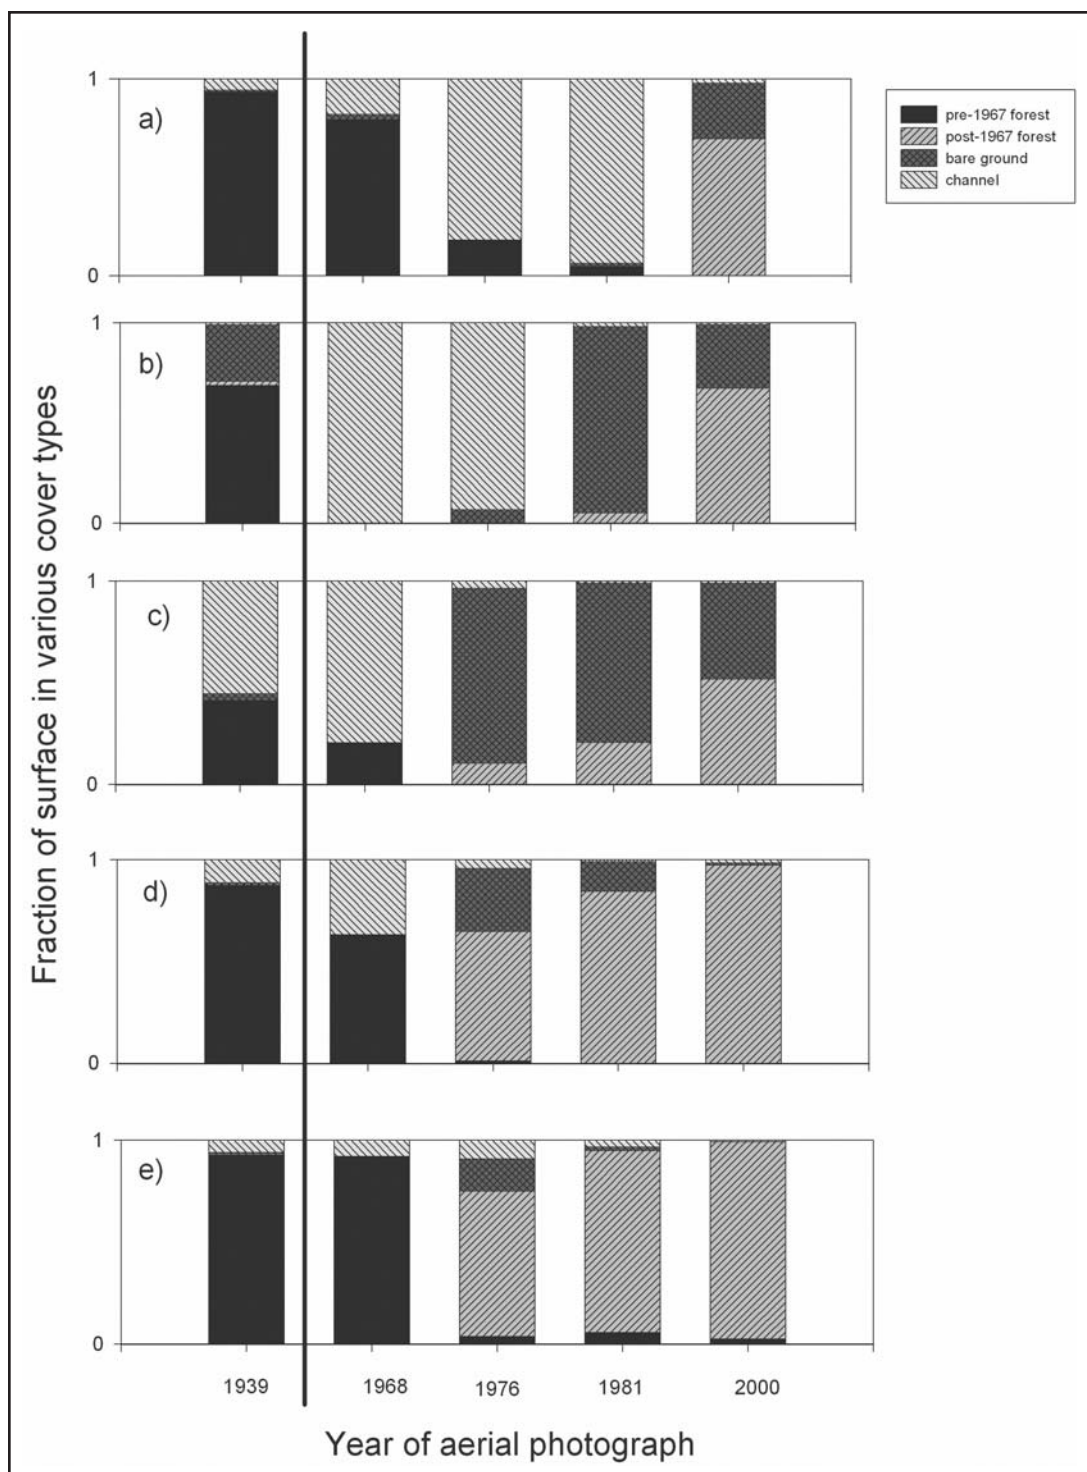
Figure 6. Proportions of area in different cover types on the geomorphic surfaces derived from the aerial photograph time series of the study site: a) surface 1; b) surface 2; c) surface 3a; d) surface 3b; e) surface 4.

between 1968 and 1976, removed more of the earlier forest from surface 1 than did the 1967 flood (Figure 6).

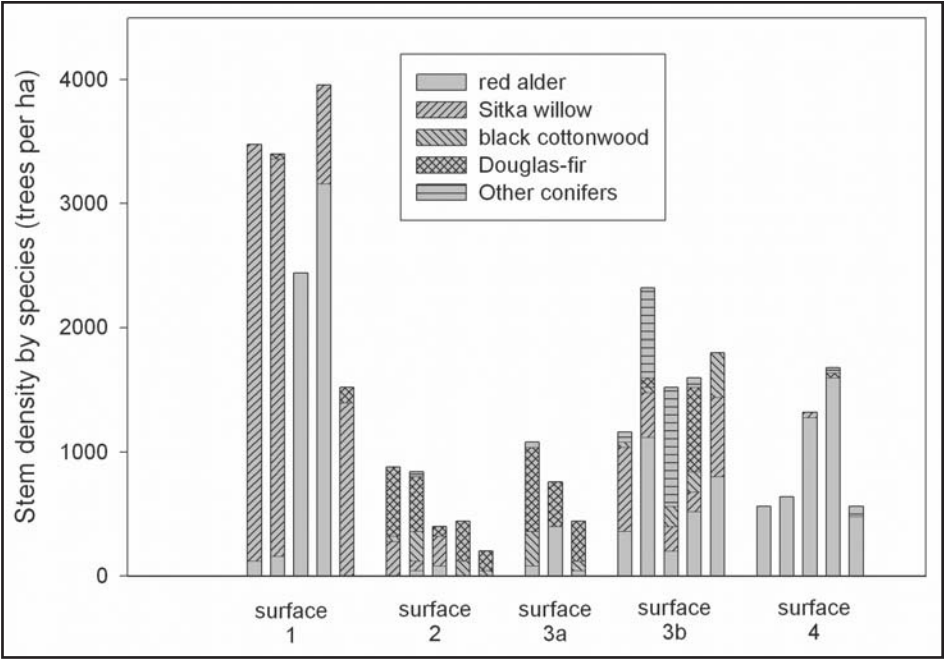
Figure 7. Stem density (numbers of trees per ha) by species for plots on the five geomorphic surfaces. Bars represent the replicate plots on each surface.

consistent among plots within each of the five surfaces; there were also similarities between some of the surfaces (Figures 7 and 8). Surface 4 was characterized by red alder and surface 1 by either Sitka willow or alder, or a mixture of both.

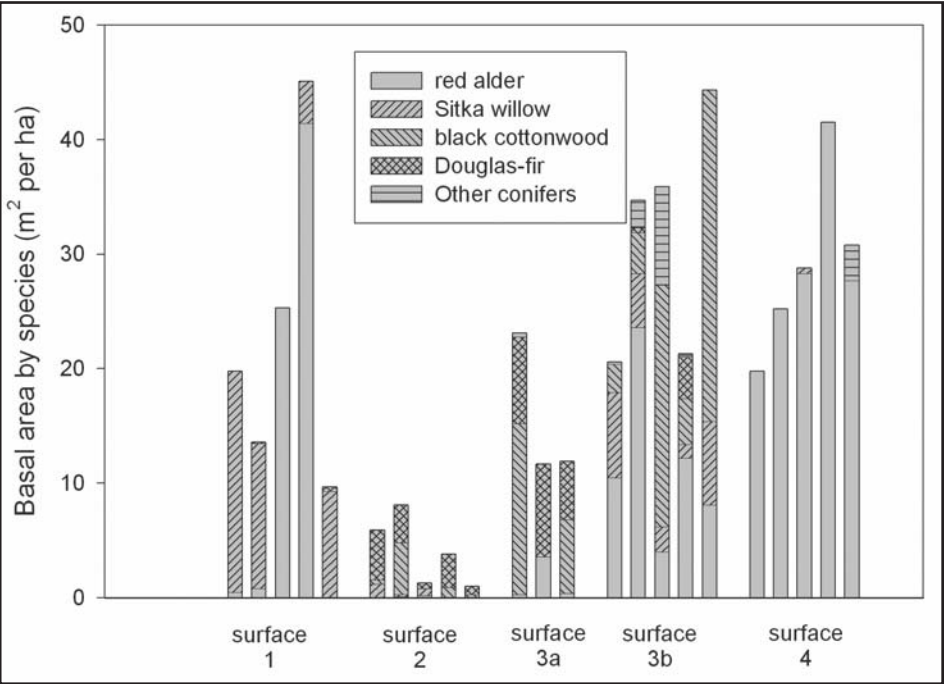
Figure 8. Basal area of trees (m² per ha) by species for plots on the five geomorphic surfaces. Bars represent the replicate plots on each surface.
