Source: Journal of Raptor Research, 51(3) : 293-304

## AVIAN ELECTROCUTIONS ON INCORRECTLY RETROFITTED POWER POLES

JAMES F. DWYER,<sup>1</sup> RICHARD E. HARNESS, AND DUNCAN ECCLESTON  
*EDM International Inc., Fort Collins, CO 80525 U.S.A.*

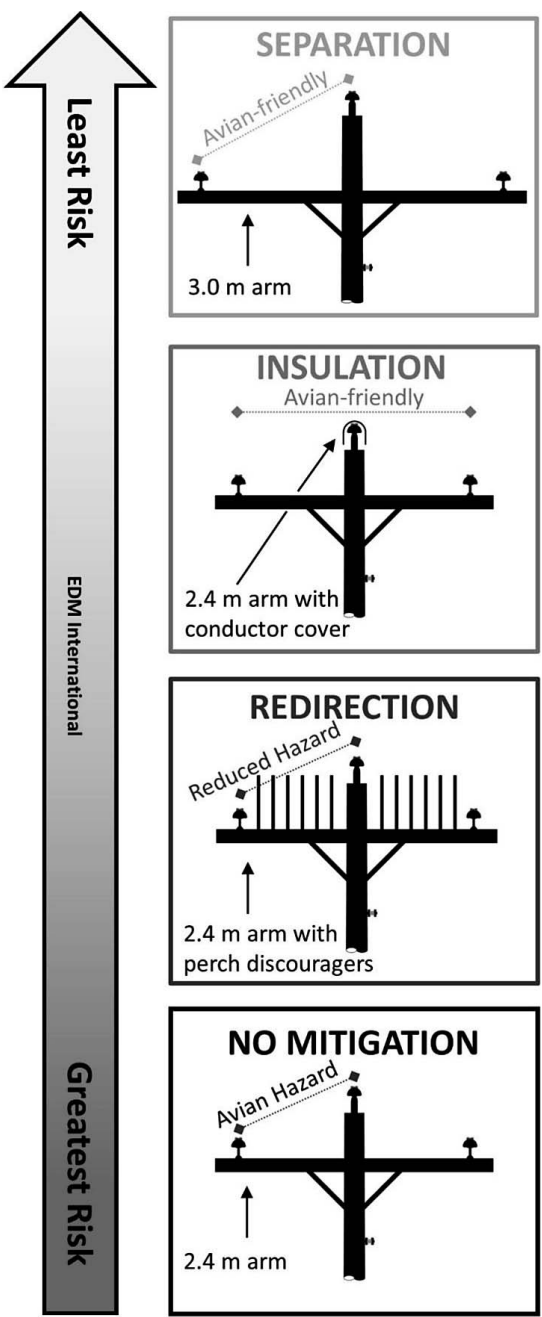
Figure 1. Avian electrocution risk is highest on poles with no mitigation, and lowest on poles with avian-friendly retrofitting achieved through insulation or separation.
