Source: Journal of Raptor Research, 51(3) : 293-304

AVIAN ELECTROCUTIONS ON INCORRECTLY RETROFITTED POWER POLES

JAMES F. DWYER,¹ RICHARD E. HARNESS, AND DUNCAN ECCLESTON
EDM International Inc., Fort Collins, CO 80525 U.S.A.

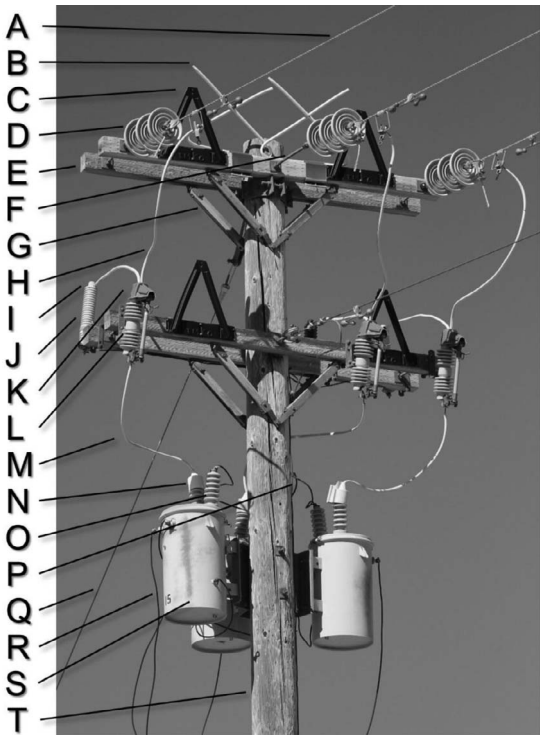
Figure 2. Common power pole (pole) components useful in understanding retrofitting mistakes for birds electrocuted between January 2013 and December 2015 on poles described as retrofitted, in Arizona, Colorado, Idaho, New Mexico, Utah, and Wyoming, U.S.A. See APLIC (2006), Dwyer et al. (2013), and APLIC (2015) for additional illustrations. See Table 1 for component names.
