Source: Journal of Raptor Research, 51(3) : 293-304

AVIAN ELECTROCUTIONS ON INCORRECTLY RETROFITTED POWER POLES

JAMES F. DWYER,¹ RICHARD E. HARNESS, AND DUNCAN ECCLESTON
EDM International Inc., Fort Collins, CO 80525 U.S.A.

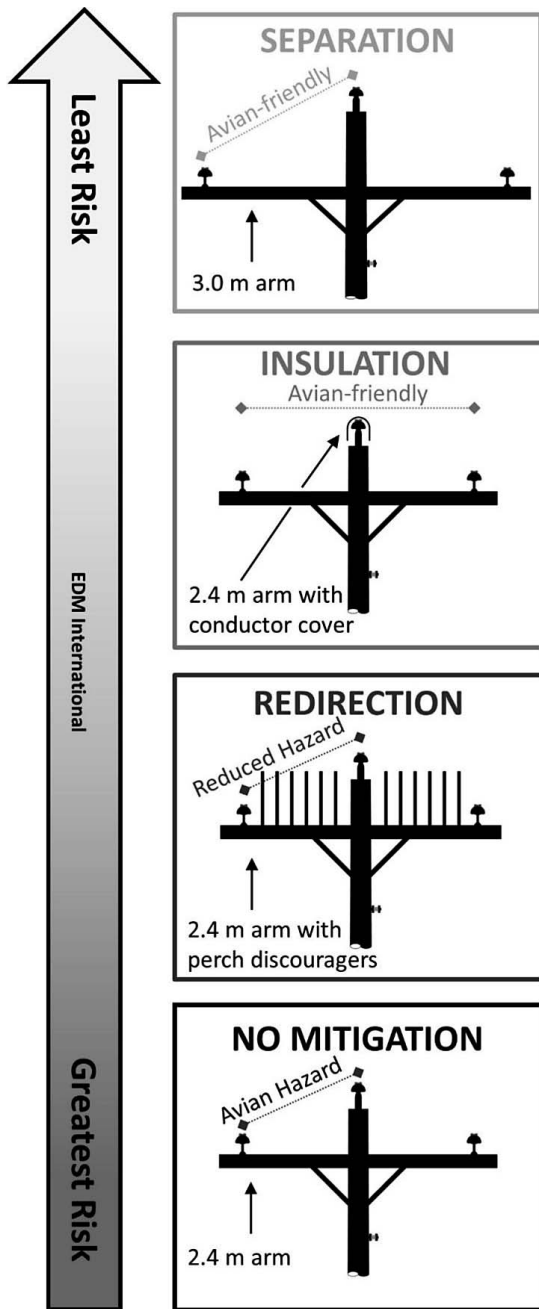
Figure 1. Avian electrocution risk is highest on poles with no mitigation, and lowest on poles with avian-friendly retrofitting achieved through insulation or separation.

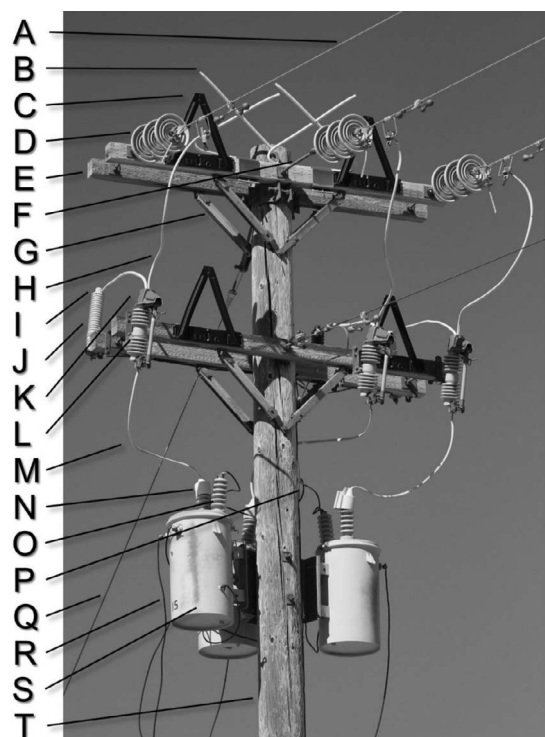
Figure 2. Common power pole (pole) components useful in understanding retrofitting mistakes for birds electrocuted between January 2013 and December 2015 on poles described as retrofitted, in Arizona, Colorado, Idaho, New Mexico, Utah, and Wyoming, U.S.A. See APLIC (2006), Dwyer et al. (2013), and APLIC (2015) for additional illustrations. See Table 1 for component names.
