Panorama of the History of Coastal Protection

Authors: Charlier, Roger H., Chaîneux, Marie Claire P., and Morcos, Selim

Source: Journal of Coastal Research, 2005(211) : 79-111

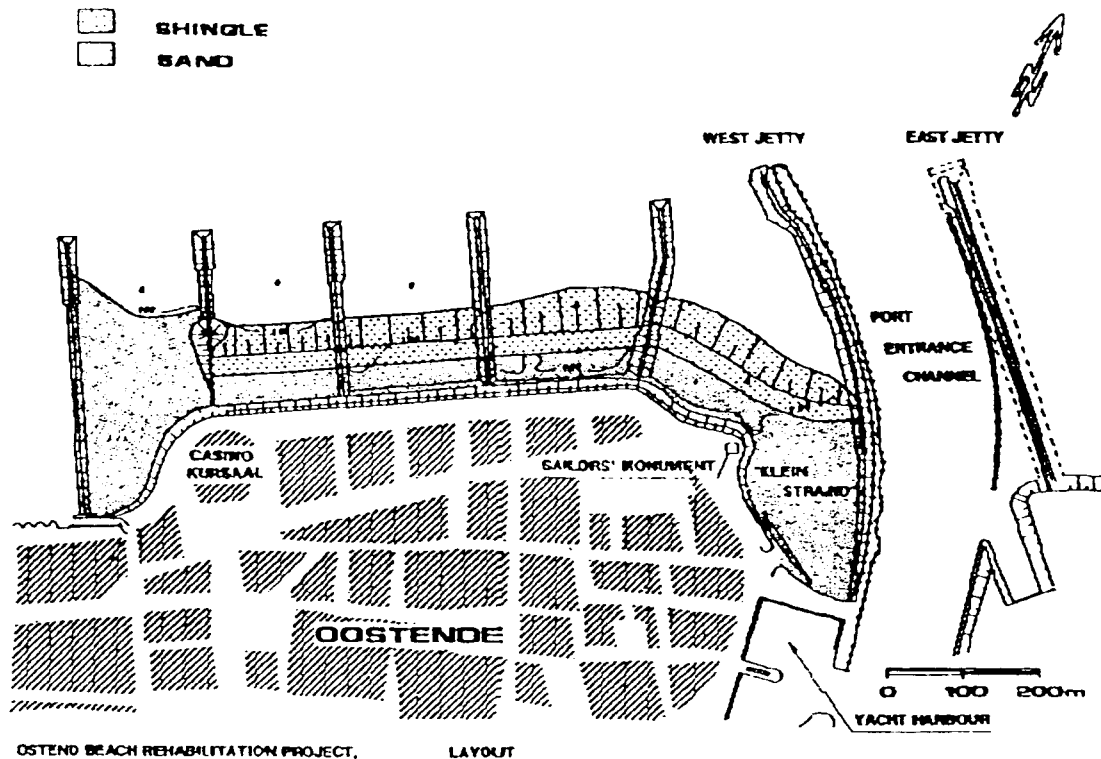
Figure 2. Layout of the beach rehabilitation project at Oostende, Belgium.

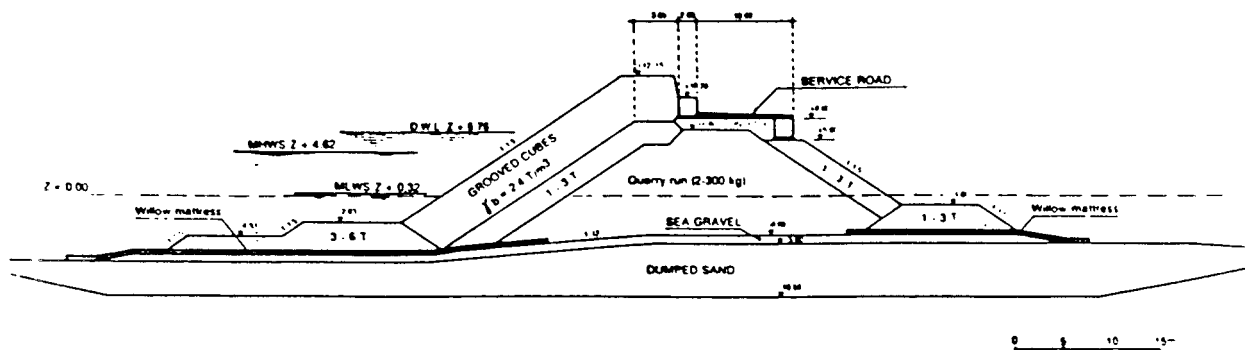
Figure 3. Typical cross-section of Zeebrugge outer harbour breakwaters.

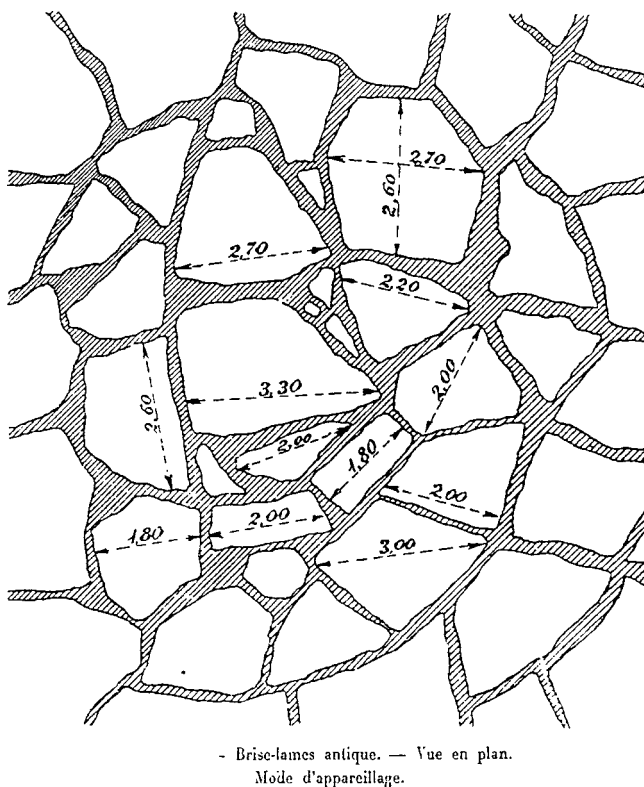
Figure 5. Upper surface view of the Great Ancient Breakwater. After Jondet, 1916.

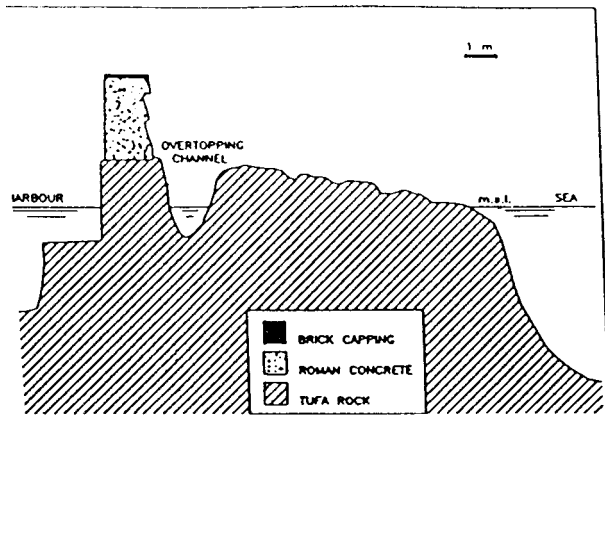
Figure 7. Cross-section of the existing Roman "carved rock breakwater" with overspill stilling channel at Ventotene (Built 2 BC).

Coastal defense history is, naturally, closely linked to harbor creation and development. Primitive breakwaters were put in place occasionally with ramps allowing the top of the waves to pass over them. Phoenicians had devised wave catchers by excavating holes and establishing trenches in the rocks lining the shores (RABAN, 1988). Carved breakwaters were cut out of bedrock: a suitable wave-absorber profile was created which had a gentle grooved slope at the waterline. The classical example dates from 2 before the present, is still visible at Ventotene; it had an over-spill. One may see in it an early version of today's Fontvieille breakwater (Principality of Monaco) (Figure 7).

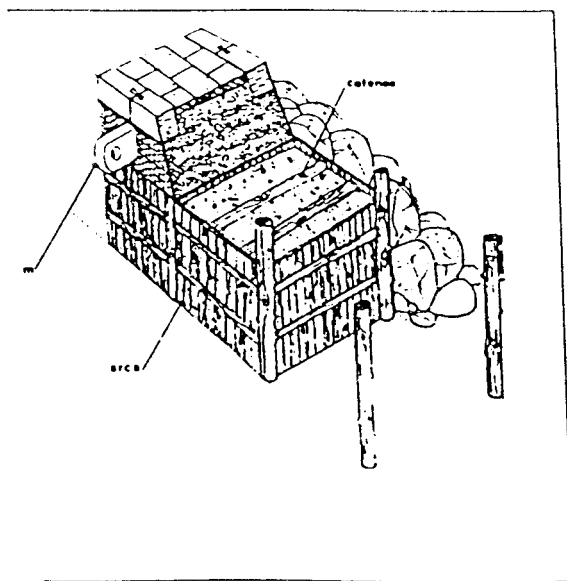
Figure 8. Reconstruction of the Roman construction system of a vertical water with cast-in-situ concrete within wooden forms and tie-rods (Clementi, 1981).

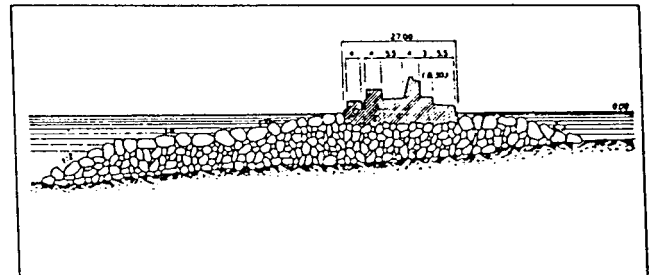
Figure 9. Modern section of the Trajan island breakwater of Civitavecchia harbour.

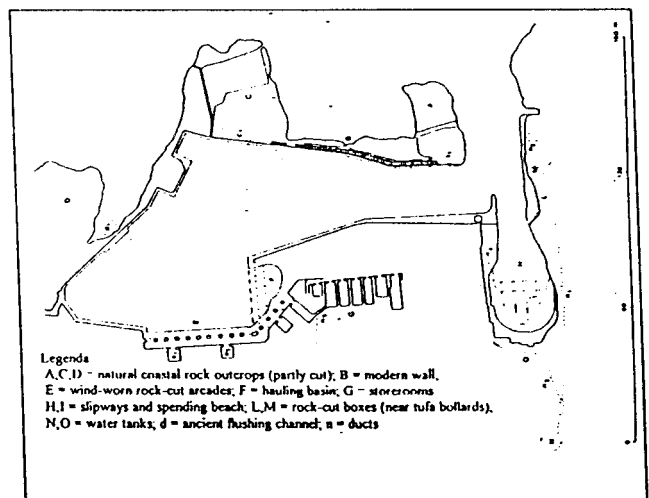
Figure 10. Layout of the Roman imperial port of Ventotene.

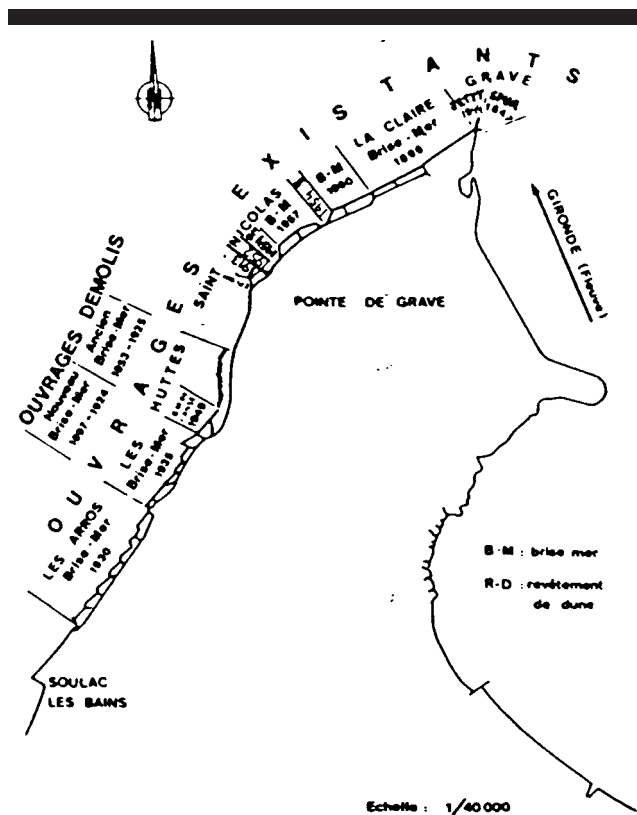
Figure 12. Shoreline protection, Pointe de Grave, France. After Laboratoire Central d'Hydraulique de France, 1979. Redrawn and modified by R. H. Charlier.

ing” notwithstanding a lengthy transport for rocks and short lifespan of wood (FRANCO, 1996). Strict environmental regulation governing shore protection can be traced back to legal documents of 1282 and 1339: prohibition to cut or burn trees from coastal forests, to pick mussels from rock revetments, to let cattle walk the dikes, to remove sand, and vegetation, from beach or dune, and to export materials used in coastal defense (GRILLO, 1989). The *Magistrato alle acque*, created in 1501, invited suggestions to reduce the high cost of the coast defenses, so, in the 18th century, appeared rip-rap revetments, gabions, staircase placed limestone blocks, and the use of mortar and steel links and flexible steel strips became common (Figures 11, 12).

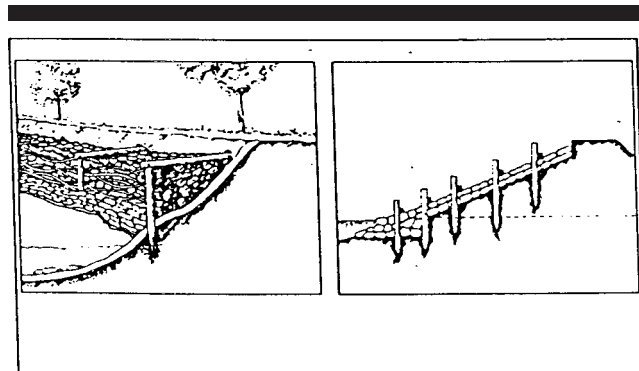
Figure 13. Ancient coastal defenses in Venice: rubble vetments within timber piled fences (6th to 17th century).

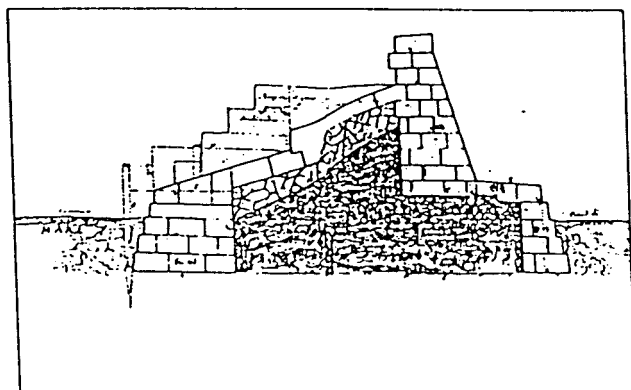
Figure 14. Original design of the "murazzi" seawall by Zandrini in 1743.

Massive *murazzi*, devised by Zentini and his team were constructed from 1741 on; with an average width of 12 m (39 ft), their crest peaked at 5 m (16 ft) above mean sea level. It took 40 years to construct a protective sea-wall 20 km (12.4 miles) long (CHARLIER and DE MEYER, 1998). *Murazzi* have withstood the test of time, though storms took their toll and toe protection was eventually provided by a rubble mound structure and, more recently, jet-grouting diaphragms. Com-

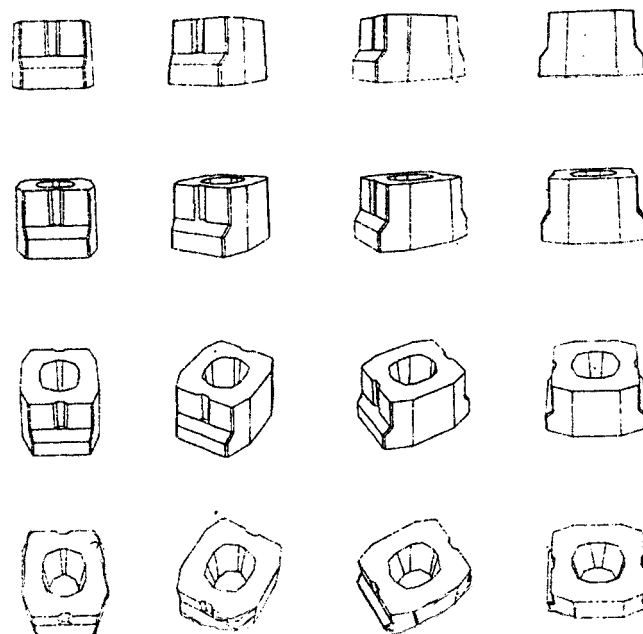
Figure 15. Various views of the "Haro" used in breakwater and groin construction.

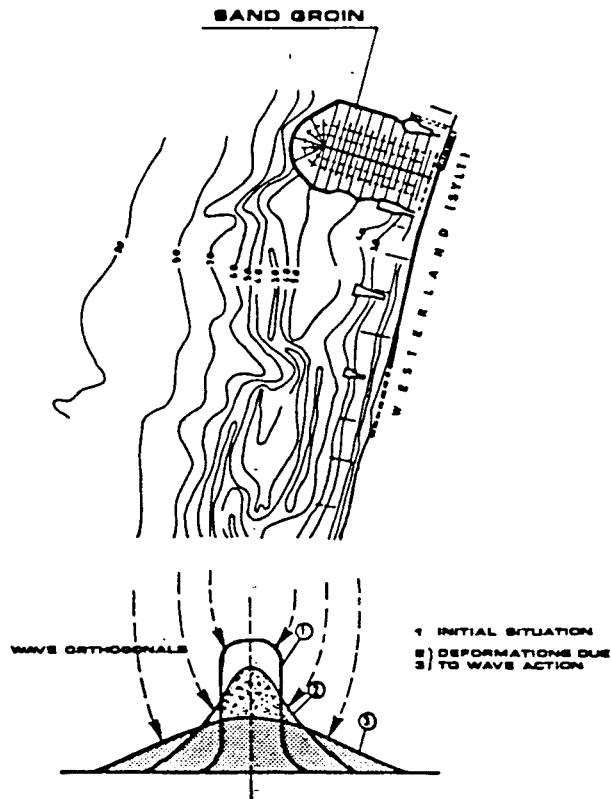
Figure 21. Construction of sand groin as coastal protection, Sylt, West Germany. Source: HAECON N.V., Ghent, Harbour and Engineering Consultants.

Along the coasts of Germany, especially those on the North Sea, situations similar to those of Denmark and The Netherlands prevailed throughout history. The eastern Friesland islands belong politically to Germany but differ in no way from their counterparts under Dutch sovereignty. Groins were implanted along the coast and some failures made history. Beaches on Sylt and Langeoog received artificial nourishment (CHARLIER, DEMEYER, DECROO, 1998) (Figure 21).

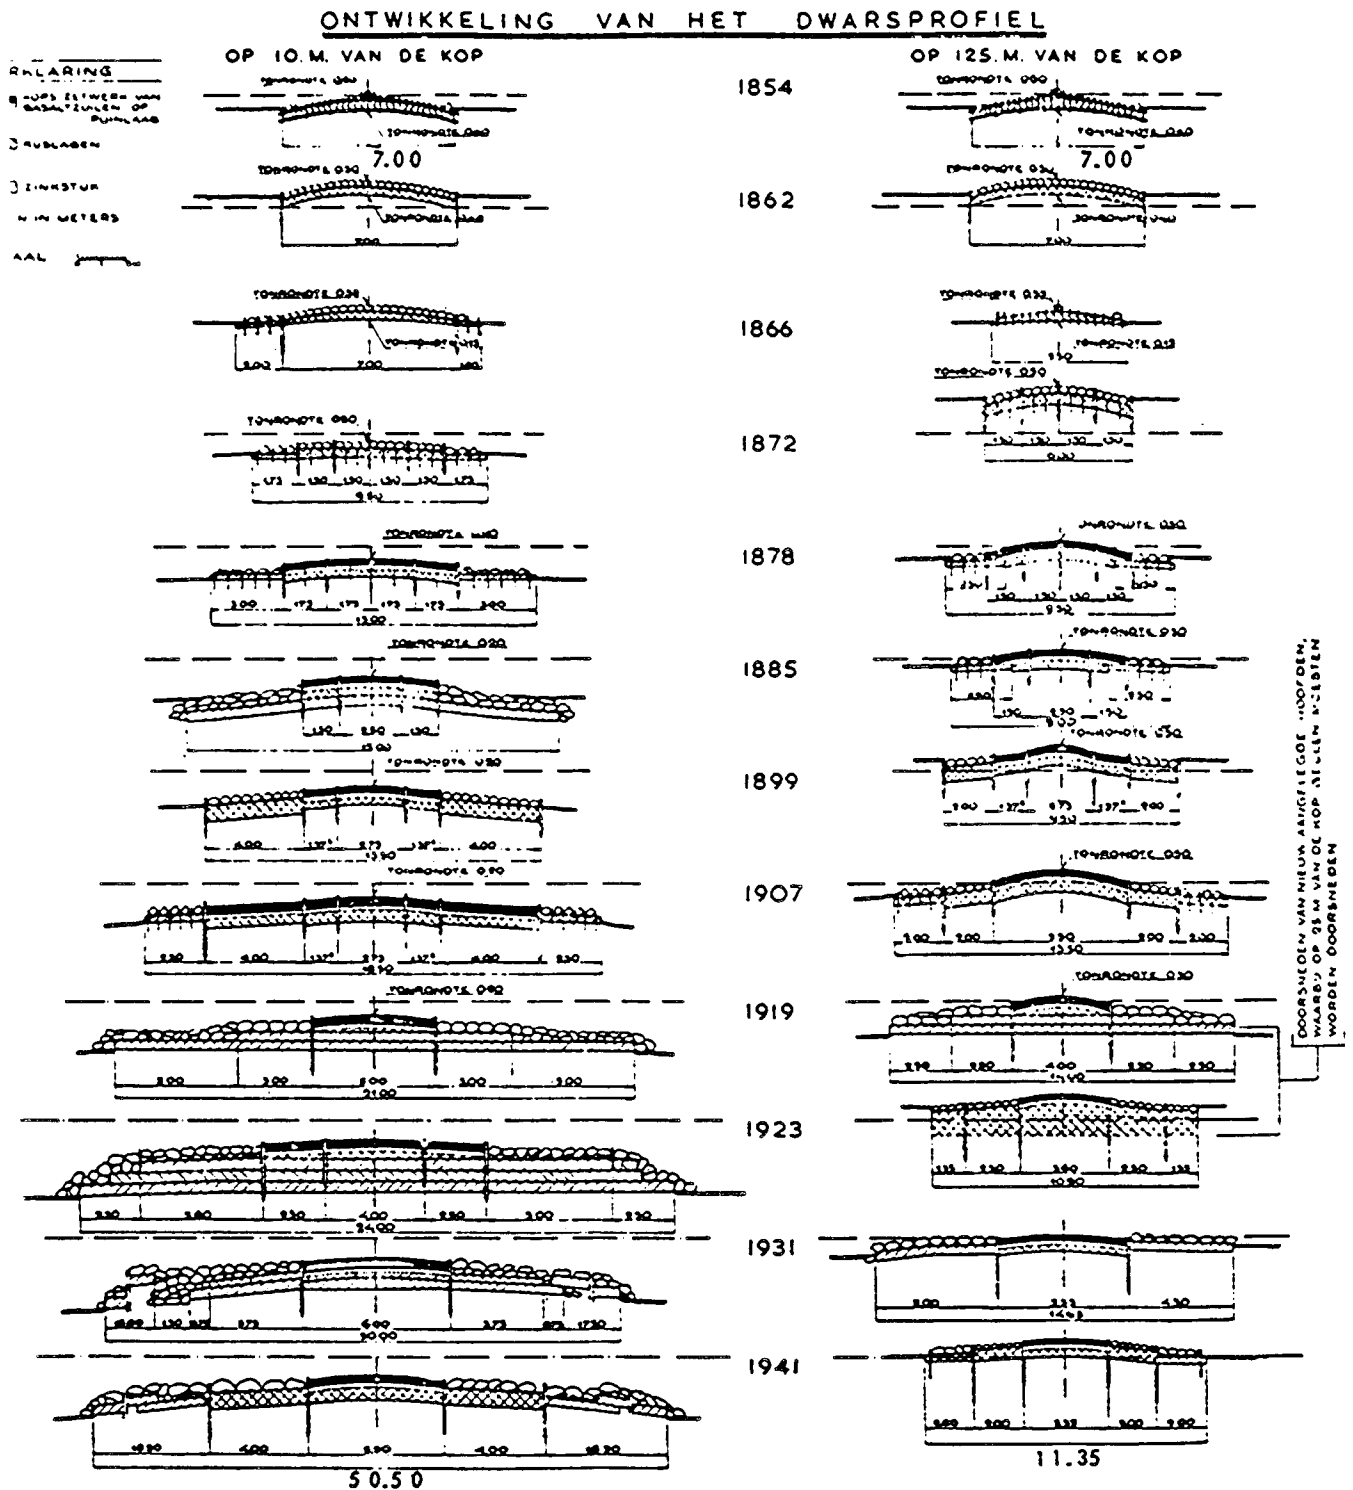
Figure 23. Development of groins in Holland 1854–1941 (Visser, 1953).

Groin-like structures were put in place, in The Lowlands (today parts of The Netherlands, Belgium and Northern France) well before the dawn of the 16th century. There is no information on what they looked like; on the other hand we are far better informed on the history of development of protective structures, streamlined and submitting themselves as little as possible to the forces of waves and currents, covering the last 100 to 150 years. Even though the groins have expanded size-wise, the engineering principles remained the same: stone (rubble) pitching on gravel and mattresses in the center, stones on mattresses on the sides with two, or more, pile walls as supports (Figures 23, 24, 25).

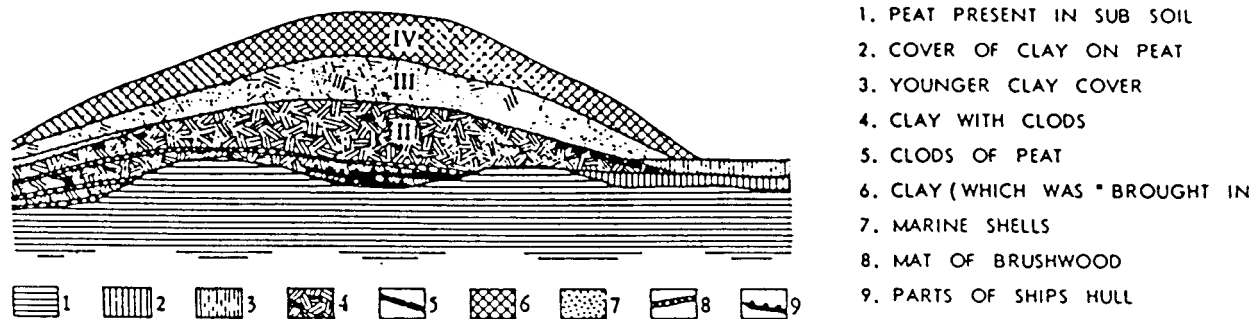
Figure 24. Cross section of ancient dike, Netherlands. ("Antiquity and Survival", 1959).

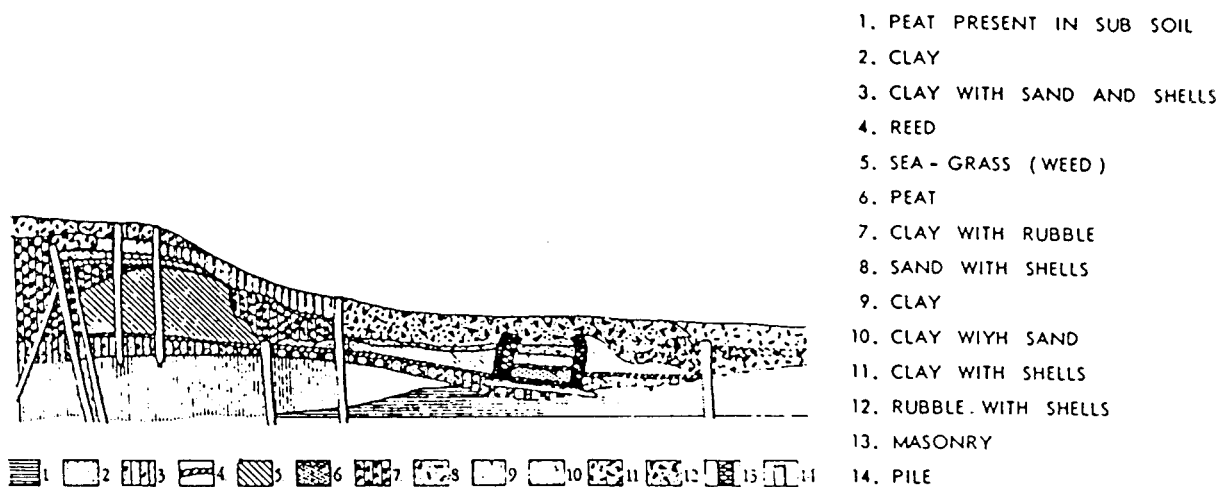
Figure 25. Cross section of ancient dike with pile support ("Antiquity and Survival", 1959).

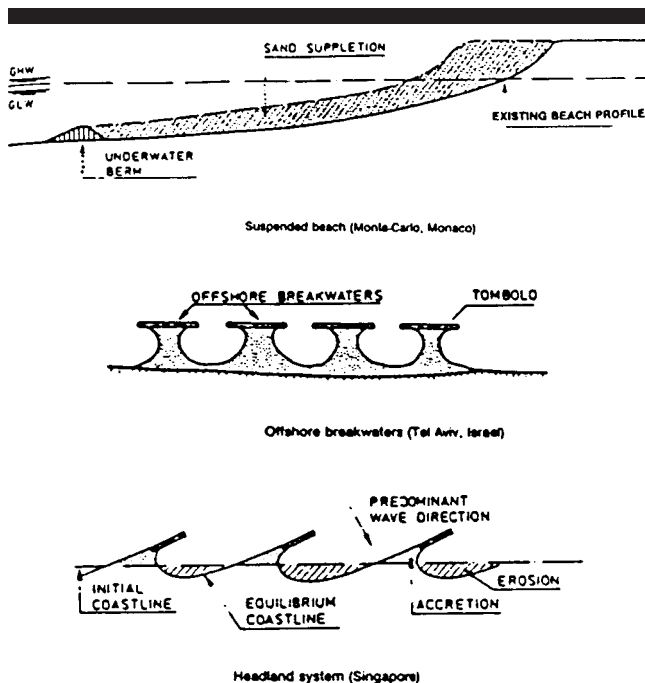
Figures 27–29. Some beach-restoration possibilities. Top, suspended beach (Monte Carlo, Monaco); Center, offshore breakwaters (Tel Aviv, Israel); Bottom, headland system (Singapore). Source: HAECON N.V., Ghent, Harbour and Engineering Consultants, Belgium.

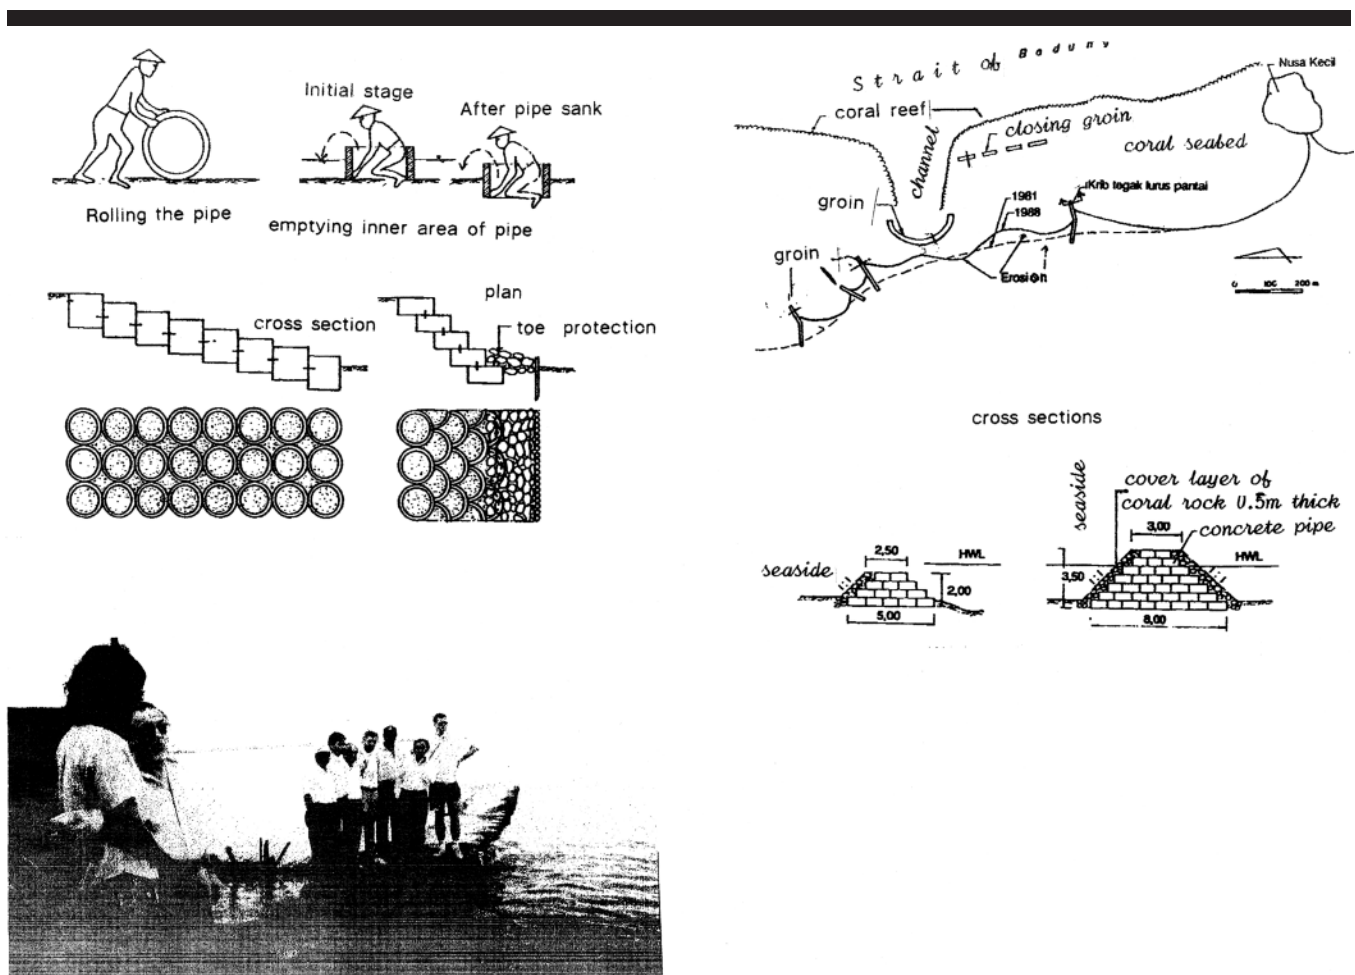
Figure 30B. Java, Indonesia. Concrete round pipes used to build breakwaters near a tourist resort (Belgian co-operation project. Author is second in picture front, to the left).

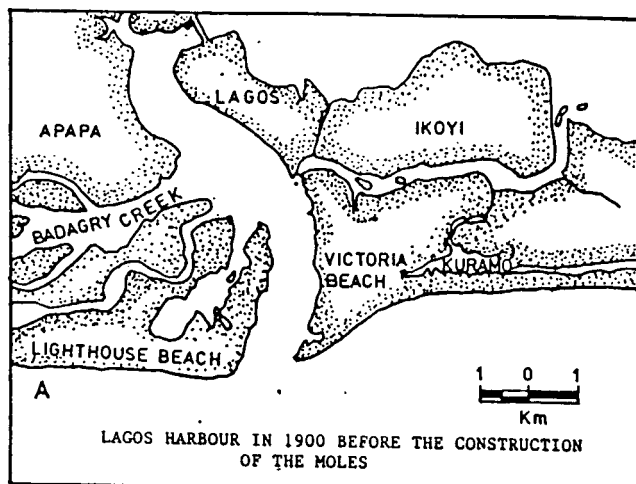
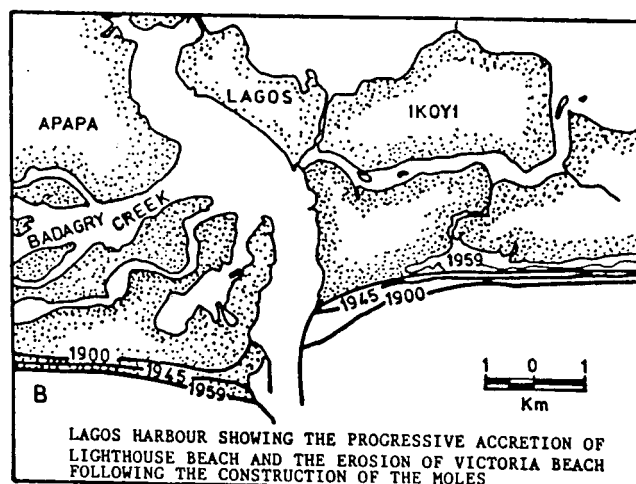
Figure 31. The Lagos coastline before (A) and after (B) the construction of the breakwaters (after IBE *et al.*, 1984).

The West African coastline, southwards of Senegal, has suffered severe erosion for decades, and land loss reached alarming and devastating proportions. Seawalls, groins and revetments have mostly been ineffective in stemming erosion. Local authorities ask for help in sand nourishment projects while recommending simultaneously semi-permeable groins, disused oil field hoses and sand-bagging. Construction of moles in Lagos has caused steady retreat of the coastline since 1900. Shoreline protection schemes include groins on Victoria Island near Lagos (Nigeria) (Figure 33) but also beach nourishment, sea-walls in Dakar (Senegal), groins on Jamestown Beach and revetments on Labadi Beach both near Accra, offshore breakwaters in Conakry (Guinea), St. Louis and Rustique (Senegal). "Local" methods are bulkheads, sand-mattresses and -bagging in Brass (Nigeria), timber groins, Chicoco blocks, wooden bulkheads and afforestation (Figures 31–34).

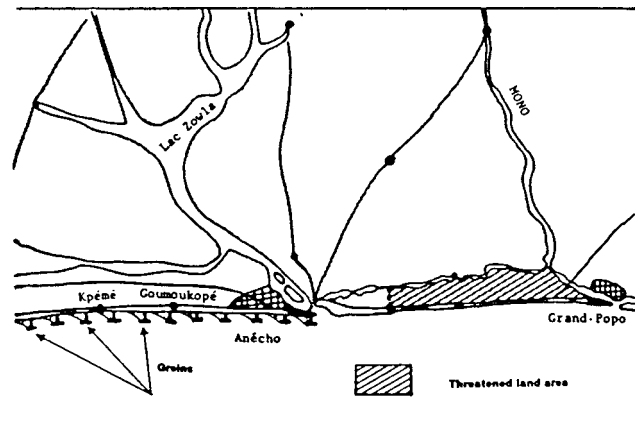
Figure 33. Proposed shoreline protection scheme, Victoria Island Beach. After M. Akle, "Problèmes d'érosion côtière dans le Golfe du Bénin," *Siren* 29 (September 1985): 20–31.

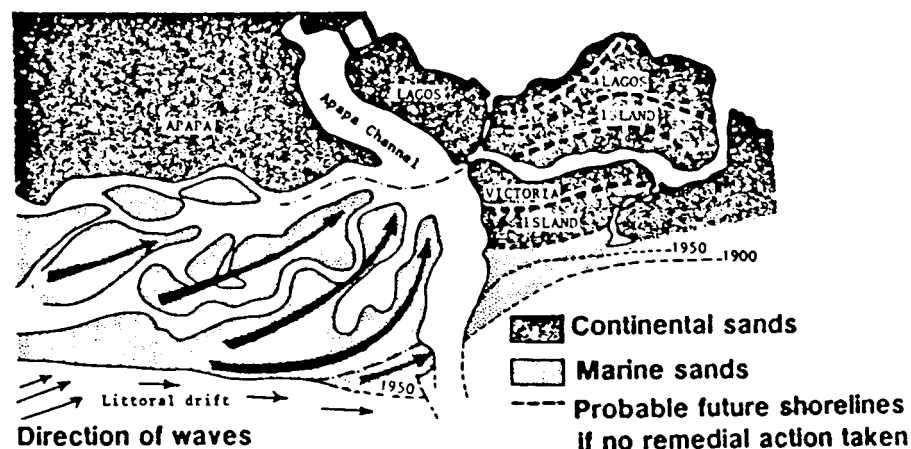
Figure 32. Shoreline shift, Victoria Beach Lighthouse, Lagos. After M. Akle, "Problèmes d'érosion côtière dans le Golfe du Bénin," *Siren* 29 (September 1985): 20–31.

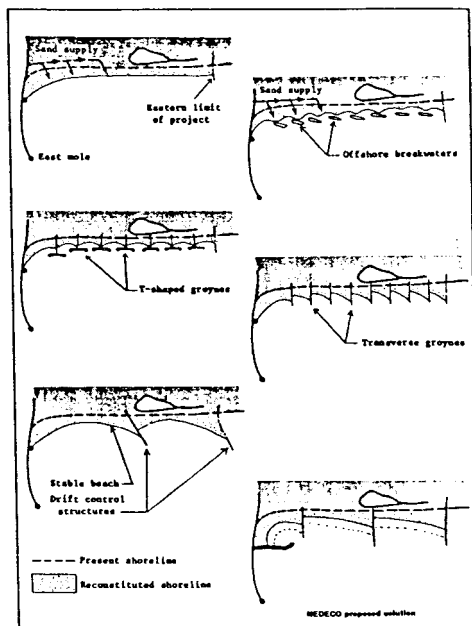
Figure 34. Proposed protection scheme for Kpémé and Aného (Togo).

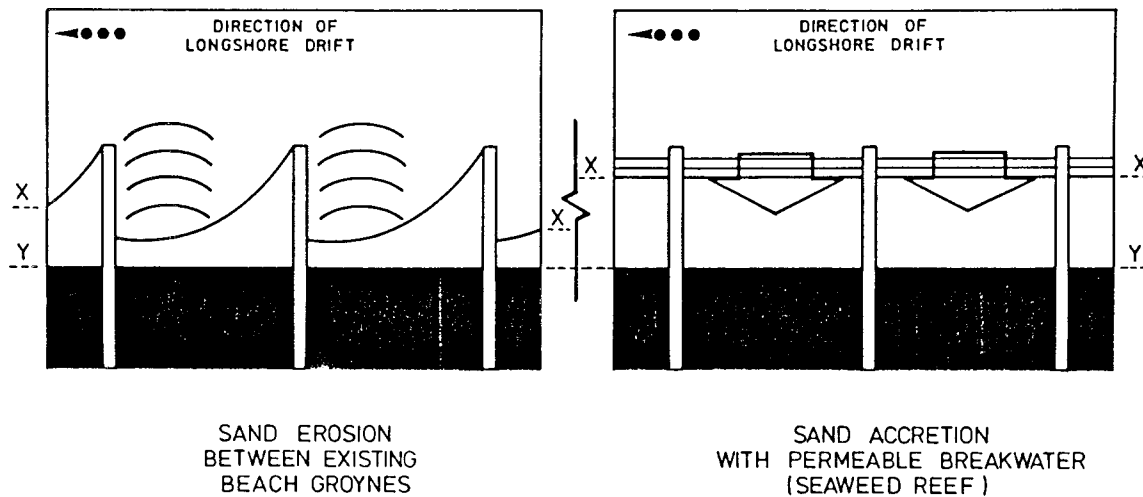
Figure 37. Beach stabilization, scheme with algae.

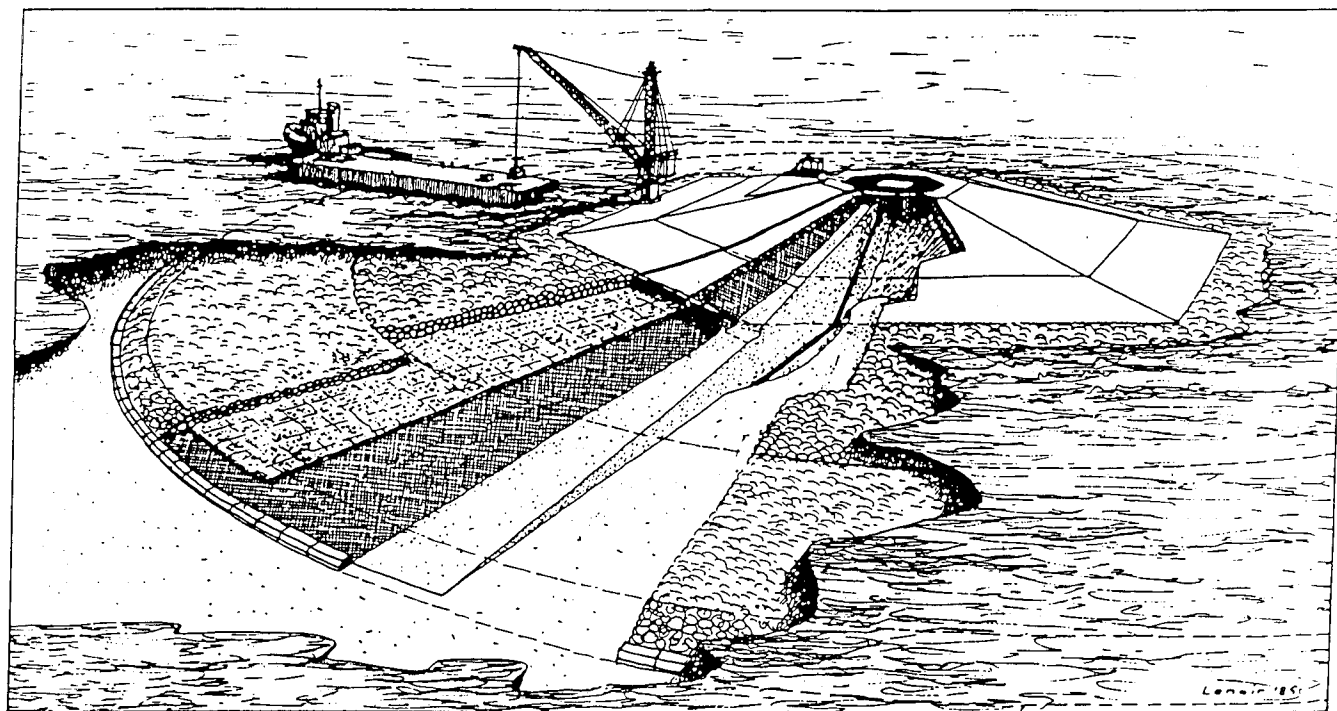
Figure 39. Boskalis Westminster's award winning design for a slope-protected, sand-fill island to be used by the Dutch hydrocarbon company NAM as a pipeline valve station.

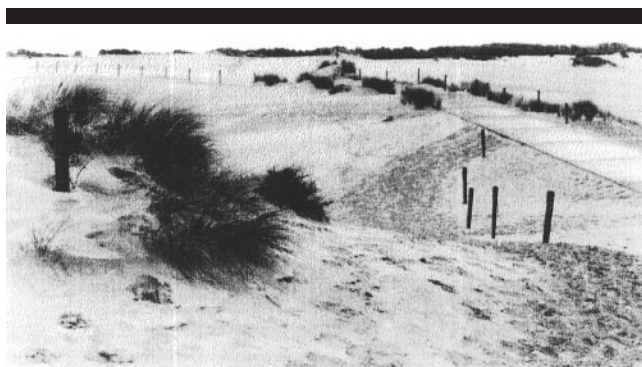
Figure 41. Entrance channels provided for the sea into the dunes where once armored seawalls had toe protection. Photograph courtesy Flemish daily from Ghent; Belgium "Het Volk".
