# The Protection/Hardening of California's Coast: Times Are Changing

Source: Journal of Coastal Research, 35(5): 1051-1061

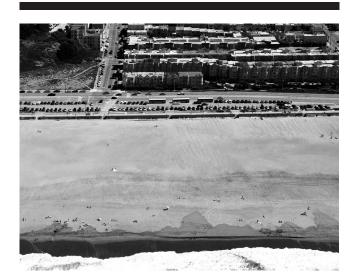
Figure 4. The O'Shaughnessy Seawall along San Francisco's Ocean Beach is one of the oldest in California and was designed and built to withstand every potential type of failure. (Photo courtesy of Kenneth and Gabrielle Adelman, California Coastal Records Project.)

The O'Shaughnessy seawall along Ocean Beach in San Francisco was arguably one of the earliest, largest, and best engineered structures built along the California shoreline in the last century. O'Shaughnessy, the city engineer for San Francisco, considered every possible way in which a seawall might fail and then designed the wall to withstand all of those possibilities. The 1407-m-long (4600-ft-long) structure was completed in 1929 and has effectively protected the Great Highway ever since (Figure 4). The wall extends about 6 m (20 ft) above and below sea level, was built in freestanding sections such that failure of one part would not compromise the adjacent sections, and has a drainage system to deal with overtopping and runoff. An additional factor in the long-term survival of this massive wall was its construction on the back beach, such that it has not been regularly exposed to the impacts of large waves. It was built for a total cost of \$600,000 at that time (or \$425/m; \$130/ft) and was extended southward about a decade ago at a cost of just over \$38,260/m (\$11,700/linear ft, in 2018 dollars). Constructing the original 1407 m of seawall today would cost about \$53 million.
