Rocky Headwaters in the Dolomites, Italy: Field Observations and Topographic Analysis

Source: Arctic, Antarctic, and Alpine Research, 40(4) : 685-694

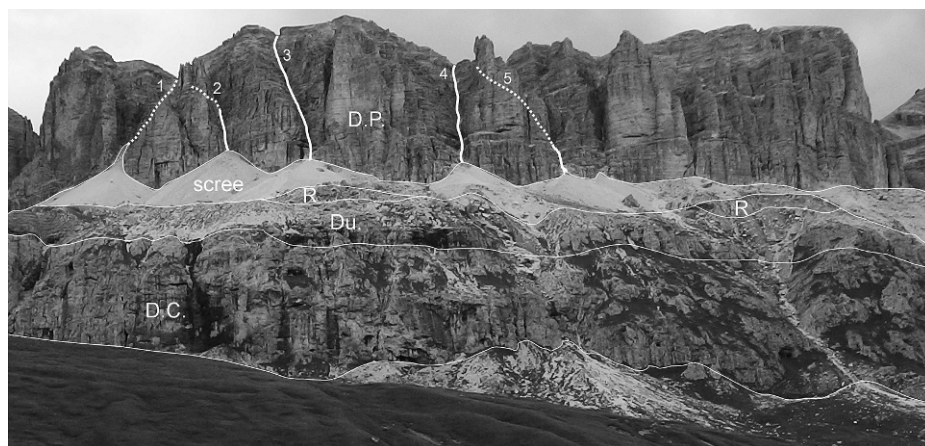
FIGURE 2. Rocks outcropping in the study area and rocky couloirs surveyed in the field (nos. 1 to 5). Dotted lines indicate couloirs hidden by rock slopes and not visible in the photo. Rock formations: D.C.: *Dolomia Cassiana*; Du.: *Dürrenstein Formation*; R.: *Raibl Formation*, D.P. *Dolomia Principale*.

In the study area, the Raibl Formation is almost completely covered by scree deposits from the overhanging cliffs of *Dolomia Principale* (Fig. 2). The abundant debris from the *Dolomia Principale* is consistent with its intense fracturing (Antonellini and Mollema, 2000) and stratification, which can be assumed to be the main joint family. In the scree belt that covers the Raibl Formation, debris cones are prominent, with apexes located at the outlet of couloirs that cut the superjacent rock slope (Fig. 2). These debris cones are a widespread landform in the Dolomites, as well as in other alpine regions (Pech and Jomelli, 2001). This study focuses on rock basins and couloirs that entrench the upper parts of dolomite cliffs, corresponding to outcrops of *Dolomia Principale* (Figs. 1 and 2). In most of the studied area, the *Dolomia Principale* has an average thickness of about 270 m, exceeding 300 m in the easternmost sector. Figure 1 shows the rock basins in the study area, and the interbasins (rock facets) between the basins and the scree slopes. The numbers 1 to 8 in Figure 1 identify the rock basins in which field observations were carried out.

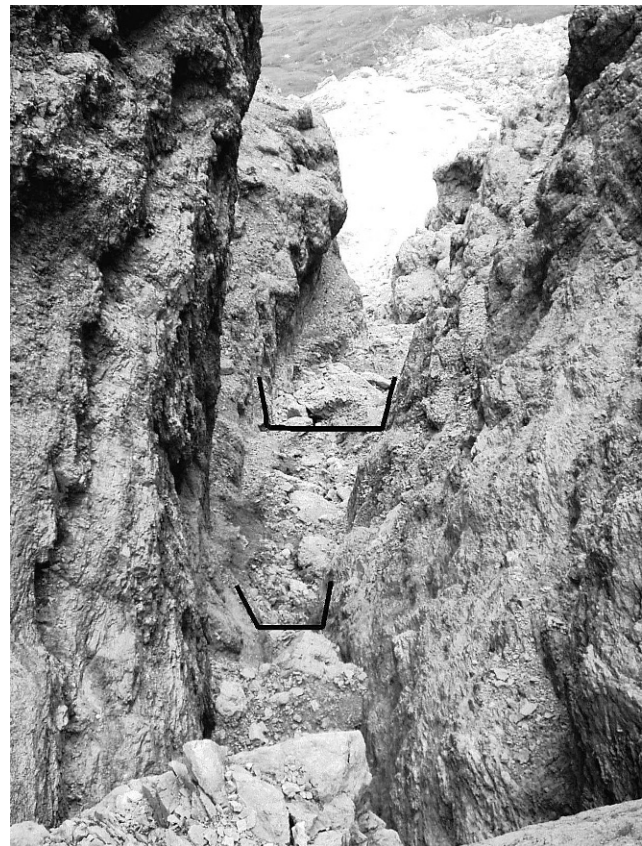
FIGURE 7. Sketch of two cross-sections surveyed in the rocky couloir no. 4.

Figure 6 shows the longitudinal profiles of the studied couloirs. Total length differs remarkably between couloirs, while the patterns of the profiles remain similar. Longer couloirs (nos. 1 and 3) originate close to the catchment divide, whereas the other catchments have a longer unchanneled valley between the divide and the upper end of the couloir. Although overall profiles are roughly linear (Fig. 6), alternating stretches with different gradients, ranging from short reaches with comparatively low slopes ($<0.5 \text{ m m}^{-1}$) to high-gradient steps, were observed in some cases (as is mentioned in the comments of Fig. 5). The floors of low-gradient reaches act as storage areas for debris coming from upstream and from lateral rock faces, while debris are often missing in high-gradient steps. The cross sections display flat floors and vertical or subvertical side slopes, resulting in rectangular or, less frequently, trapezoidal shapes (Fig. 7).
