Three Recent and Lesser-Known Glacier-Related Flood Mechanisms in High Mountain Environments

Source: Mountain Research and Development, 42(2)

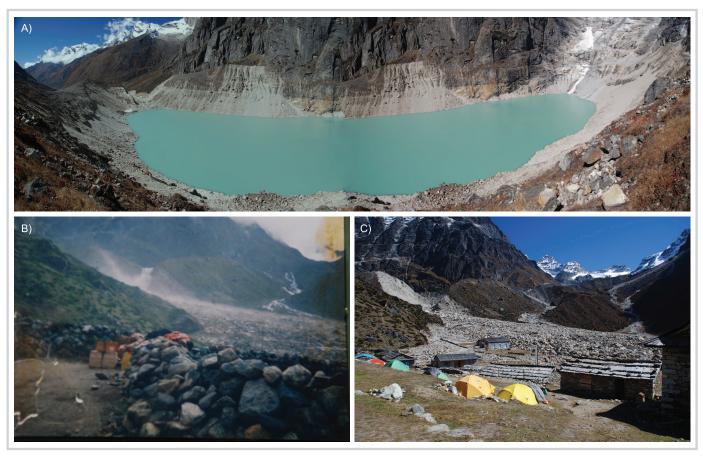
FIGURE 2 (A) Tama Pokhari in the Makalu-Barun National Park, Nepal, provides a good example of a lake where a glacial lake outburst flood (GLOF) was triggered by an ice avalanche from overhanging ice (far right of the photograph). The flood occurred on 3 September 1998. In 2010 the breached terminal moraine can be seen to the far left. (B) One of the only known photographs of a GLOF in progress at its source. Water can be seen cascading over the Tama Pokhari's newly breached terminal moraine, which reportedly was repeated in a series of distinct waves. (C) The same general location in 2010, showing the extensive damage caused to what had been the northeastern section of Tagnag village (4350 m). Downstream impacts were also considerable. (Photos A and C by Alton C. Byers; B by Lhakpa Sherpa)
