Marambaia Bay, Restinga da Marambaia (Rio de Janeiro, Brazil).

Source: Journal of Coastal Research, 39(2)

COVER PHOTOGRAPH

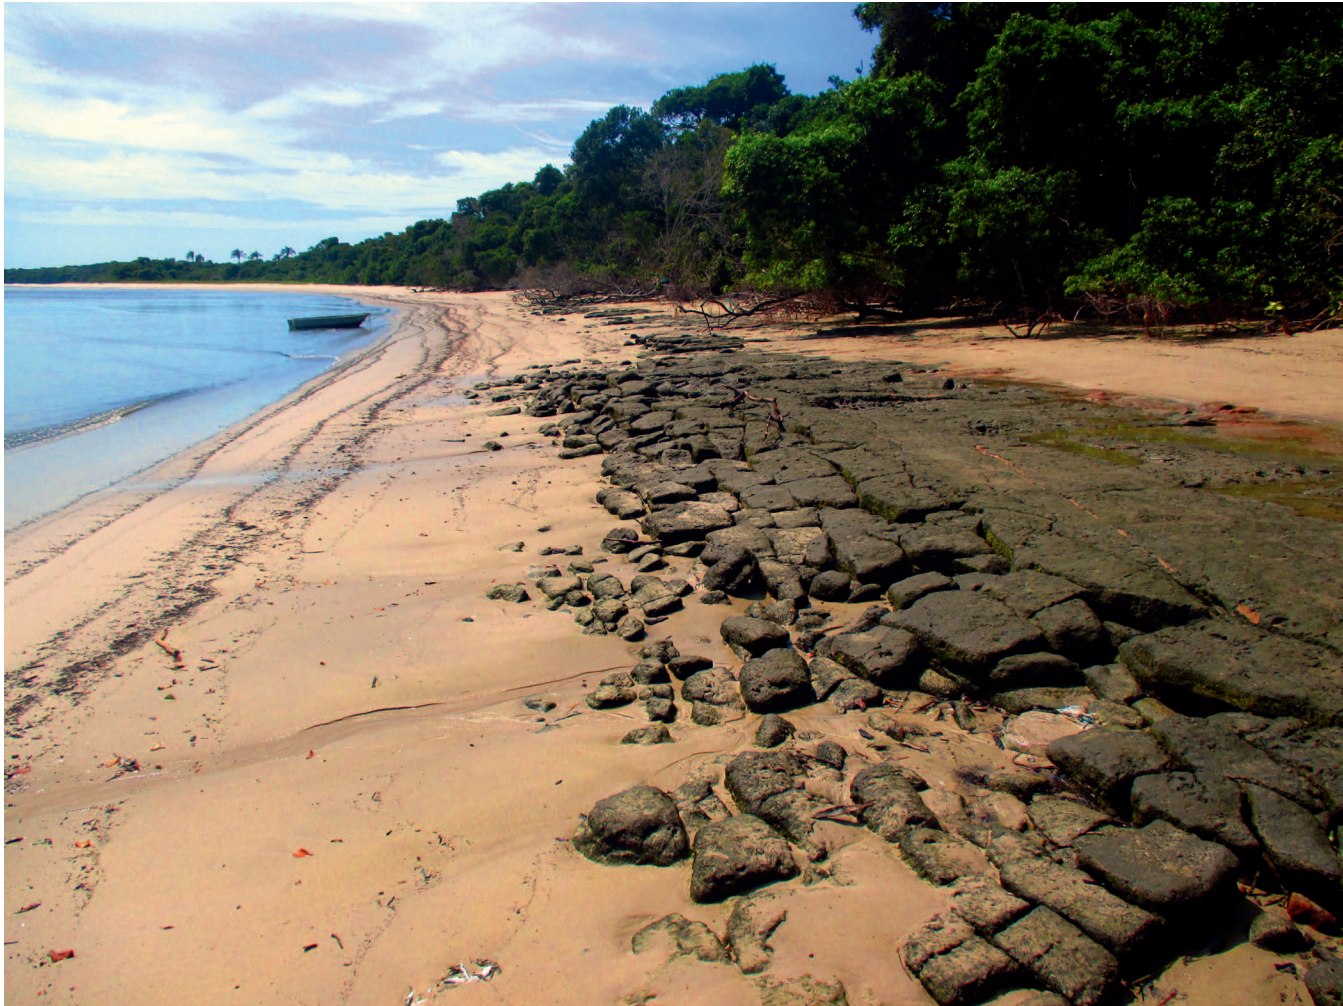
Marambaia Bay, Restinga da Marambaia (Rio de Janeiro, Brazil). Marambaia Bay is located along the Marambaia barrier island western sector (on its northern margin) and faces Sepetiba Bay, which runs the southern coastline of Rio de Janeiro state (SE Brazil). The development of the “Marambaia barrier island – Sepetiba Bay – Marambaia Bay” complex is not fully understood, but recent research indicates that the barrier island began its formation Mid-Holocene, under normal regressive conditions. Marambaia Bay is set in a sector composed of beach ridge truncations and by the presence of a flying spit (Ponta da Pombeba). Sepetiba Bay circulation is influenced by fluvial discharge in its eastern section and by an exchange with the adjacent ocean, especially in its western section as the barrier island affects this process. The tides play a fundamental role, being the main component for current flow inside both bays.

Marambaia Bay exhibits a sedimentary coverage of very fine sand with some regions of very coarse silt that are moderately sorted. Morphological characteristics of the Marambaia Bay shoreline indicate areas of extreme sediment removal, with erosive scarps that translate as a flat and retinalized shoreline. As shown in the photograph above, the predominance of sediment removal allows for the exposure of sandstones that are cemented by organic material and iron oxides. This feature is semi-consolidated, composed of coarse to medium fine sand and covered by what seems to be humic acids. Similar features were found in other sites along the Rio de Janeiro coastline and are associated with pedogenetic processes common in barrier islands during the Holocene. (Photograph taken on 6 March 2015 by Breylla Campos Carvalho, Instituto Brasileiro de Geografia e Estatística (IBGE), Rio de Janeiro, RJ, Brazil.)
