# Risk-conscious Reconstruction in Pakistan-administered Kashmir

## A Case Study of the Chakhama Valley

Markus N. Zimmermann<sup>1\*</sup> and Shireen S. Issa<sup>2</sup>

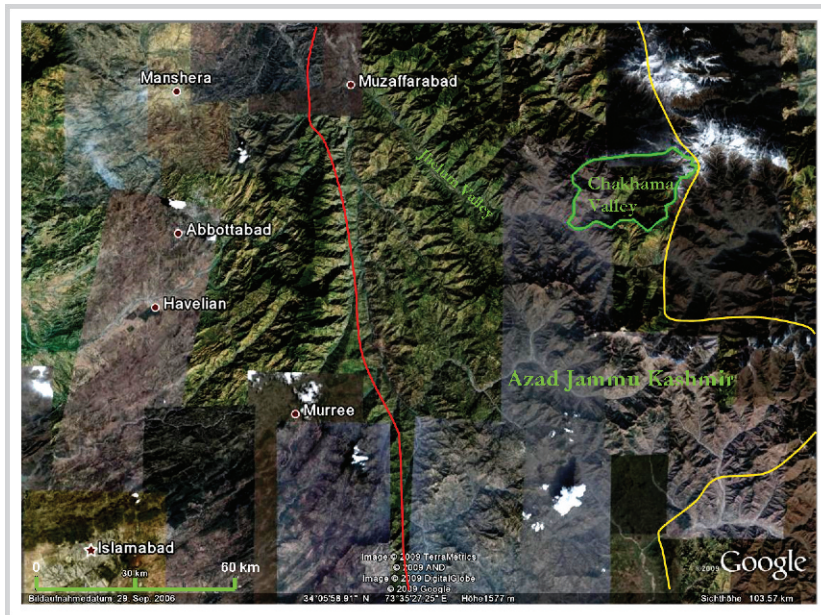
**FIGURE 1** The Chakhama Valley along the Jhelum River. The orange line marks the “Line of Control” between India and Pakistan; the red line marks the border between Pakistan and Azad Jammu Kashmir (borders not authoritative). (Source: Google Earth; accessed on 18 April 2009)

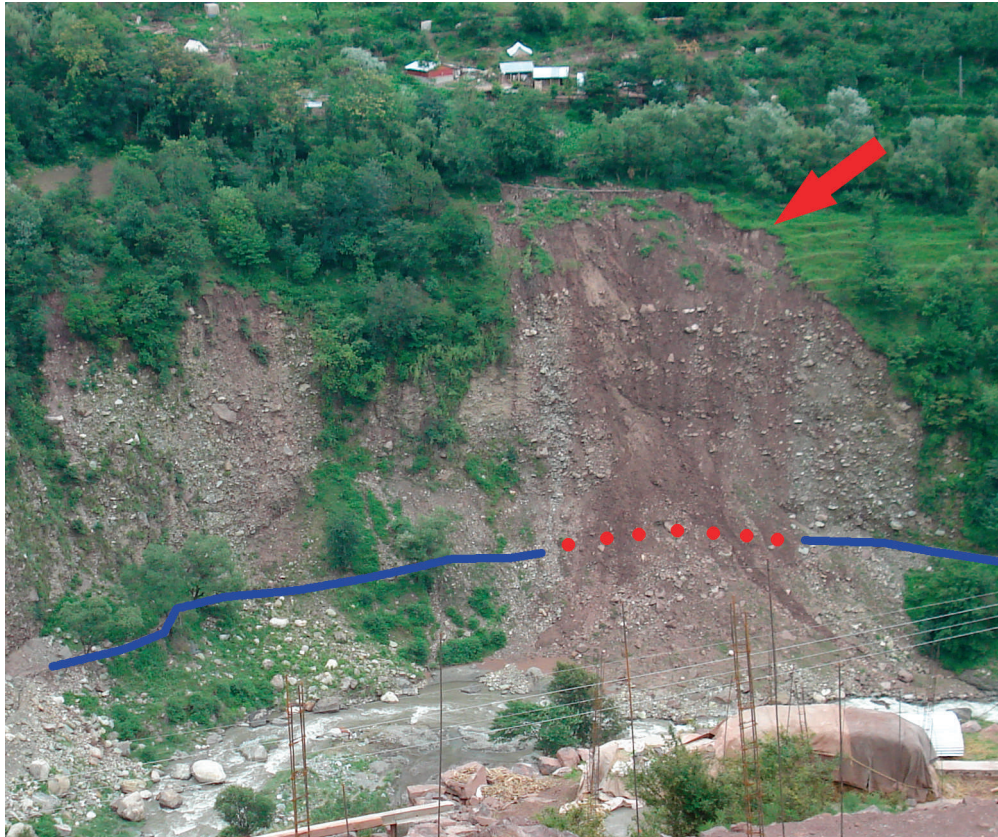
**FIGURE 6** Kathai irrigation canal (blue line); most critical section for rehabilitation (red dots) with highly unstable slope above (arrow). (Photo by Markus Zimmermann, 3 July 2007)

The slopes along the canal are of an alluvial nature, comprising gravel, cobbles, and boulders with sand and silt. The slopes are generally stable in dry conditions but begin to move when saturated, particularly in the upper portions. Landslides, slope failures, and falling debris after heavy rains in early 2007 caused significant damage to the canal (Figure 6).

At critical points where landslides were a particular threat (Figure 6), the canal was protected with concrete slabs so that debris could flow over the covered/slabbed section of the canal. Retaining walls were constructed where required. In the most critical section, the freshly accumulated debris in the canal was carefully stabilized for rehabilitation.
