## **A Conceptual Model for Rehabilitation of Puna Grassland Social–Ecological Systems**

Source: Mountain Research and Development, 43(4)

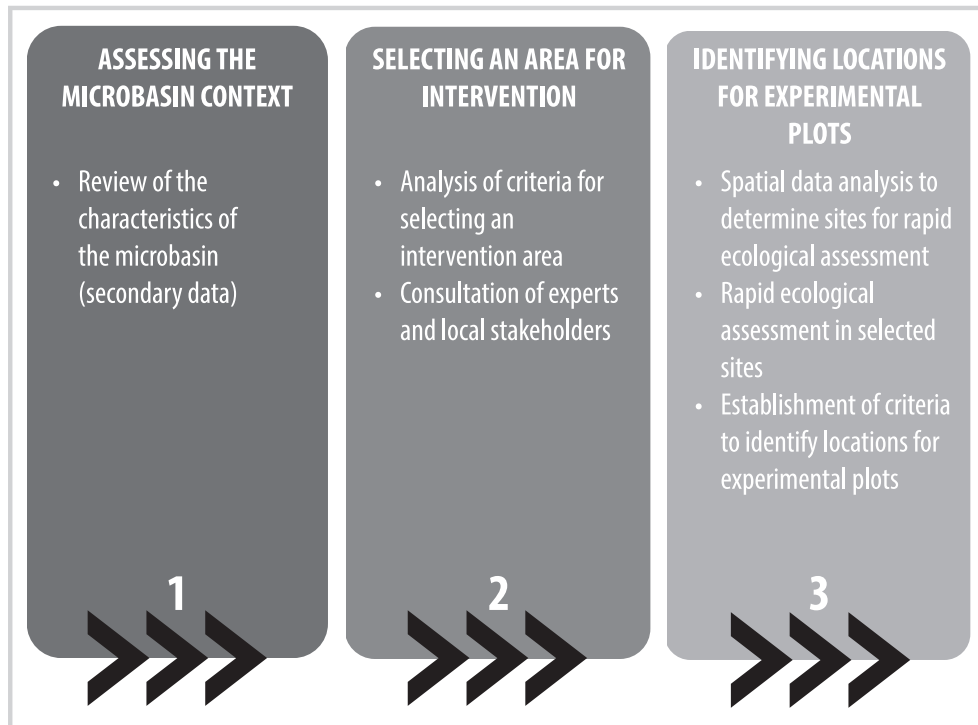
**FIGURE 3** Steps to selecting sites for experimental plots to recover hydrological functions in microbasins. (Figure by Angela Mendoza-Ato)

**Site selection for experimental plots:** There are 3 steps in selecting sites for plots, namely assessing the biophysical context, selecting an area, and identifying specific plot locations (Figure 3). We assessed the context by analyzing primary and secondary data, such as precipitation and temperature, soil characteristics, soil humidity, and vegetation composition; all of these variables are key drivers of mountain ecosystems. Understanding the context allowed us to adjust the research and next steps at the plot scale. To select an area to set up the plots (ie the rehabilitation pilot site), the following parameters were used: slope, vegetation cover of the headwaters, and contribution of the headwaters to hydrological recharge and regulation. In our case, the area selected was the Umasbamba Valley (Quebrada Umasbamba), with slopes of less than 20°, different land covers (including a site with terraces), and an normalized difference vegetation index between 0.185 and 0.275. At this point, we approached the authorities of the Indigenous peasant community of Umasbamba to ask for a social license. After this, the authorities were involved in deciding on potential sites for a rapid ecological assessment and in applying the assessment. The rapid ecological assessment evaluated vegetation, the physical and chemical composition of soils, and soil hydrology. Three vegetation types were identified: short grasses, tussock grasses, and a mix of both (ecological

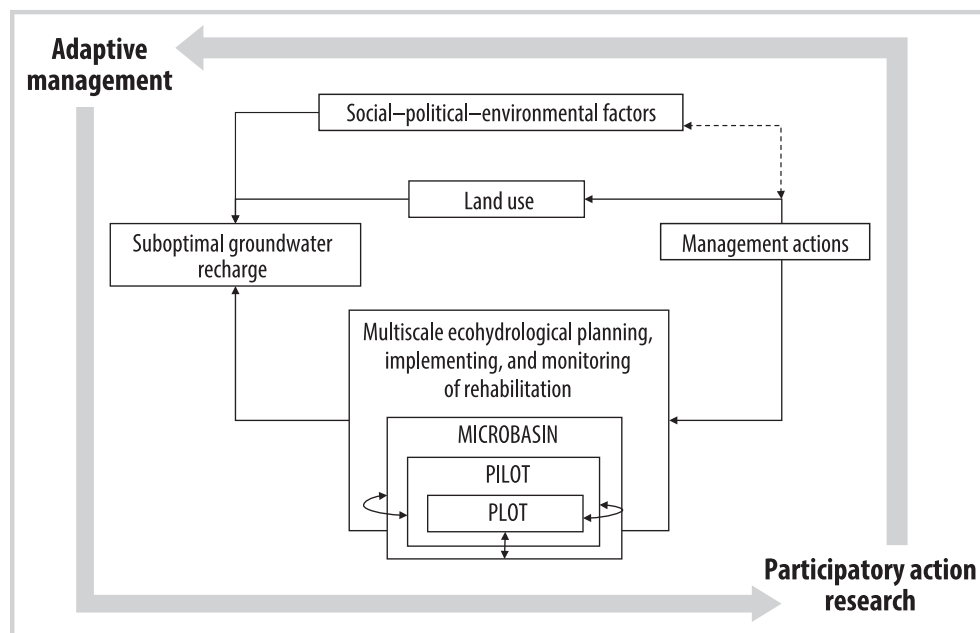
**FIGURE 5** Conceptual model for rehabilitation in a microbasin with an ecohydrological approach. (Figure by Angela Mendoza-Ato and Julio C. Postigo)

Our model proposes multilevel rehabilitation of hydrological services in the puna grassland social–ecological system that begins at the plot and scales up to the microbasin (Figure 5). The spatial unit of observation and analysis is the plot. The knowledge gained at this scale provides a foundation for understanding both the condition of the ecosystem and the rehabilitation actions required. This knowledge stems from carefully identified relevant variables and systematic and consistent data collection using appropriate and calibrated instruments. Sound data analysis generates useful knowledge to select our sites and distribute our plots, covering the diverse locations and the heterogeneous mosaic of puna grassland.

The participatory approach involves the integral participation of the local stakeholders in all the stages of the rehabilitation process (Figure 5). This type of participation increases the legitimacy and sustainability of rehabilitation. In practical terms, the participatory approach entails that community members, government agencies, and

hydrological functions. Another management action mentioned in Figure 5 is land use, which does not necessarily aim to improve ecosystem functioning but will affect groundwater recharge. The model recognizes the influence of sociopolitical–environmental factors on management, and vice versa. These factors are among the causes of land degradation, which, in turn, is one of the drivers of the reduced groundwater recharge (Malik et al 2014). Addressing these factors entails management measures ranging from capacity building to participatory monitoring, as well as the involvement of all local stakeholders throughout the rehabilitation process (from planning to implementation) and in all scaling phases (from plot to microbasin scale).
